Central Coast Council
Terrigal Boardwalk
Geotechnical Interpretive Report

TBP-GE-GN-RPT-002

Rev A | 6 November 2018

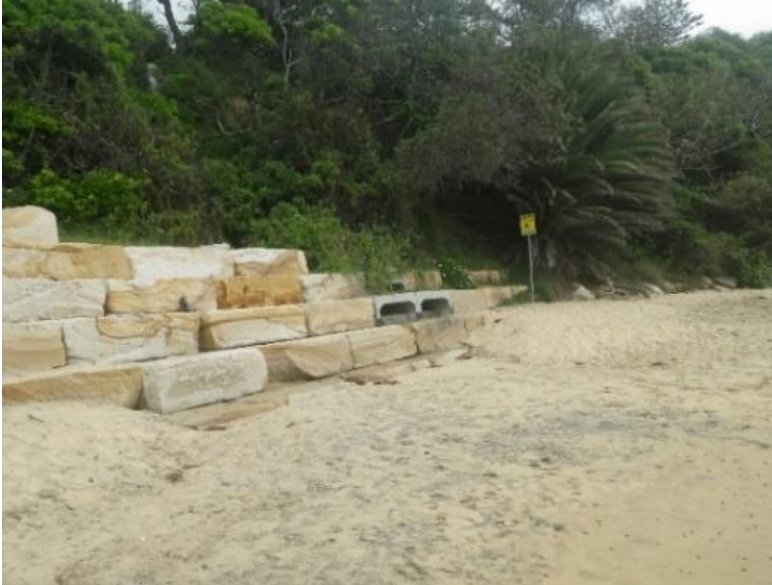
Figure 7 - Wall and vegetated slope in Domain 1

The slope stability hazards identified within Domain 1 are deep-seated rotational landslides or smaller surficial soil debris slump/flow.

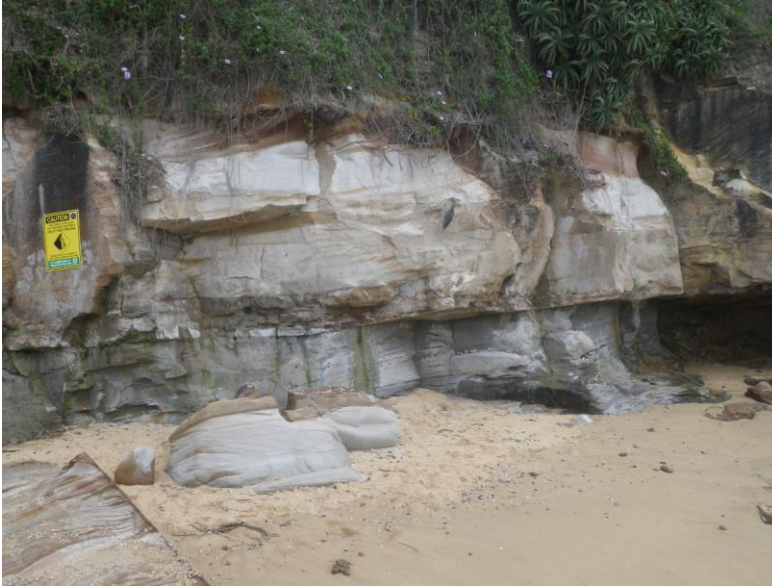
Figure 9 - Domain 3 cliff face

Slope hazards present in Domain 3 are larger rockfalls (>0.5m diameter) and debris flows off the crest. The weaker siltstone layers has not been significantly eroded in Domain 3.

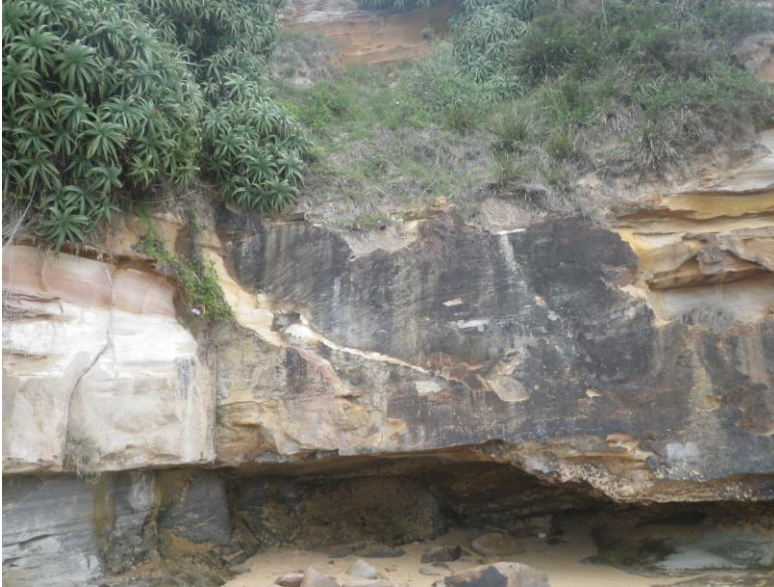
Figure 10 - Domain 4 cliff face

The slope hazards identified with Domain 4 are rockfalls, debris flows, and cliff collapse from wave erosion.

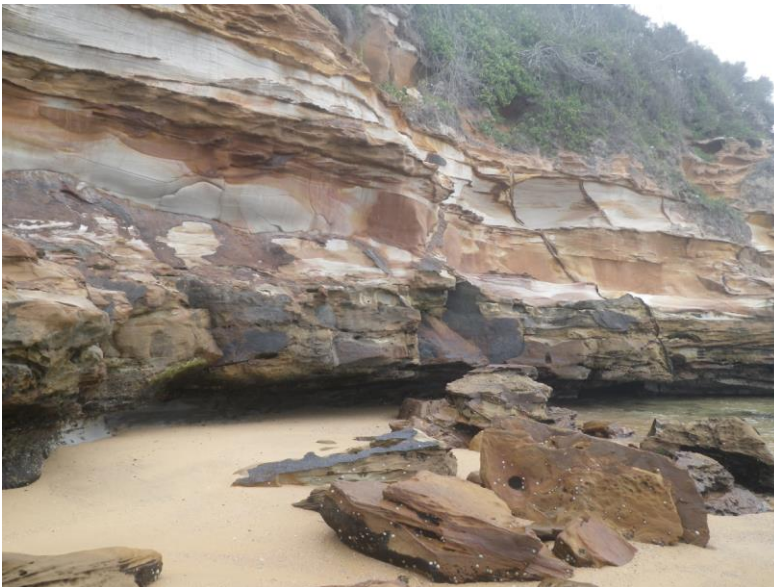
Figure 11 - Domain 5 cliff face

The major hazard within Domain 5 is cliff collapse from the wave erosion of the weaker siltstone and undercutting the sandstone. Debris flows off the crest and smaller rockfall are also identified hazards.

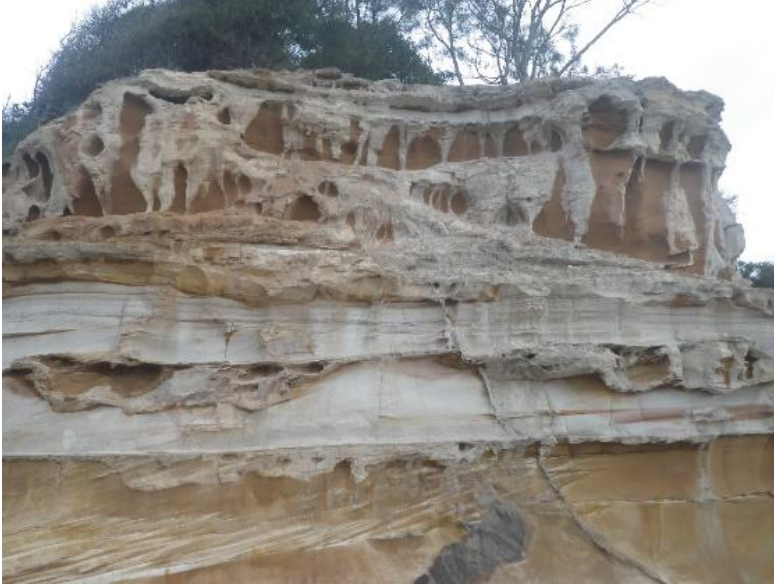
Figure 12 - Domain 6 (cliff nose) cliff face

Rockfall hazard exists out of the steep cutting.

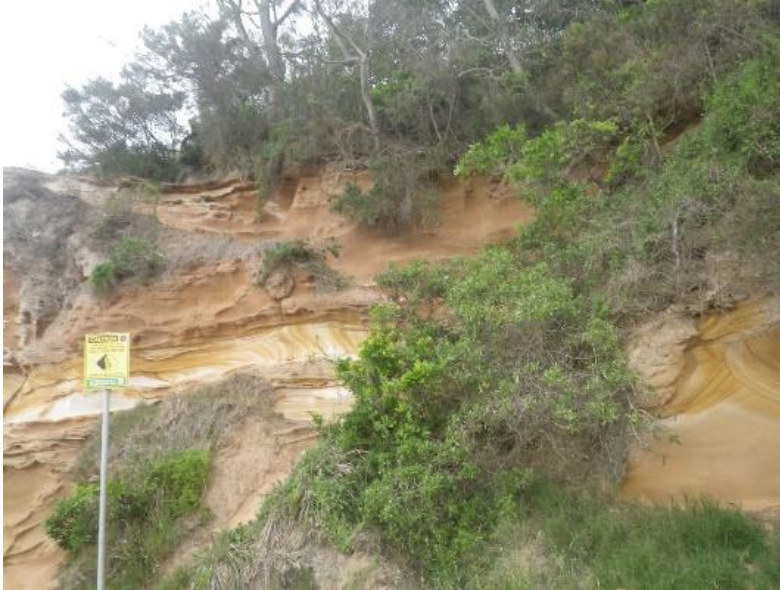
Figure 13 - Domain 7 cliff face

Debris flows are the main slope hazard present.

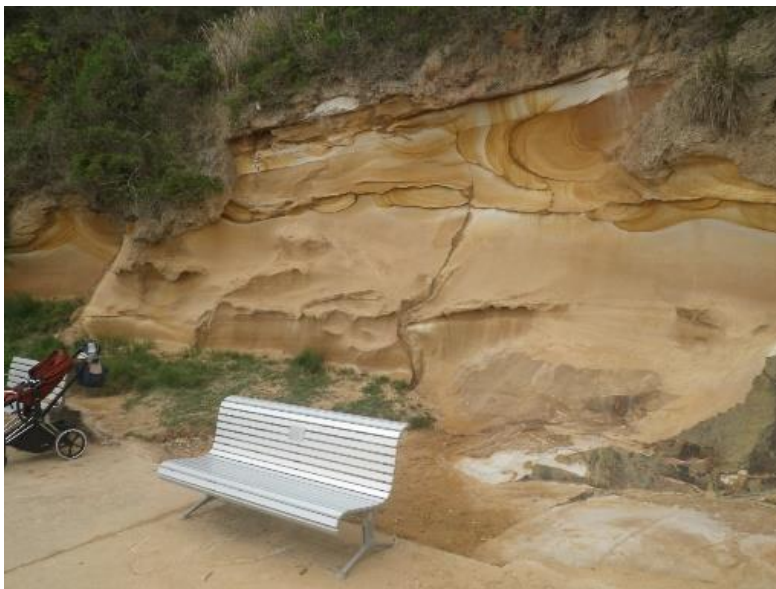
Figure 14 - Footpath, bench, and cliff face in Domain 8

The main hazard present in Domain 8 is rockfall and debris flow off the crest.

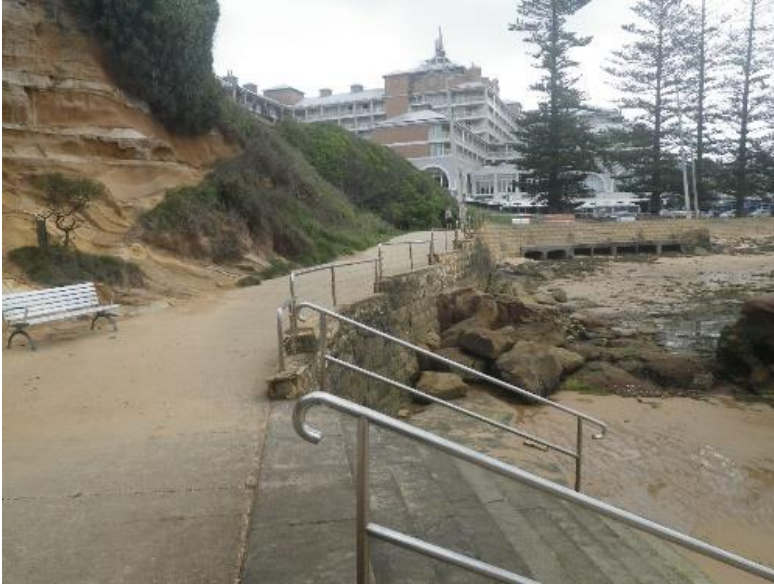
Figure 15 - View of Domain 9 (vegetated slope) from Domain 8

Landslide is the identified hazard in Domain 9.
