Report on
Preliminary Site Investigation for Contamination

Proposed Rezoning for Residential Development
15 Mulloway Road, Chain Valley Bay

Project 83024.00
August 2016

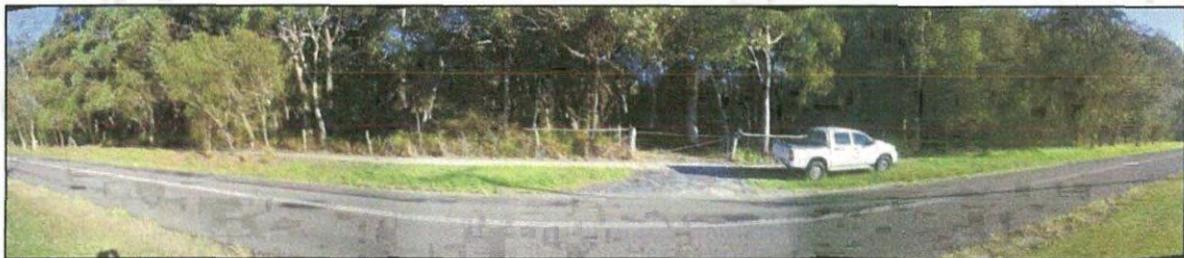
Figure 8 – Photograph from Mulloway Road showing bushland vegetation with single driveway access into site – looking south.

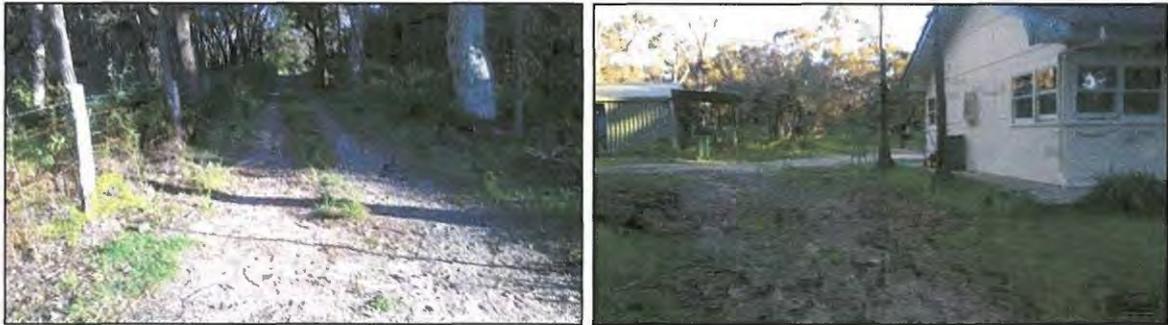
Figures 9 and 10 – Photograph of access driveway into site from Mulloway Road with some recycled aggregate materials used to surface the driveway. Photograph of residence and detached shed. The shed was used to house several cats, with a tractor parked under the attached awning.

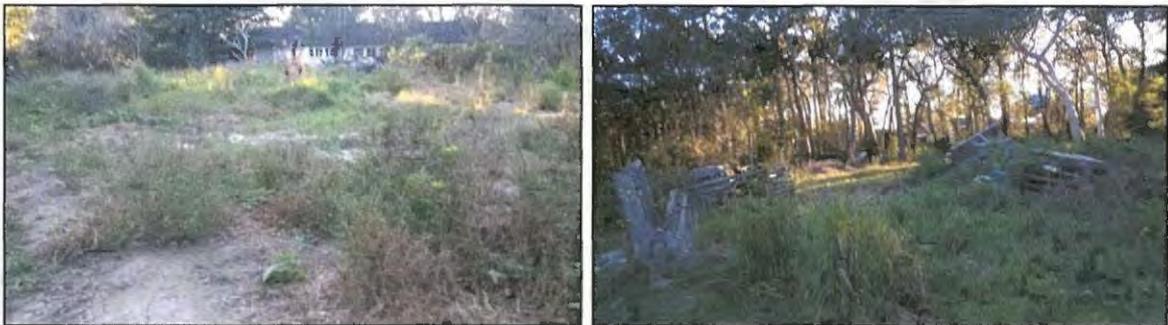
Figures 11 and 12 – Inspection of the general site conditions in the locality of the residence indicated that the area immediately to the south was cleared with a scattered grass/weed cover. Surface soils appeared to have been disturbed in the past possibly as a result the livestock known to occupy the site. Various materials and debris (i.e. mix of metal, timber, plastic, concrete and foam) were stored in this portion of the site.

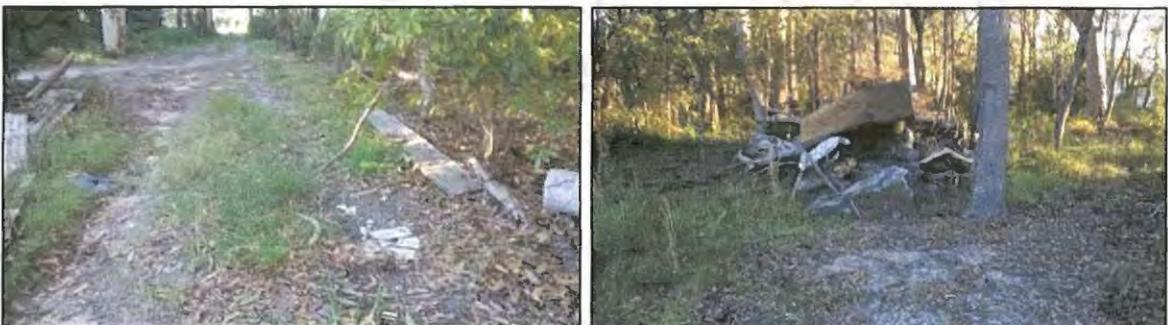
Figures 13 and 14 – Photograph of various materials and debris were stored in general locality of the residence (refer to Drawing 1, Appendix A). Materials observed comprised a mix of metal, timber, plastic, concrete and foam, a derelict truck, tractor and trailer, and small quantities of suspected asbestos-containing-material (ACM) fragments were observed at the ground surface (refer to Figure 13) at three locations.

Prior to completion of the further intrusive contamination investigations it is recommended that a licensed contractor is engaged to remove all debris and waste materials and suspected ACM fragments observed at the ground surface (refer to Drawing 1, Appendix A).

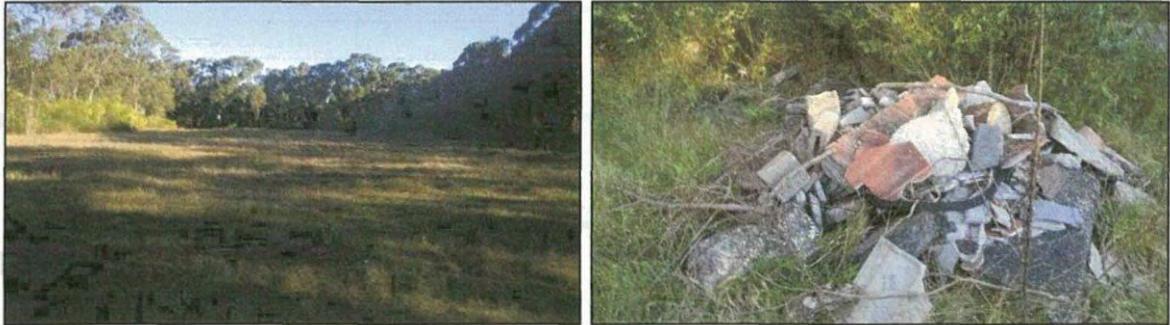
Figures 15 and 16 – Remaining portions of the site comprised bushland with several grass surface clearings linked with typically unsurfaced access tracks. No obvious signs of widespread filling were identified during the walkover, however, isolated areas on the tracks appeared to have been resurfaced with concrete rubble. Small stockpiles of building waste materials (i.e. mix of brick, concrete, tiles and metal - refer to Figure 16), soils and timber logs (suspected to be sourced from fallen trees) were observed during the walkover. No additional suspected ACM fragments were observed at the surface of the stockpiles.
