FINAL REPORT:

The Hawkesbury-Nepean River System Estuary Bank Erosion
Assessment and Options Report

December 2022

Hawkesbury-Nepean River System (HNRS) Coastal Management
Program (CMP) – Stage 2

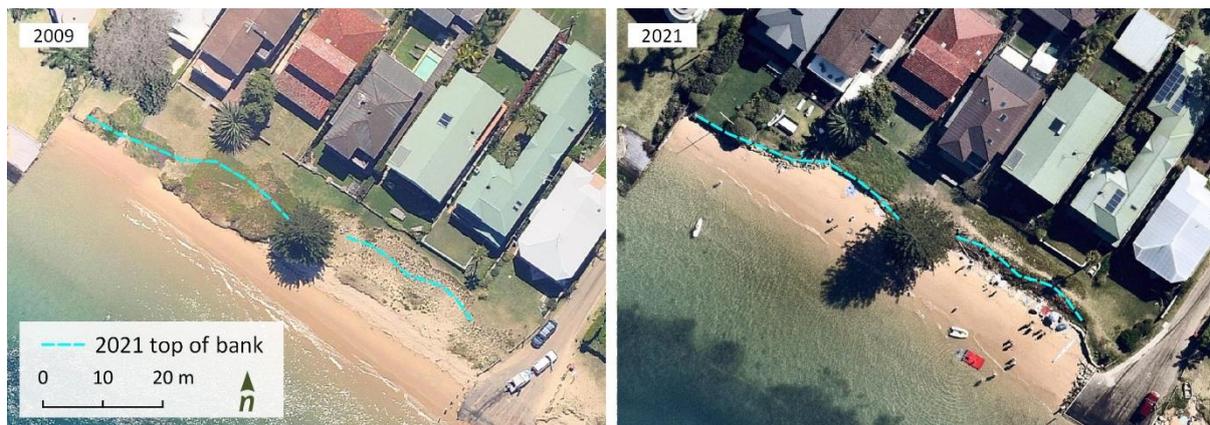
Figure 5. Multi-temporal aerial imagery analysis at Sand Point Beach, Pittwater, showing up to 10 m of bank retreat between 2009 and 2021.

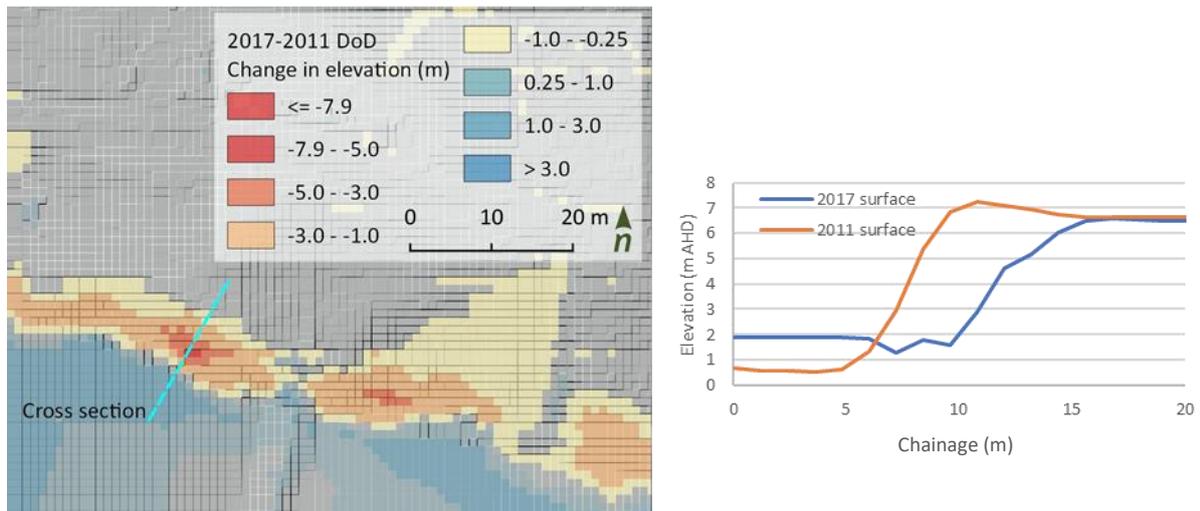
Figure 7. Example of DoD analysis between 2017 and 2011 on the Hawkesbury River at Holmes Drive Reserve. Cross section comparison of bank morphology shown on right.

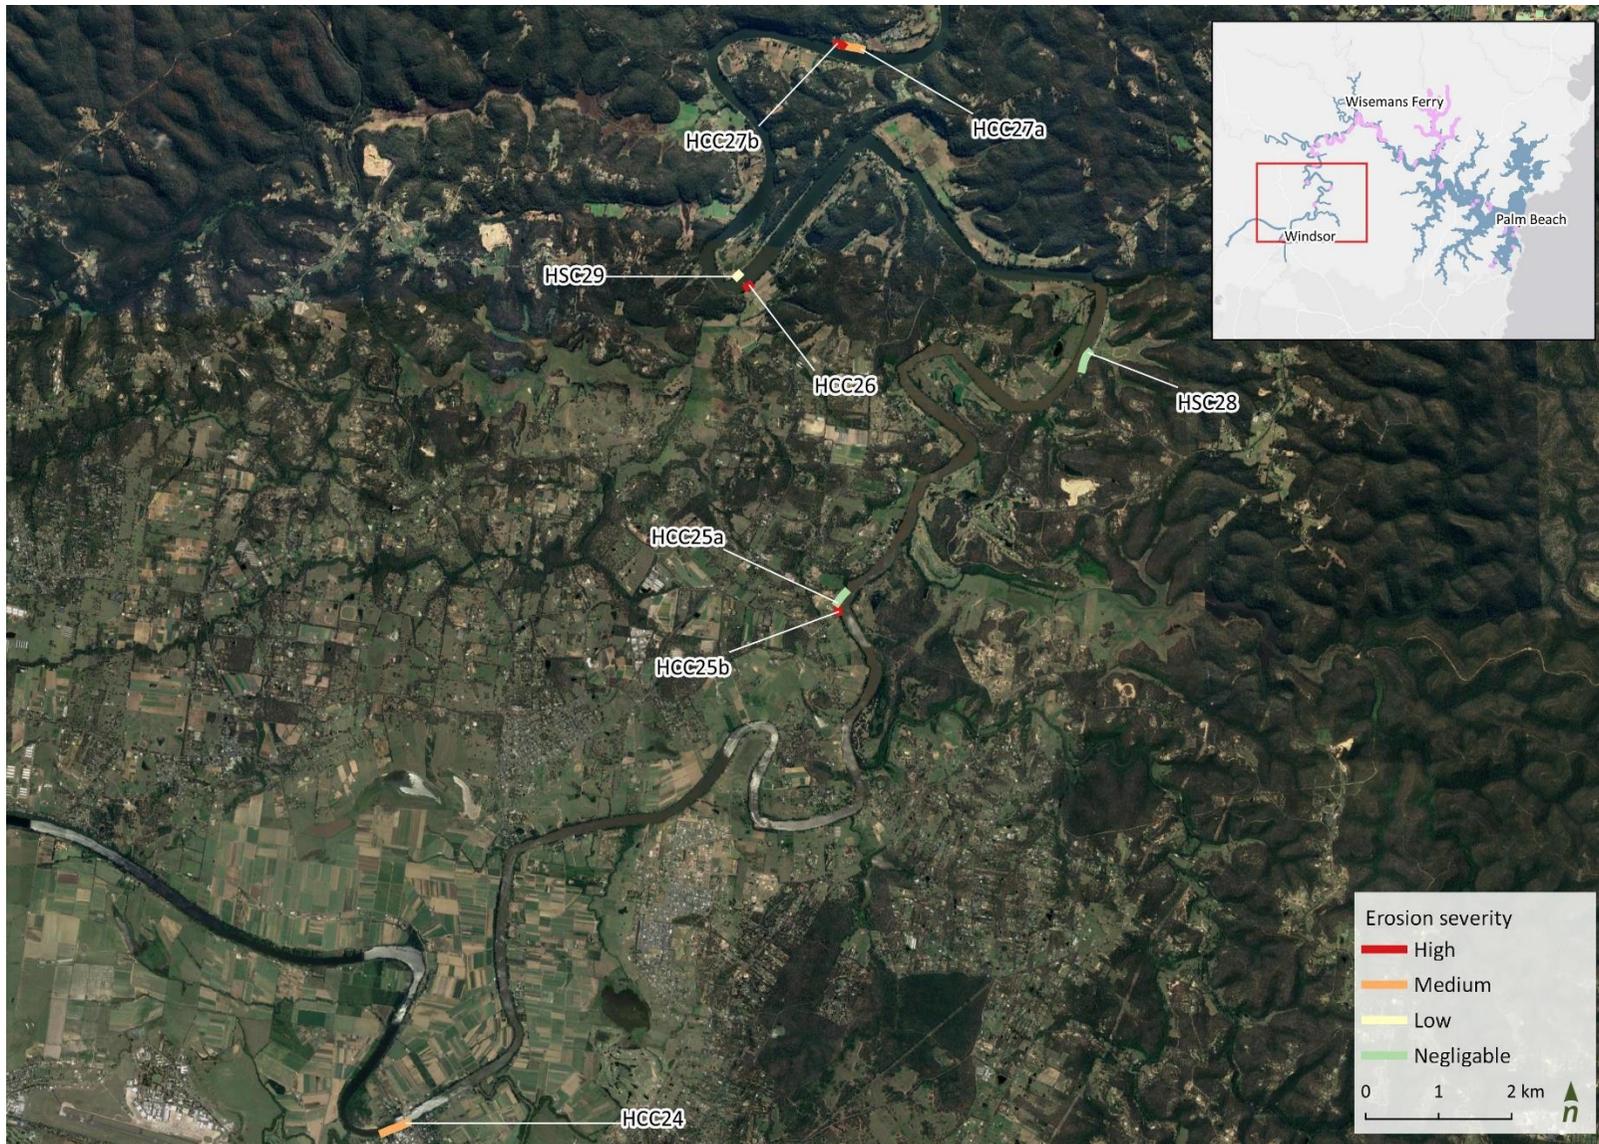
Figure 16. Erosion severity at the full bank erosion assessment sites between Windsor and Cumberland Reach

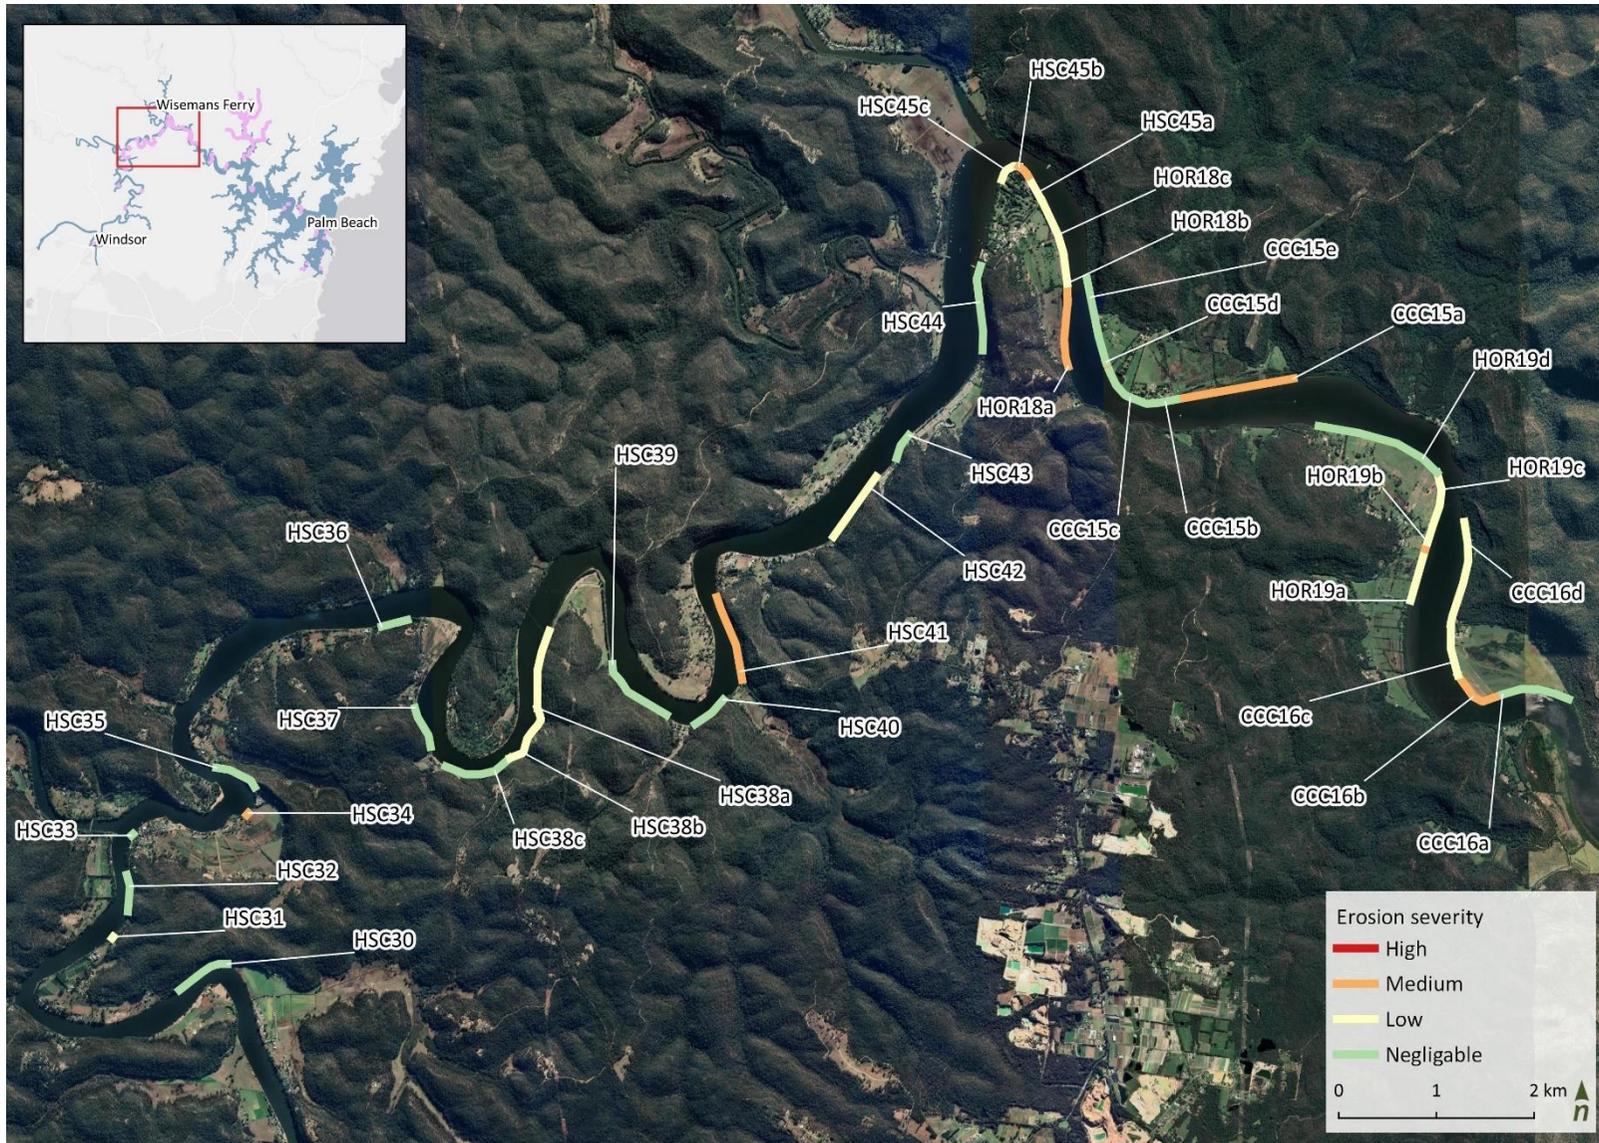
Figure 17. Erosion severity at the full bank erosion assessment sites between Portland and Laughtondale

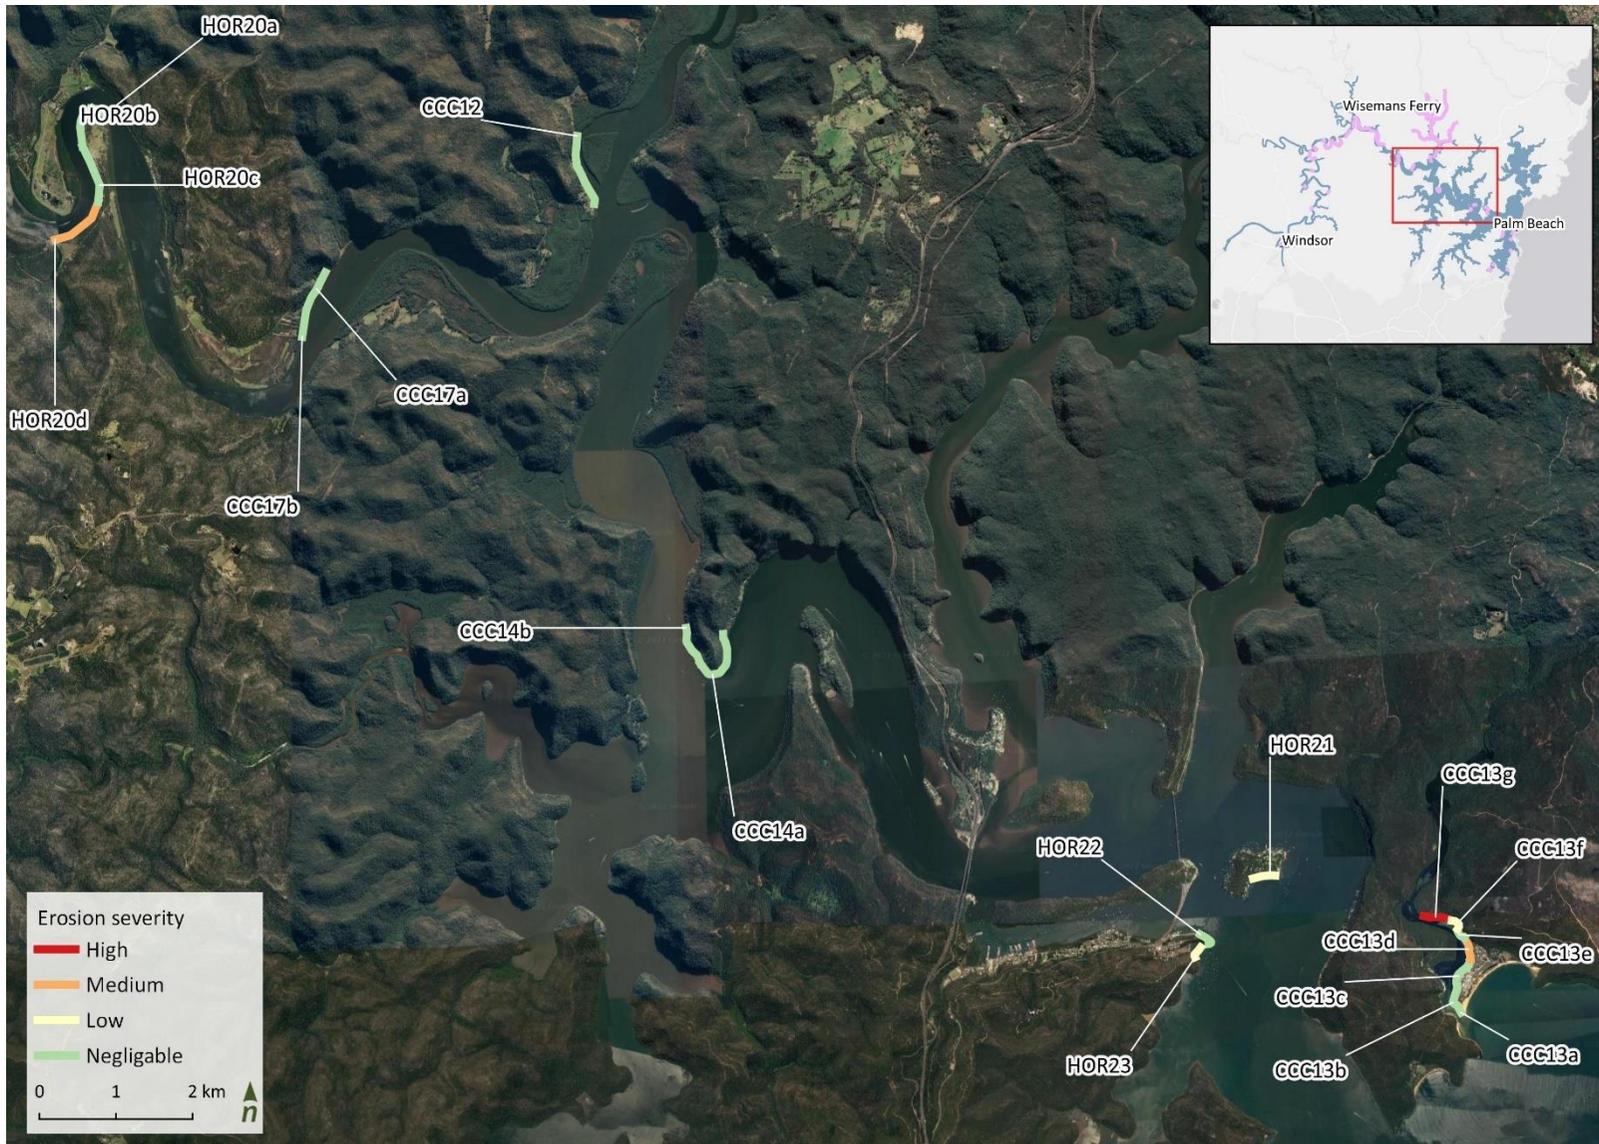
Figure 18. Erosion severity at the full bank erosion assessment sites between Singleton's Mill to Patonga

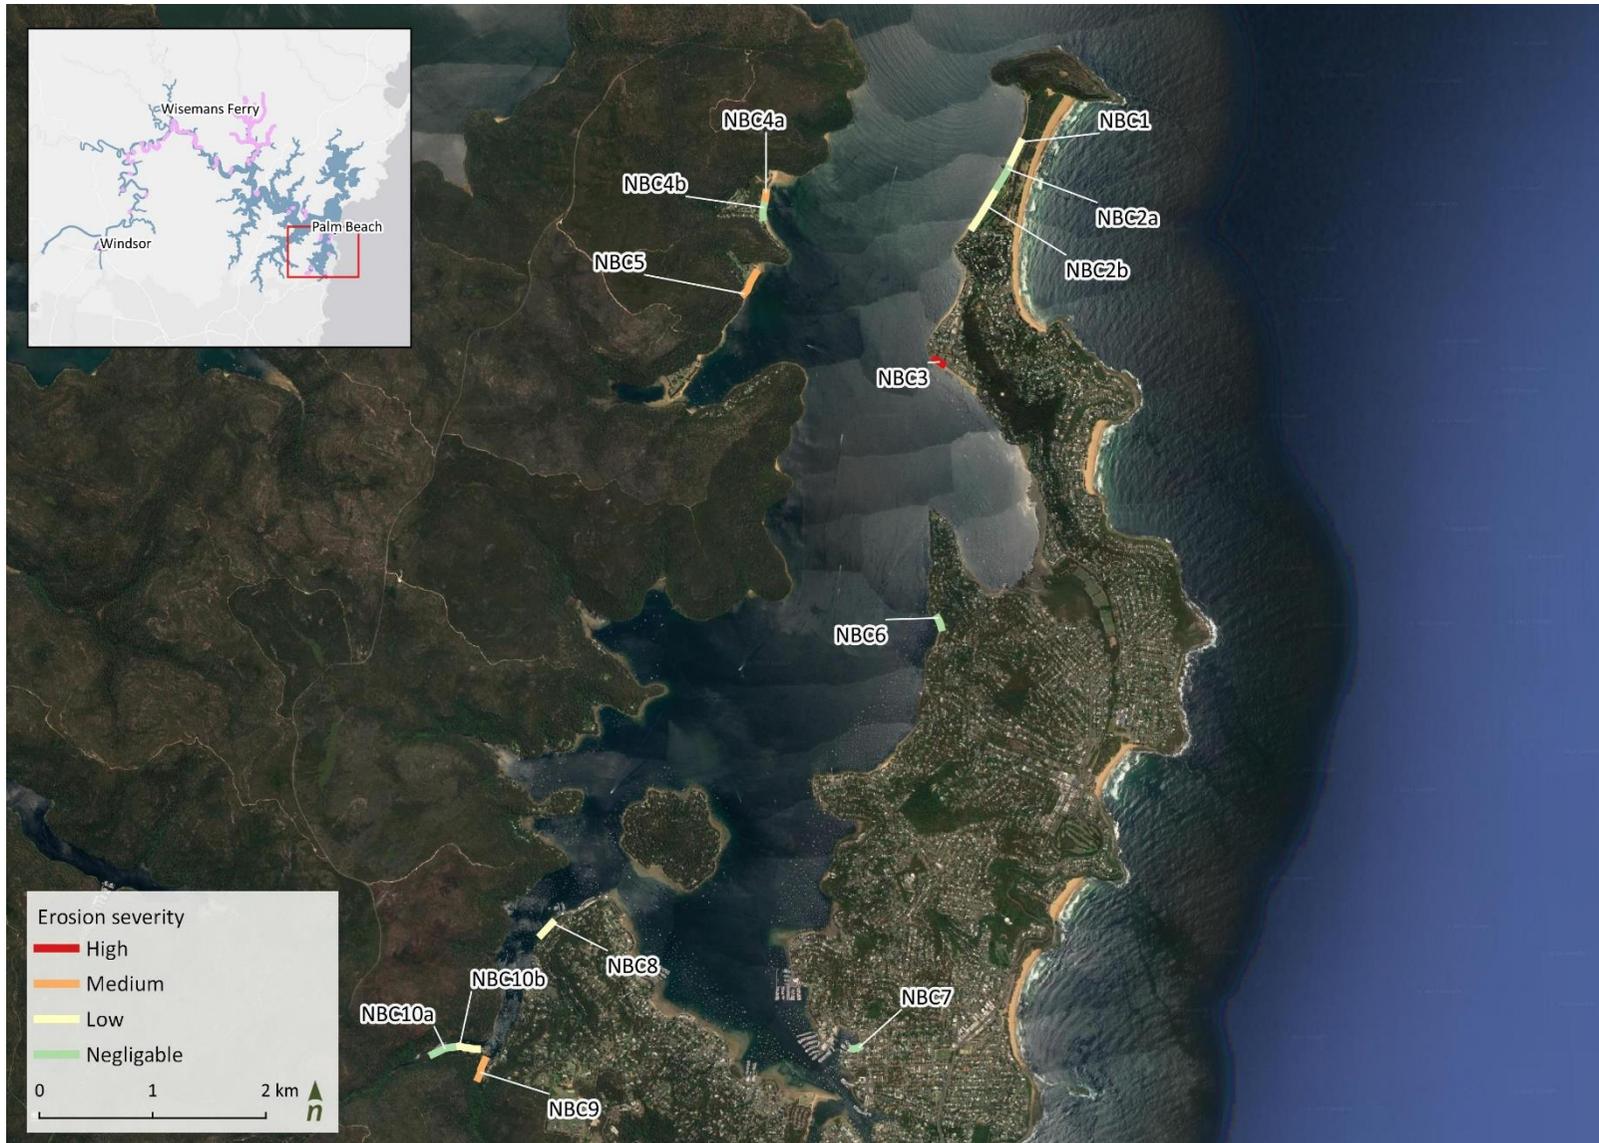
Figure 19. Erosion severity at the full bank erosion assessment sites within Pittwater Estuary

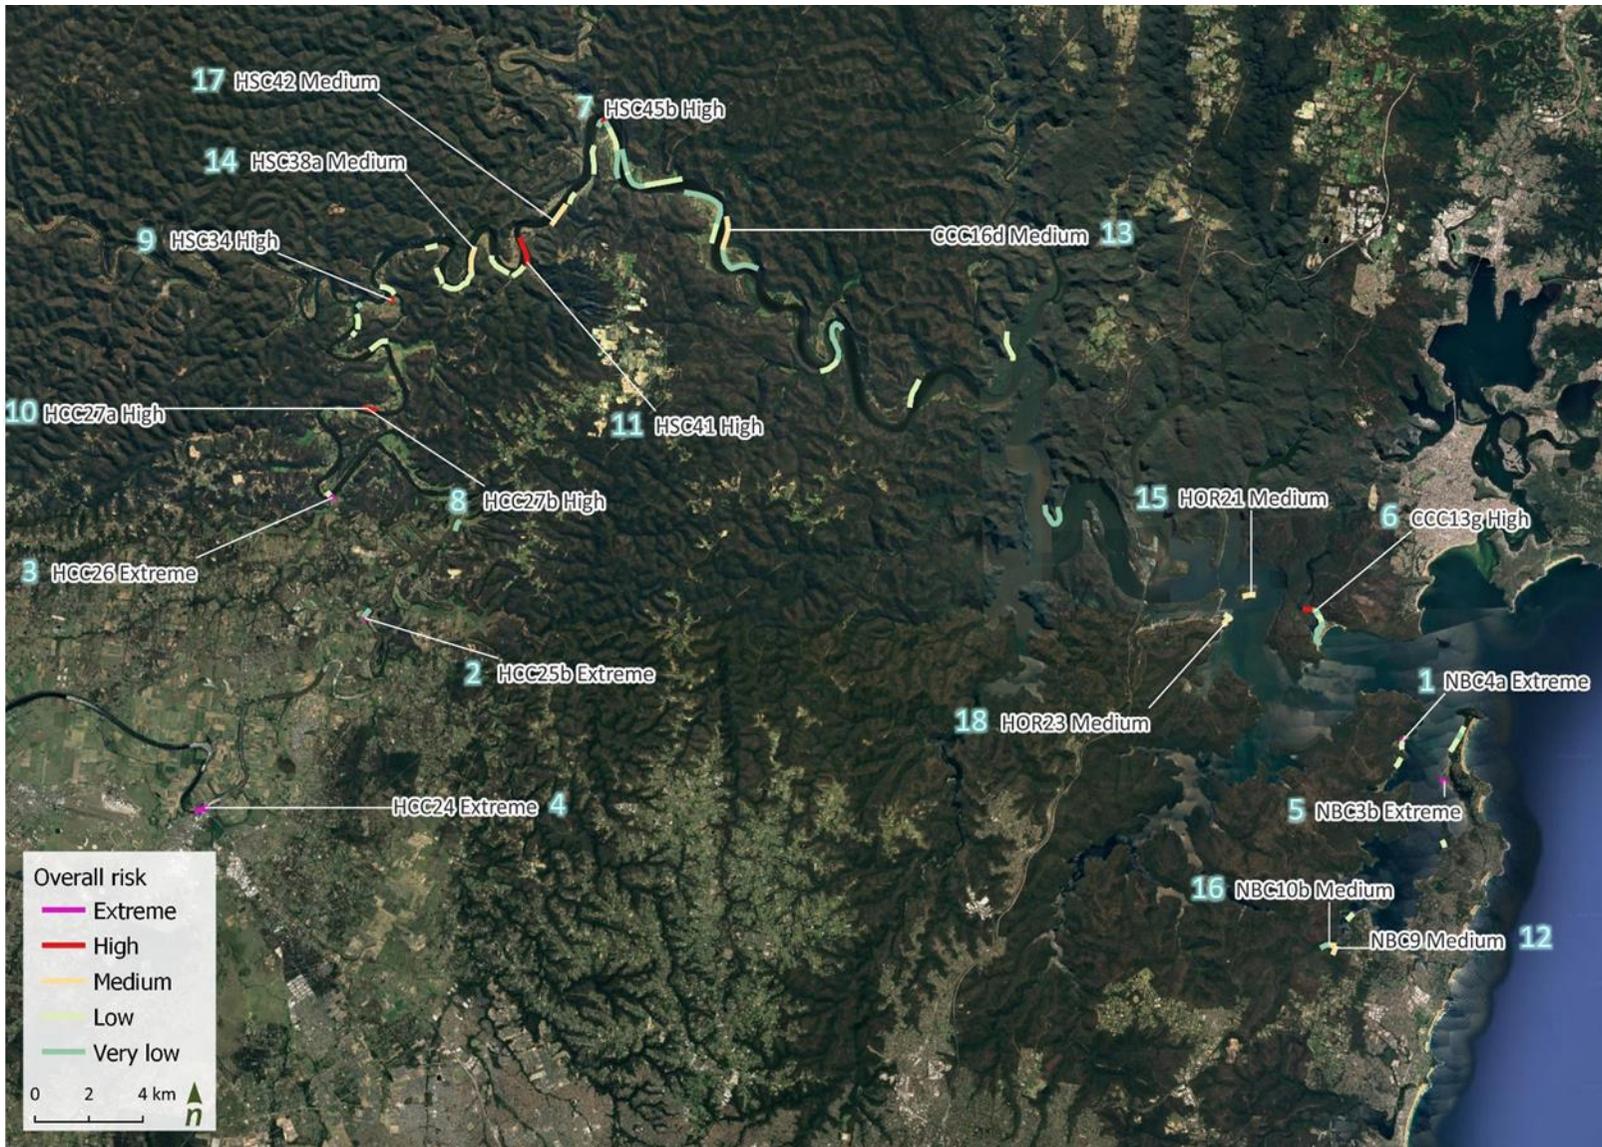
Figure 20. Priority ranking (blue text) of full bank erosion assessment sites with the sites at medium or higher risk labelled

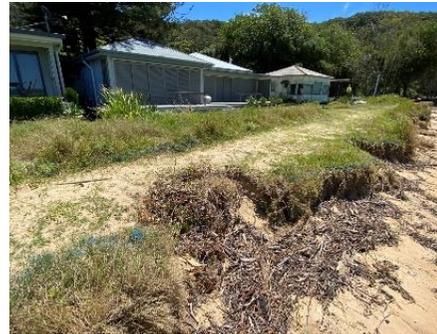
- Sandy beach/shoal
- Limited/no available set back
- Private assets in close proximity and at risk
- Public access and amenity impacts

- NBC3- 'Sand Point Beach'
- NBC4a – 'Great Mackerel Beach' (*example photo*)
- HOR21- 'Dangar Beach'
- NBC1
- NBC2a
- NBC2b
- NBC4a
- NBC4b
- NBC5

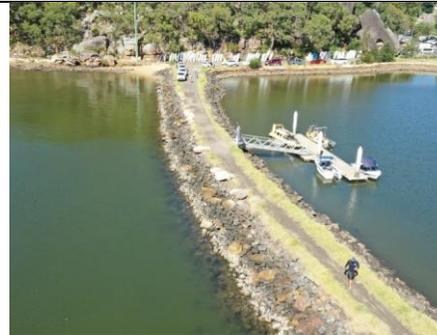
- Existing breakwall
- Public access and safety/amenity impacts

- HOR23- 'Parsley Bay breakwall' (*example photo*)
- HOR22
- NBC6
