CONSERVATION MANAGEMENT PLAN

Former Peat Island Centre,
Peat Island and Part Mooney
Mooney NSW 2083

Prepared for
**PROPERTY & DEVELOPMENT NSW (HOUSING &
PROPERTY, DEPARTMENT OF PLANNING,
INDUSTRY & ENVIRONMENT)**

20 October 2020

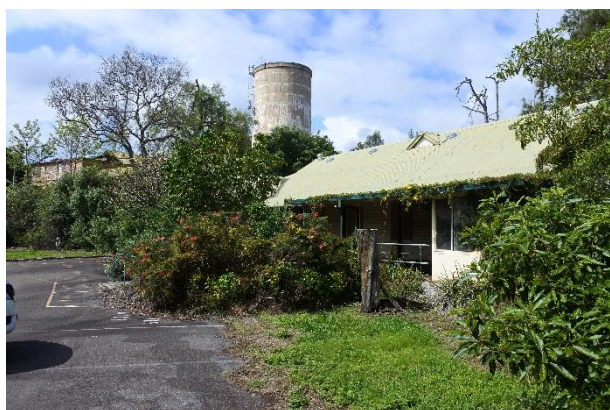
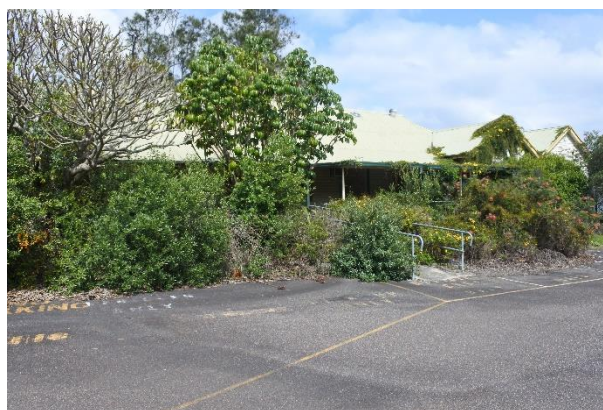
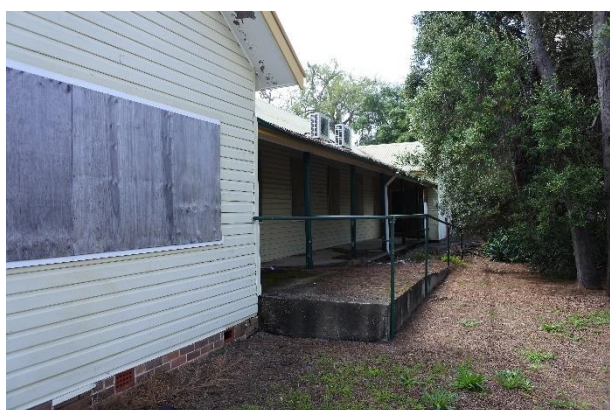
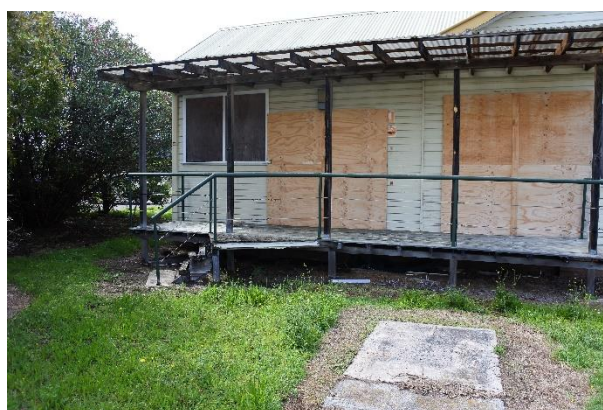
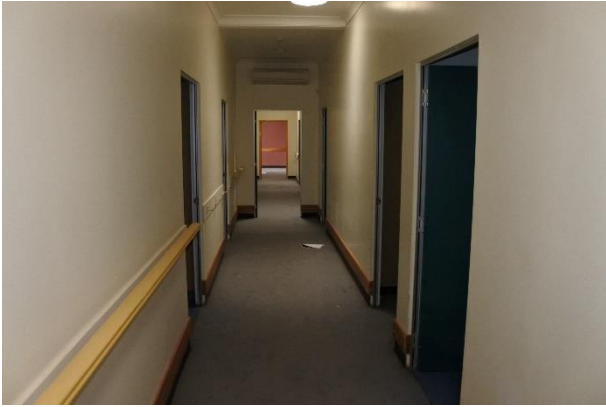
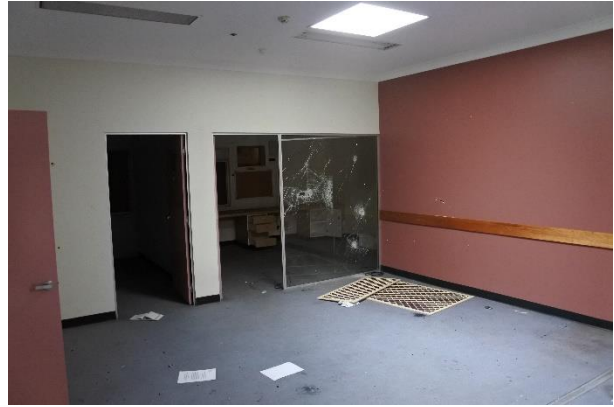
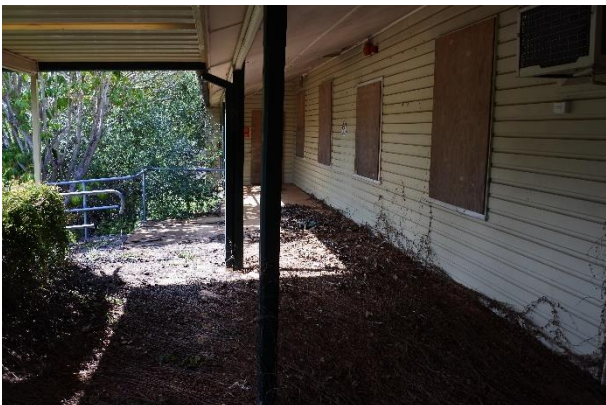
2.2.2.1. Bindaree – Reference 1

'Bindaree' is a single-storey weatherboard building with corrugated metal gable roof. The building has verandahs on the east, west and north elevations. The majority of windows are timber framed (with some later addition aluminium framed windows). The interior of the building contains a later addition fitout including offices and communal rooms at the northern end. A central corridor within the building leads south, providing access to residential rooms and bathrooms. Numerous large termite nests were observed during our site visit. The exterior of the building is overgrown with vegetation.

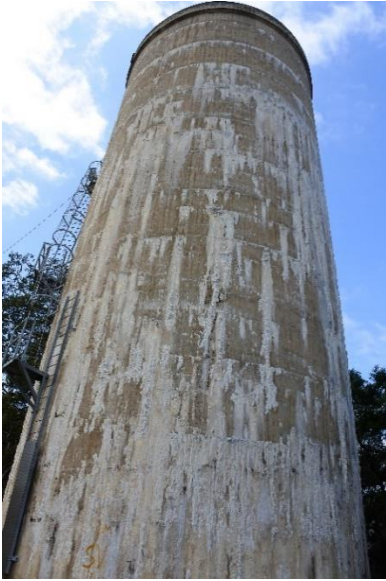
Figure 18 – View of reservoir.

A concrete cylindrical structure with a later addition steel maintenance ladder. The structure appears in relatively good condition. A substantial amount of limescale/calcification was observed on the exterior.

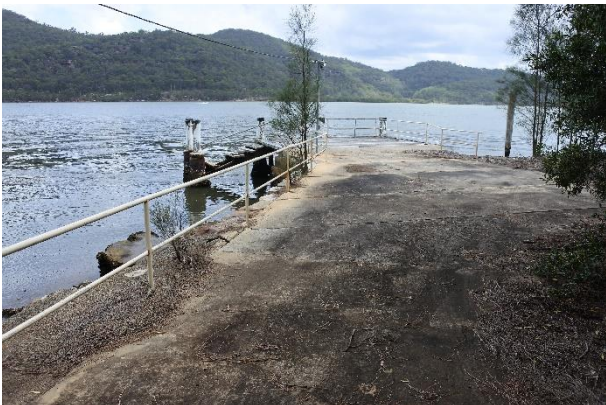
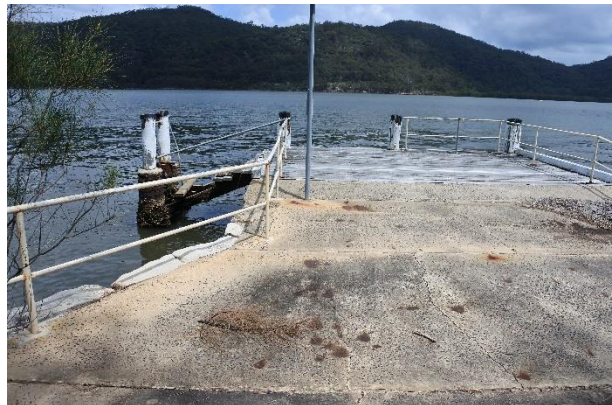
Figure 20 – View west toward wharf.

The 'Wharf' is located on the west side of the island. Terrestrial access is via a concrete roadway (Wharf Road) leading to the hardwood timber wharf. The wharf has later addition metal railings. A number of timber stair treads are missing towards the low tide level.

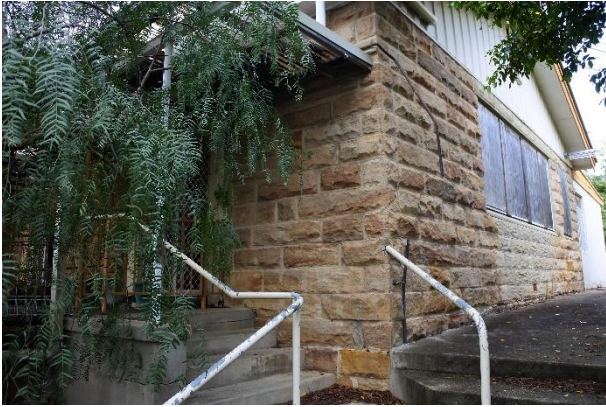
Figure 22 – View of north and east elevations at stair entry.

'Rizkalla' is a sandstone single-storey building with a corrugated metal gable roof. The roof has projected eaves at the south and north elevations. There is a fibro western lean-to addition with skillion metal roof. There is a large timber deck on the east elevation which was overgrown with vegetation. Numerous repairs and infill of previous openings (at the north and south elevations) were observed. The infill has been completed using concrete with a rusticated sandstone appearance.

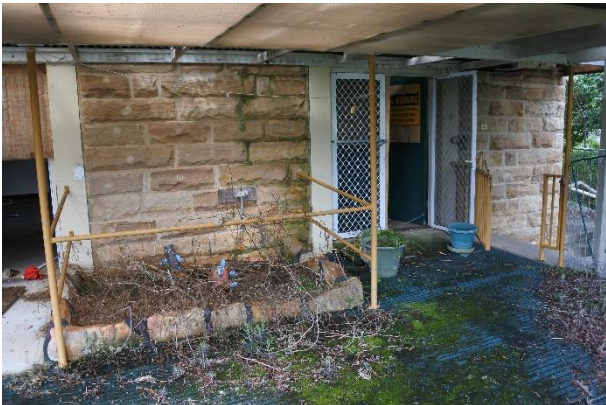
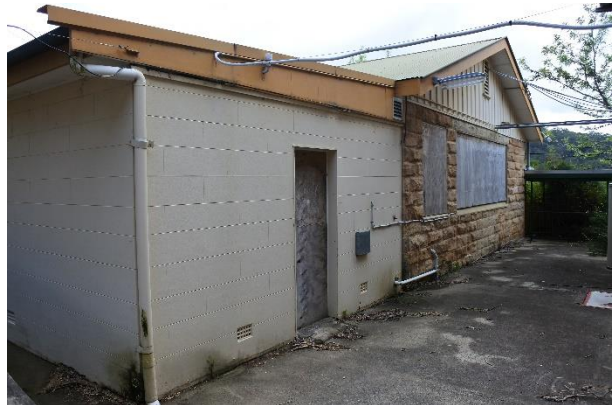
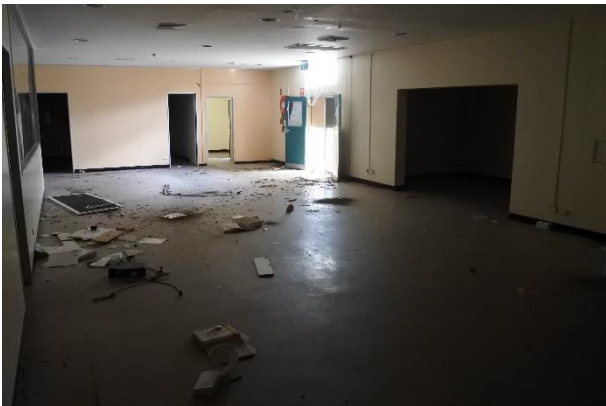
2.2.2.4. Rizkalla – Reference 5

Internally, the building contains a main hall, with large fixed pane glazed observation window to staff offices. Residential rooms lead directly off the main hall with the west extension area containing a large bath and shower room. The building appeared in fair condition. Graffiti and vandalism was observed.

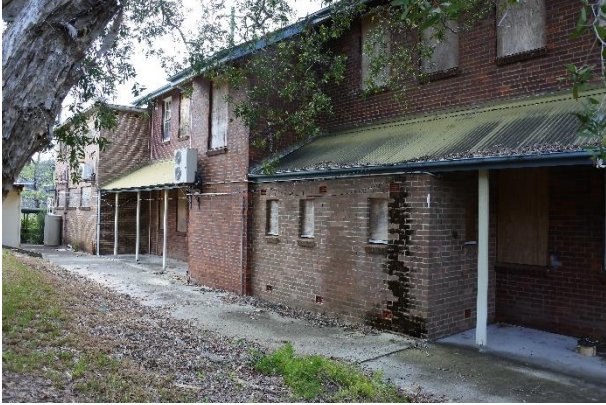
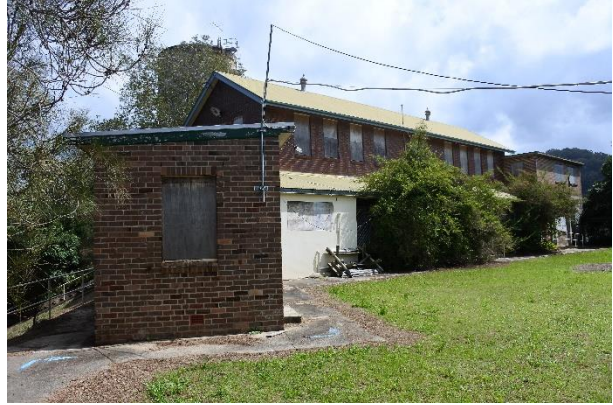
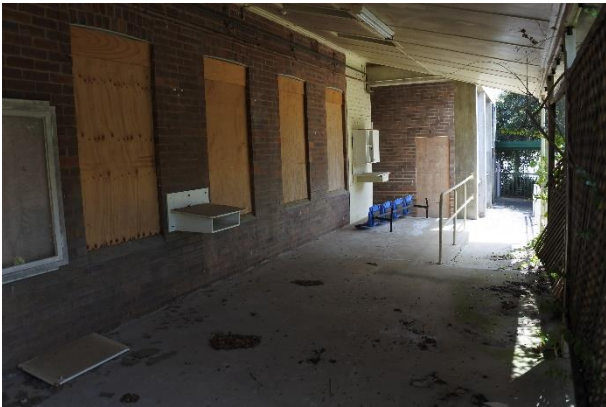
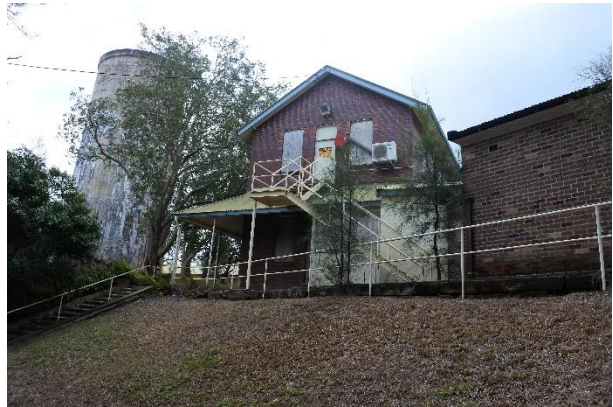
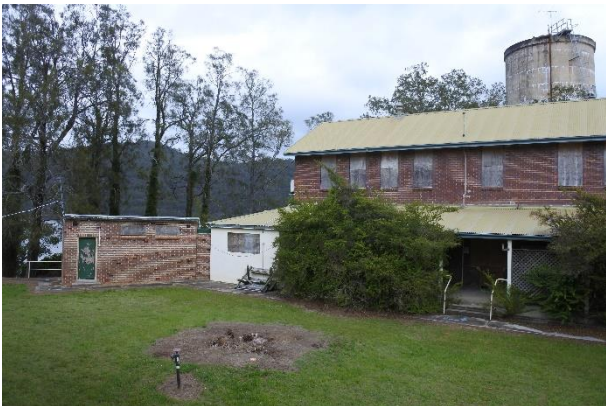
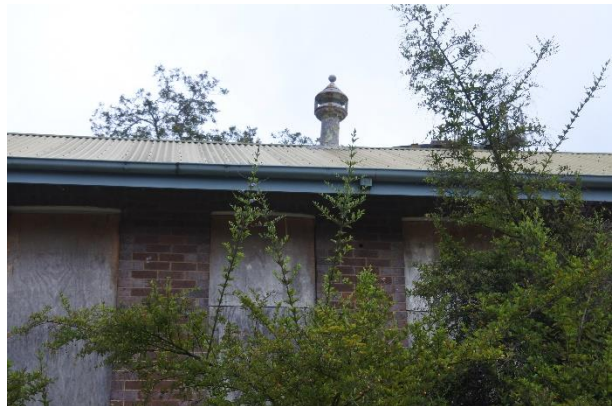
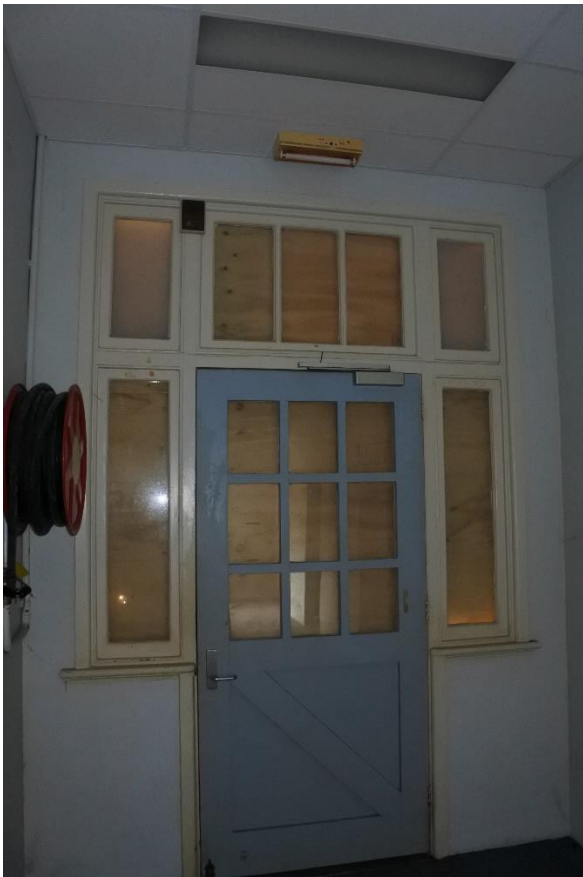
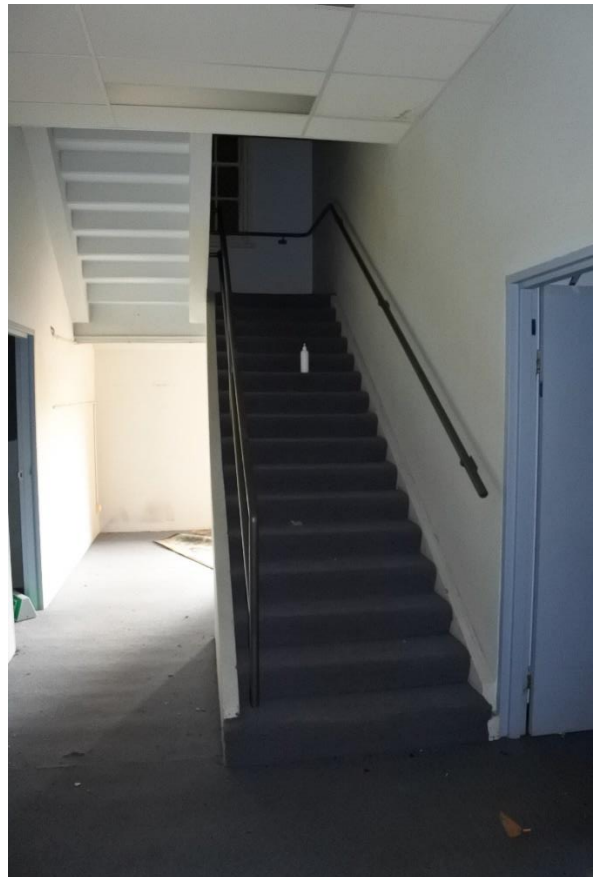
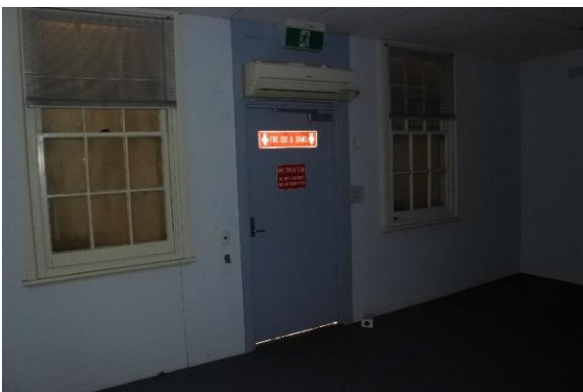
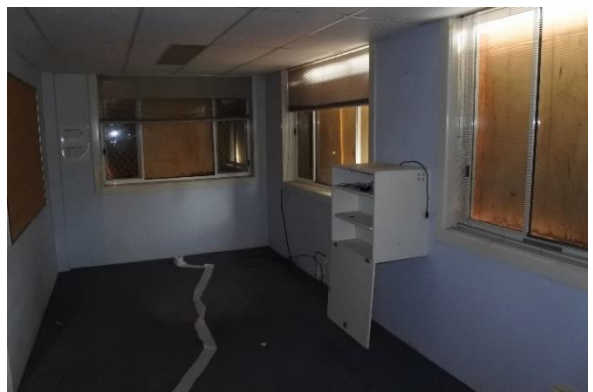
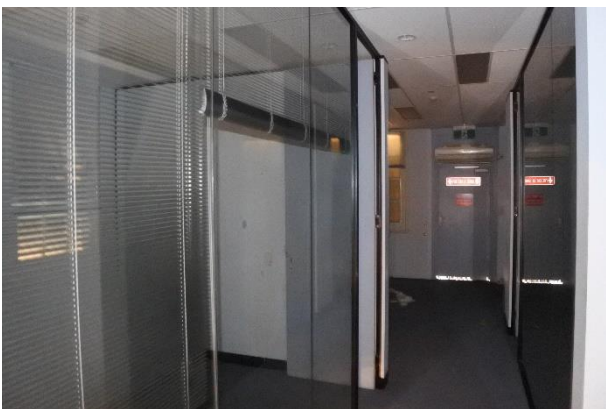
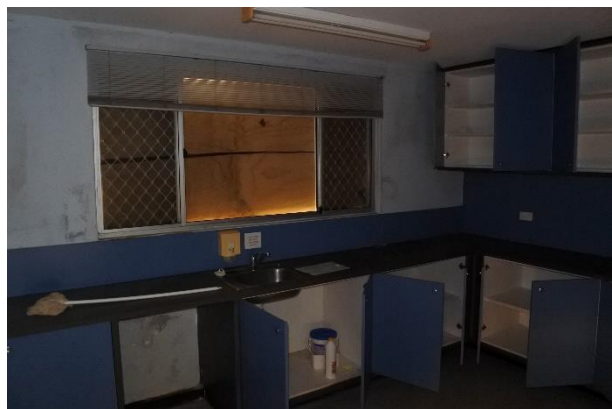
2.2.2.5. Administration Building – Reference 6

The '*Administration Building*' was originally constructed (1904) as a dormitory building. The building is a two-storey face brick structure, retaining many of the original timber sash windows. The window fenestration is symmetrical along the original sections of the east, west and south elevations. The building has a verandah on both the east and west elevations and has a gable corrugated metal roof. The roof features two ornate ventilation cowls. The building features a large timber *Federation* style main entry door with a transom window and side windows. The design and style of the building is clearly identifiable as being from the Edwardian era.

- post-1950 two-storey addition added to the north;
- post-1950 single-storey addition added to the south;
- areas of its eastern verandah being enclosed;
- later addition metal fire stairs, located on the south elevation;
- modified window openings for air-conditioning and other services.

The building appears in relatively good condition.

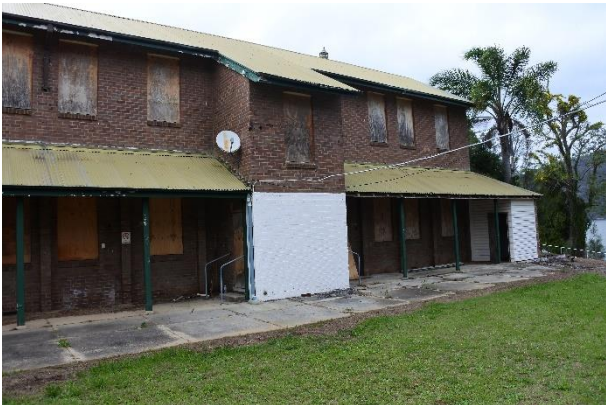
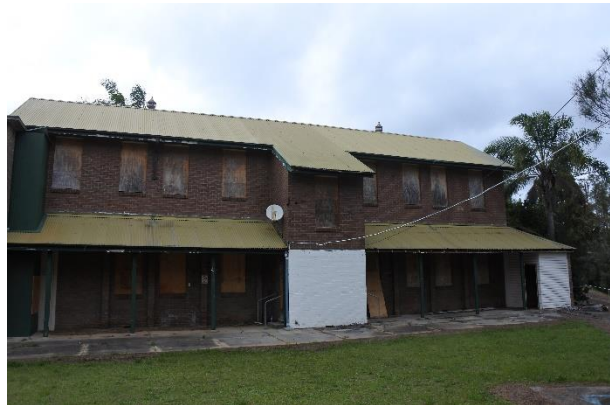
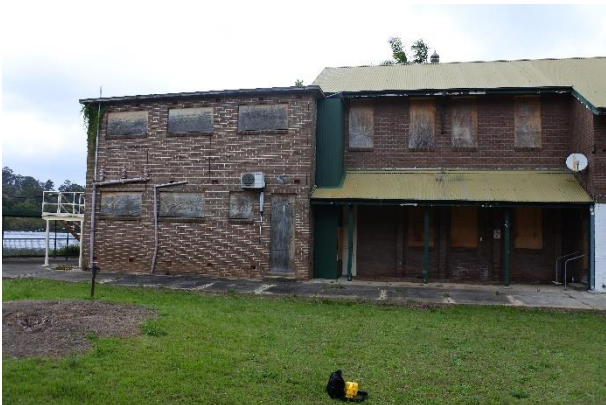
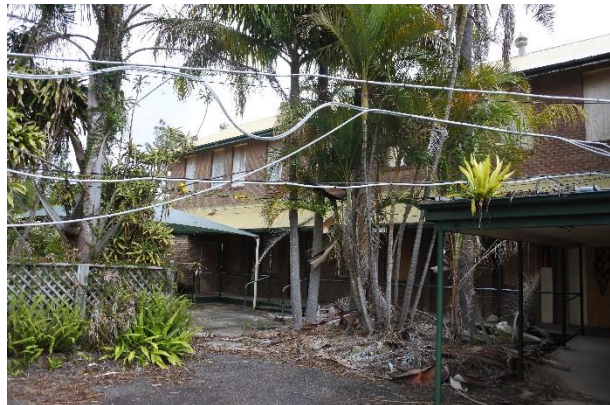
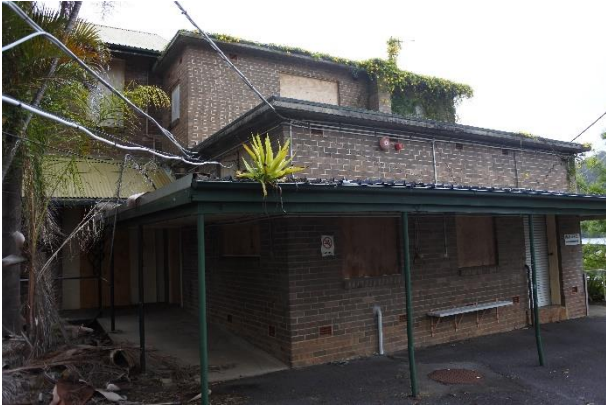
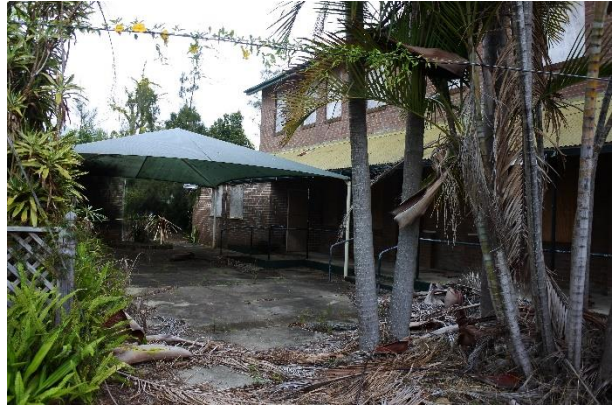
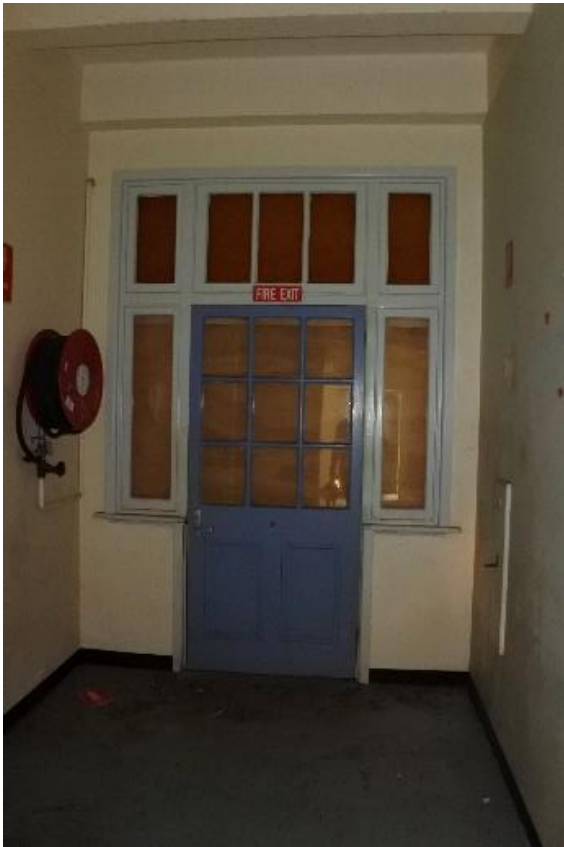
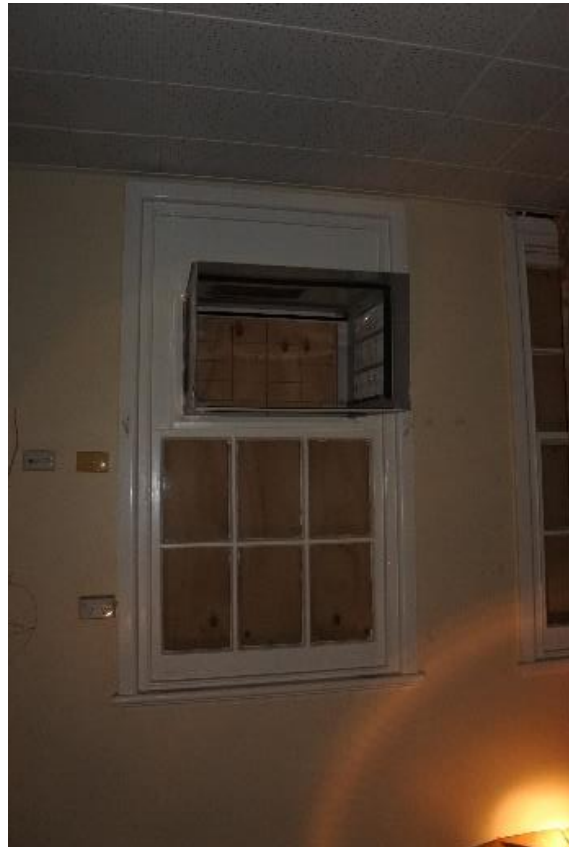
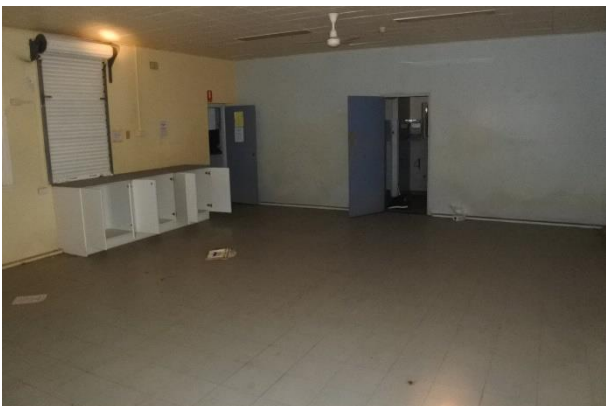
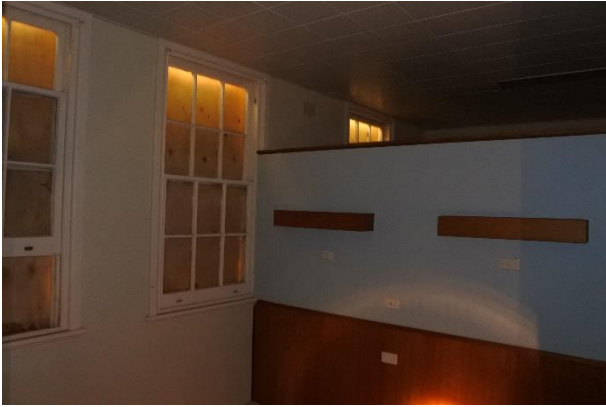
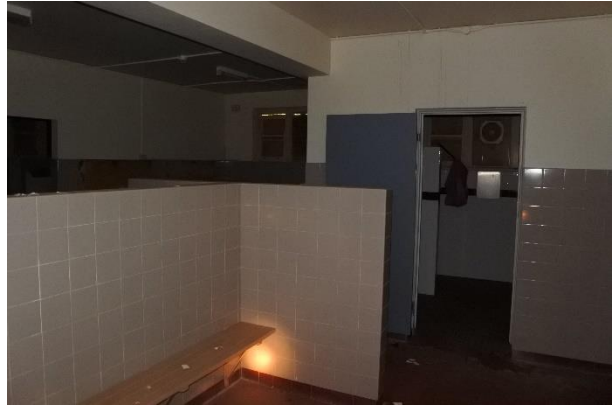
2.2.2.6. Pines Ward Building – Reference 8

- post-1950 two-storey addition added to the north;
- post-1950 single-storey addition added to the south;
- areas of its eastern verandah being enclosed;
- modified window openings for air-conditioning and other services.

The building appears in relatively good condition.

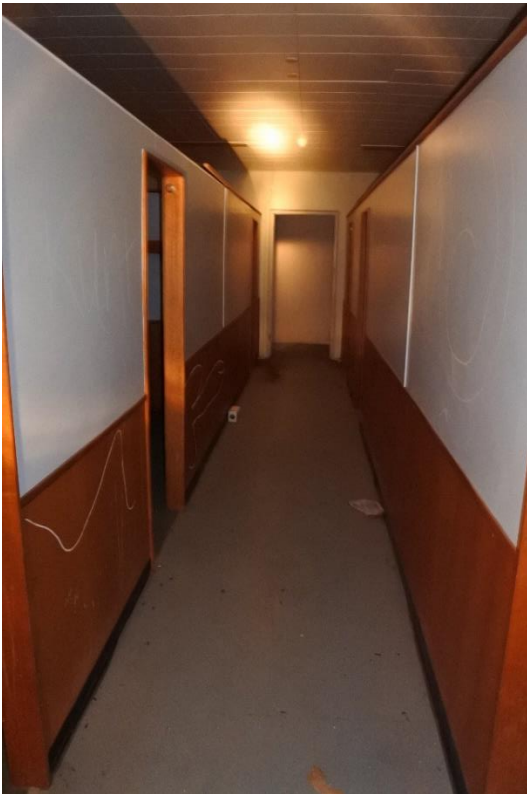
Figure 52 – View north in First Floor hall, showing room partitions.

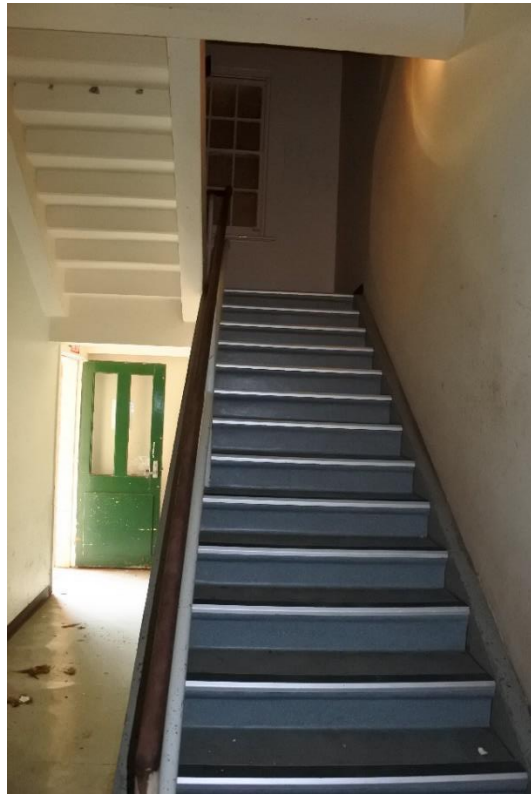
Figure 53 – View of main stairs.

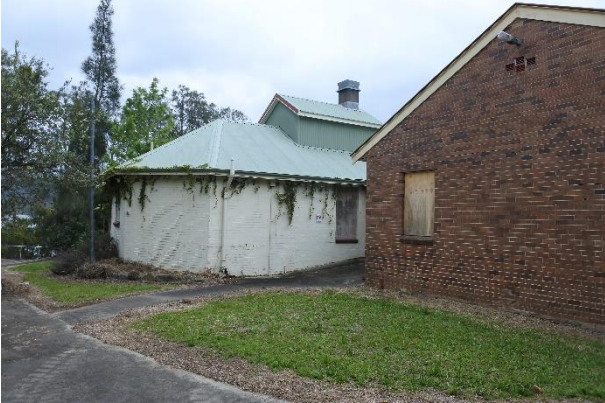
Figure 54 – View of south elevation of kitchen, with the attached 'store' building on the right.

The '*Kitchen*' is of masonry construction with corrugated metal roof. The original section of the building dates to 1903. The elevations of the original section have been painted. The south elevation is a semi-octagonal form with hipped roof. The brickwork in this octagonal area has been altered and includes bricked up openings and modified windows. Internally, this area has been used for storage. The north end has a gable roof form.

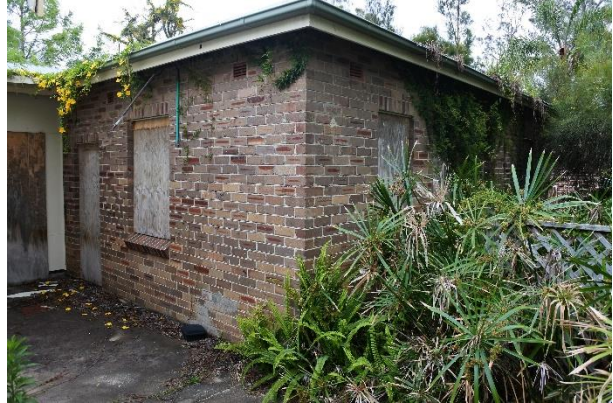
Figure 55 – View of section of the north and west elevations of kitchen.

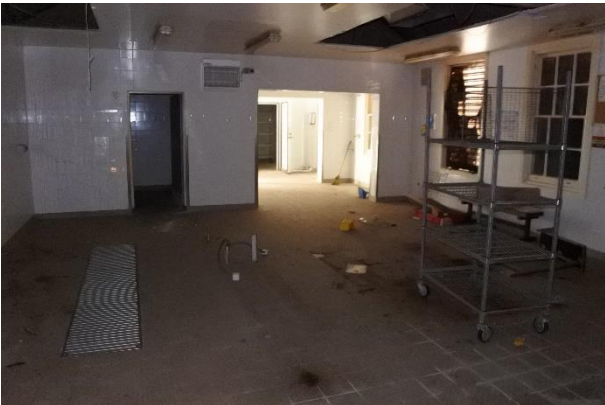
Figure 56 – Internal view of kitchen.

Internally, the '*Kitchen*' has been heavily modified. The original configuration is no longer interpretable. The building has a c.1960s masonry addition to the west elevation. This addition has a corrugated metal hipped roof. To the east, the building is linked with a c.1960s masonry building (used as a store), which has a corrugated metal gable roof. The modifications to the original building are extensive. The multiple layers of alterations and additions have substantially reduced the heritage significance of this building.

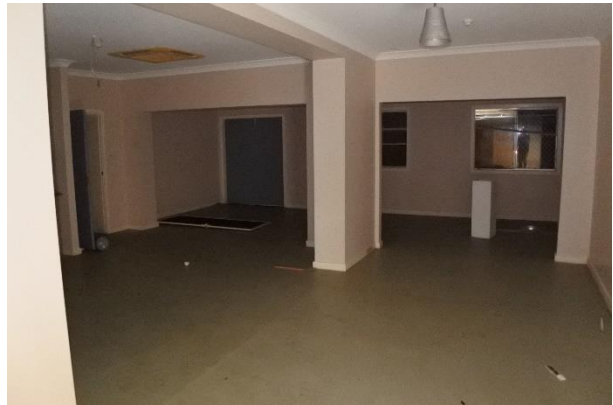
Figure 57 – Internal view of kitchen.

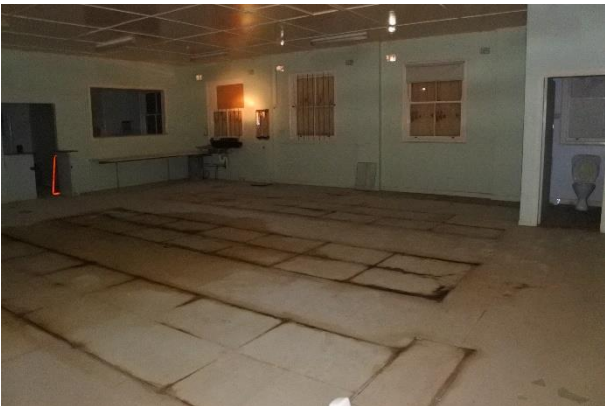
Figure 58 – Internal view of kitchen area.

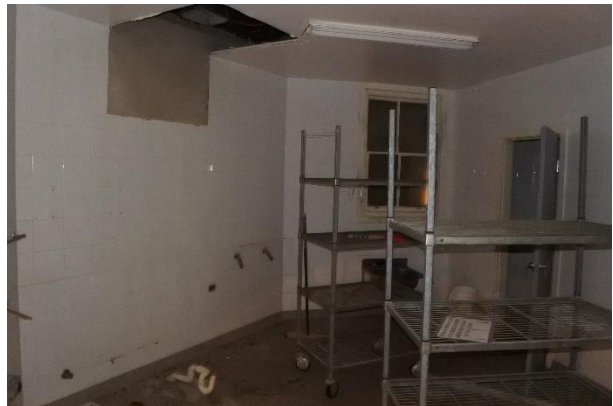
Figure 59 – Internal view of south section of kitchen.

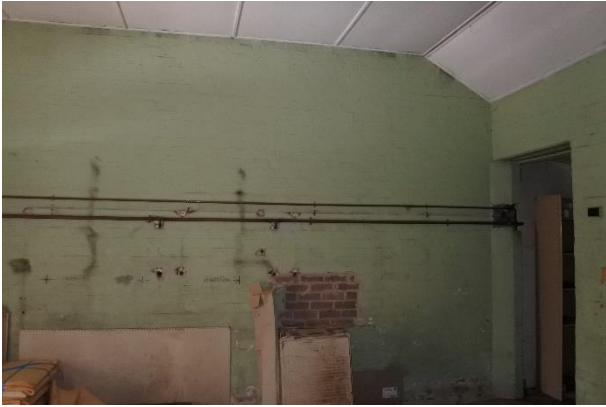
Figure 60 – View inside northern room of kitchen.

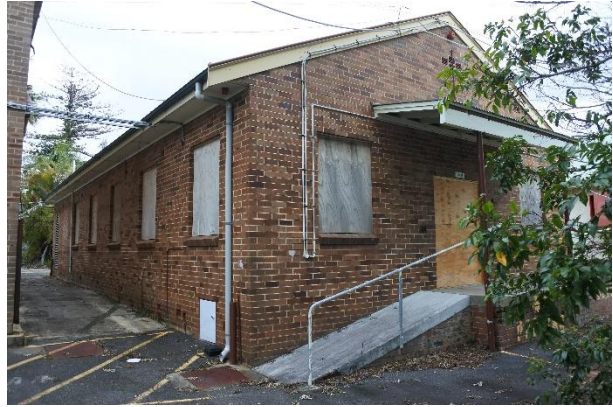
Figure 61 – View of north and east elevations of the attached 'storeroom' of kitchen.

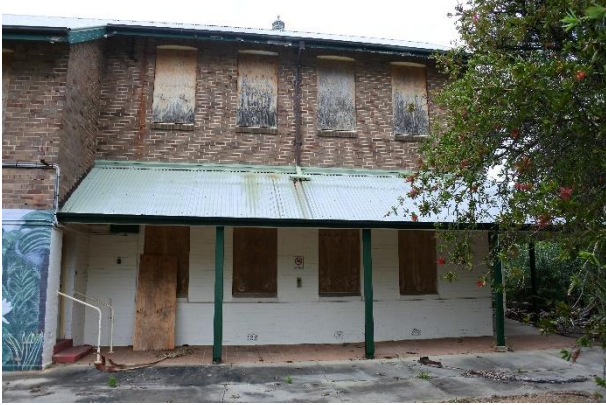
Figure 62 – View of southern section of west elevation.

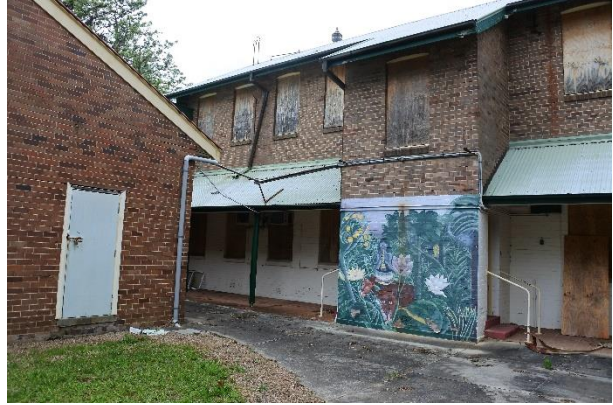
Figure 63 – View of central section of west elevation.
Storeroom is on left.

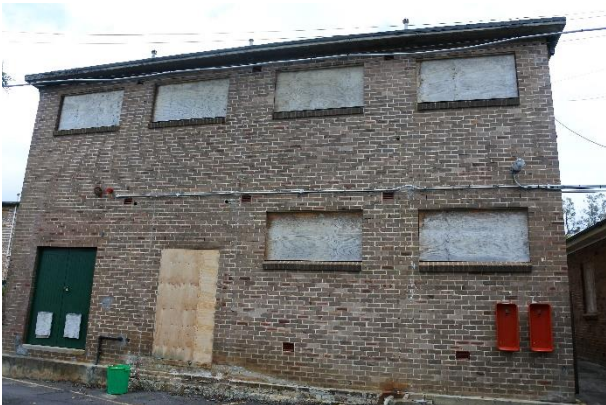
Figure 64 – View of north elevation (addition).

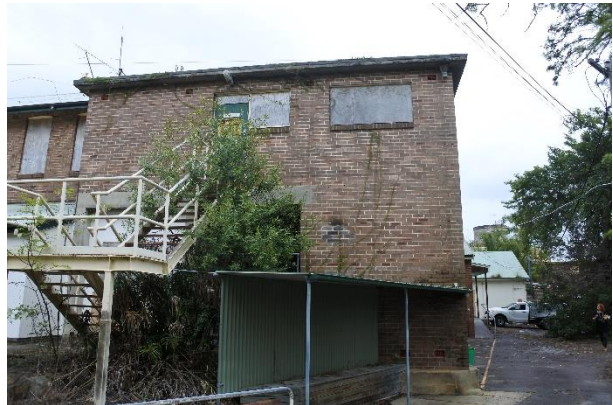
Figure 65 – View of east elevation of northern addition.

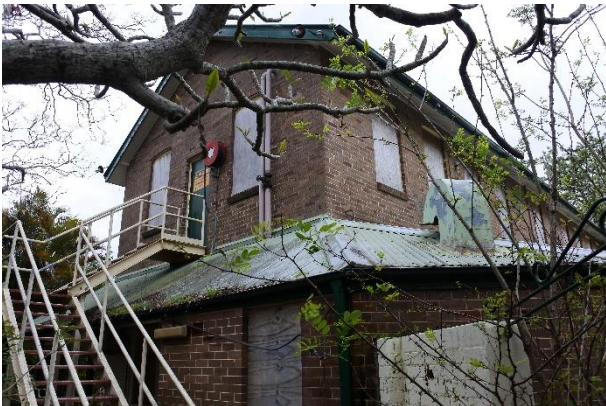
Figure 66 – View of south elevation.

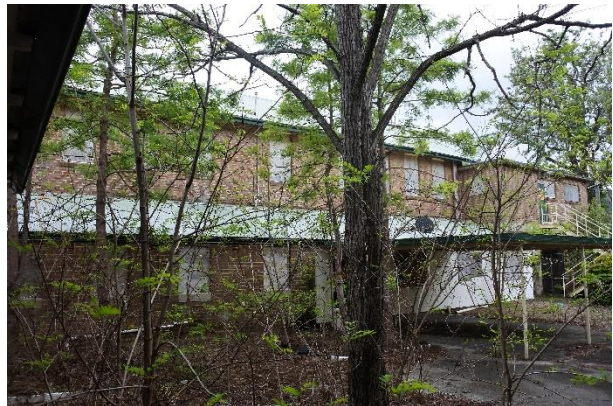
Figure 67 – View of east elevation.

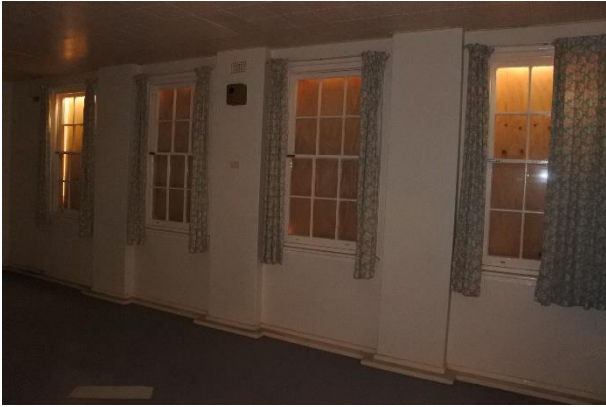
Figure 68 – View inside Ground Floor showing timber sash windows.

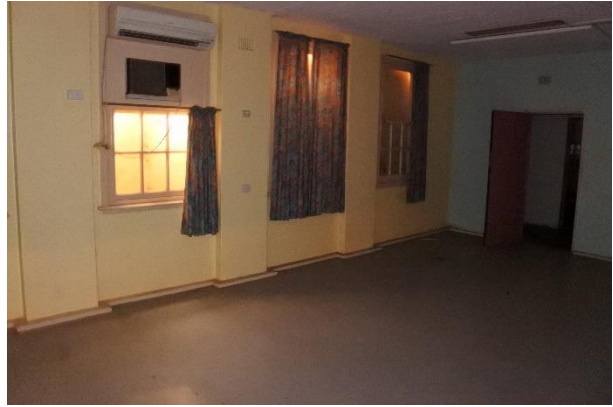
Figure 69 – View inside building showing modified timber sash window (with air-conditioning unit).

- post-1950 two-storey addition added to the north (containing bathrooms);
- areas of its eastern verandah being enclosed;
- later addition metal fire stairs, located on the south elevation;
- modified window openings for air-conditioning and other services.

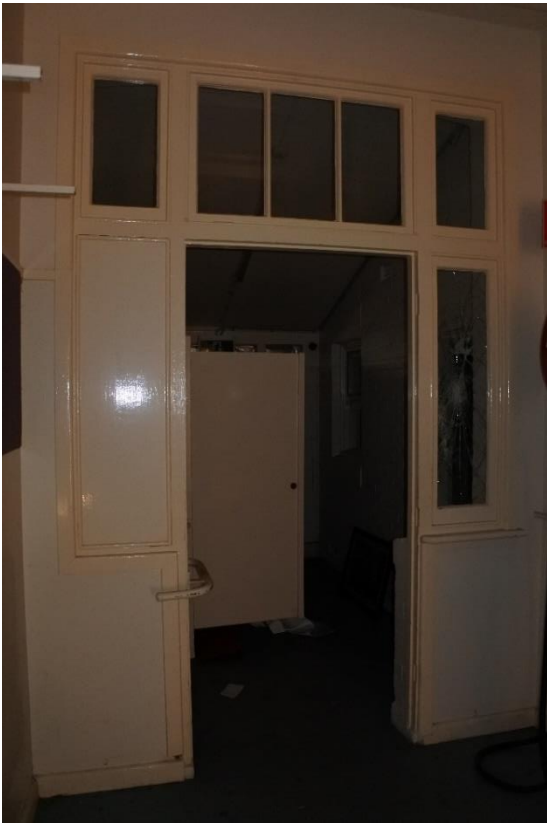
Figure 70 – View of main door on original east elevation, later enclosed verandah can be seen.

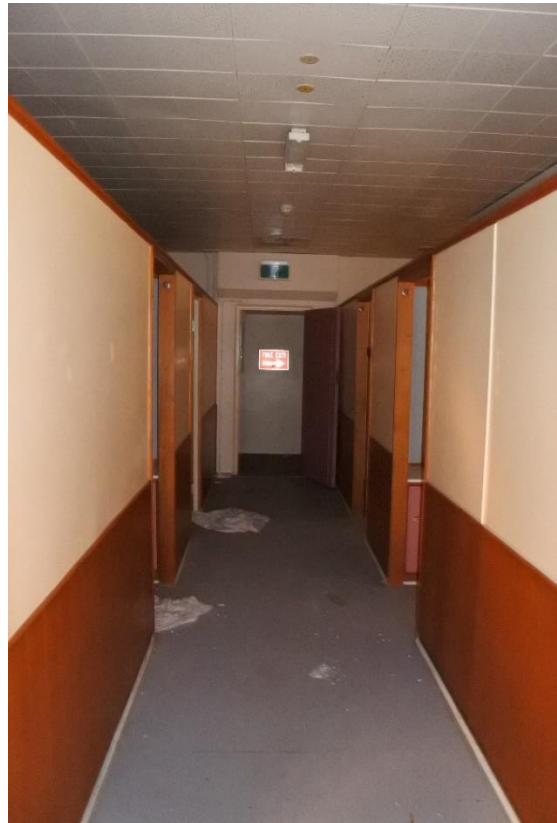
Figure 71 – View north within First Floor showing partitions.

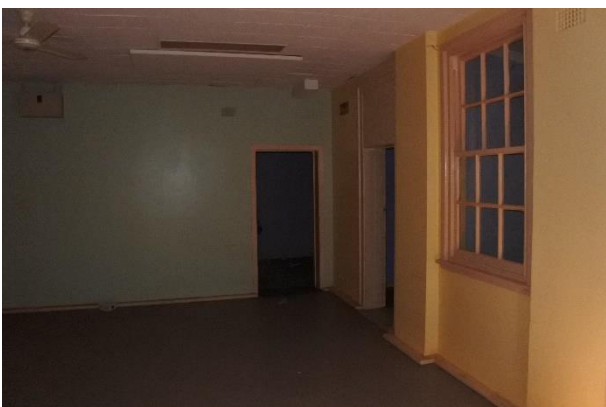
Figure 72 – Open room within First Floor.

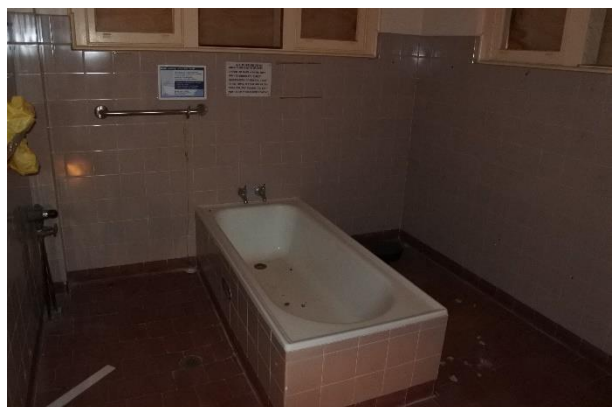
Figure 73 – View of bathroom within First Floor.

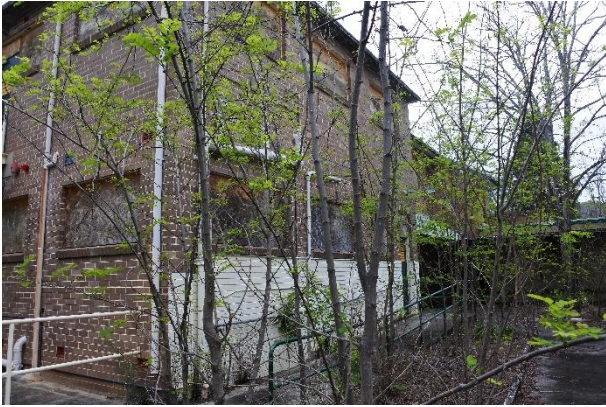
Figure 74 – View of west elevation.

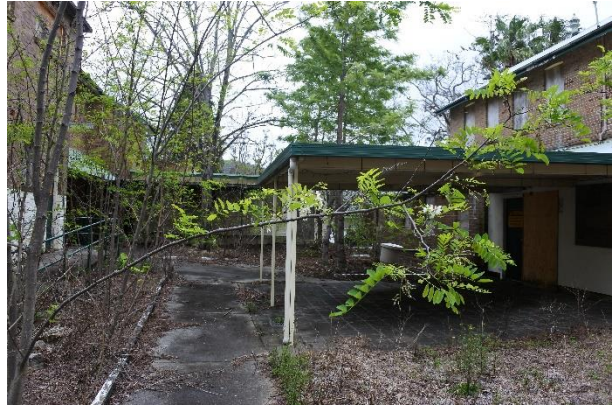
Figure 75 – View of both west elevation of Sea Breeze and west elevation of Denby.

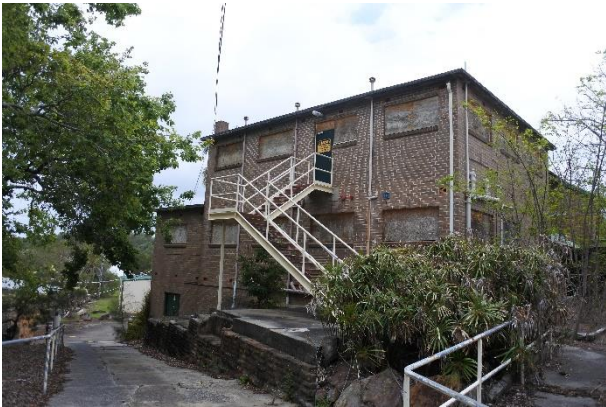
Figure 76 – View of north elevation of addition.

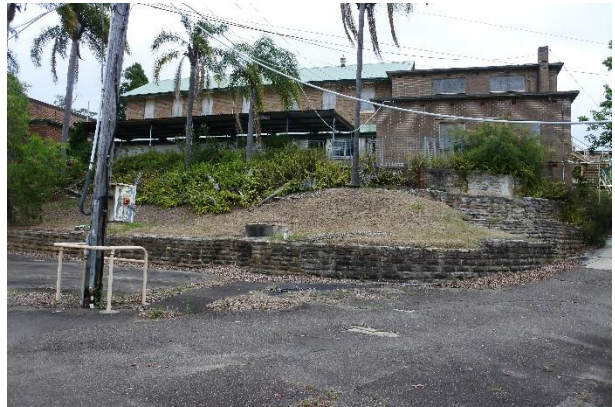
Figure 77 – View of east elevation.

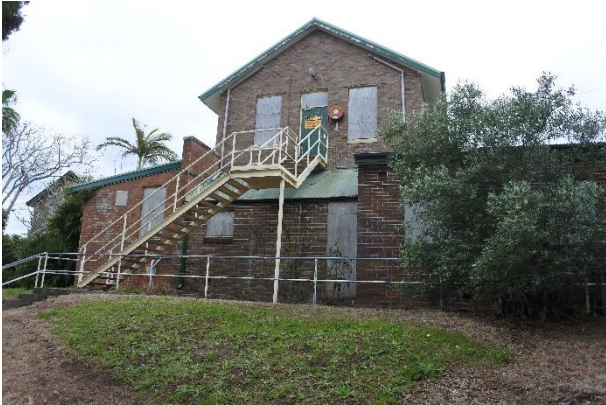
Figure 78 – View of south elevation.

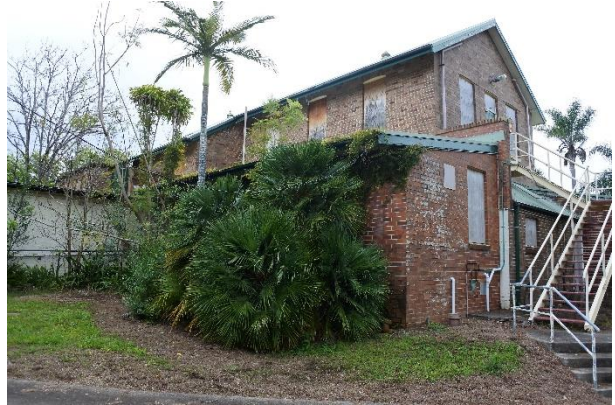
Figure 79 – View of west and south elevations.

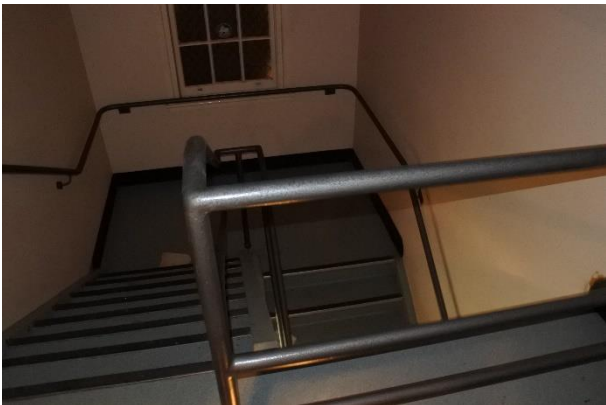
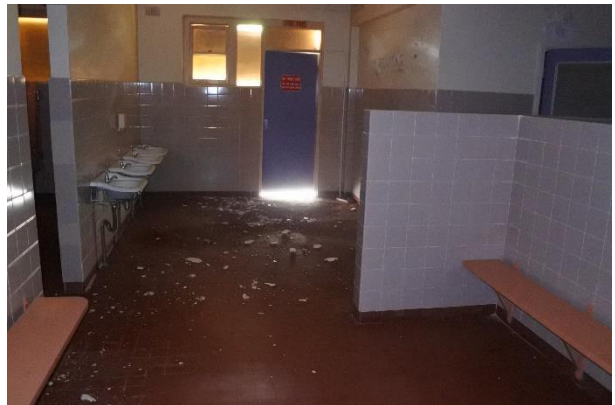
Figure 80 – View of main stairs.

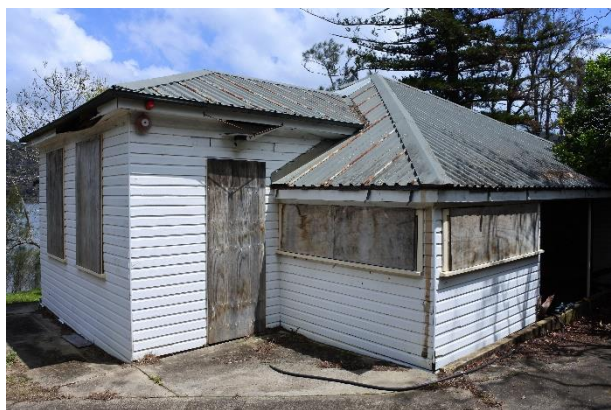
Figure 84 – View of north and east elevation.

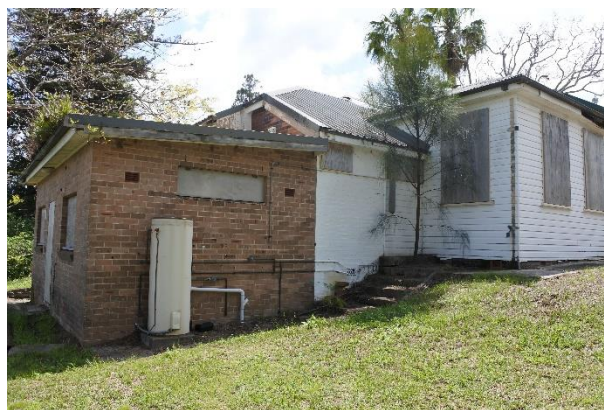
Figure 85 – View of south and east elevation.

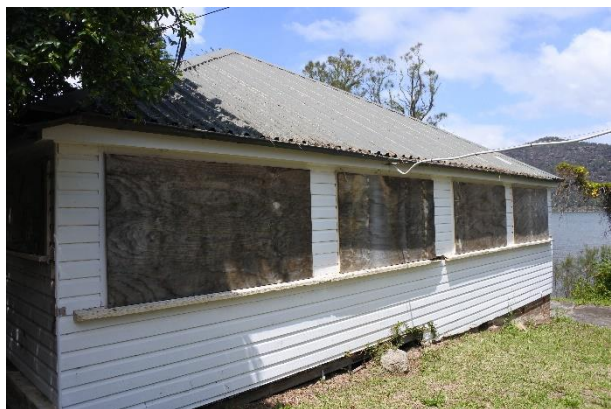
Figure 86 – View of west elevation.

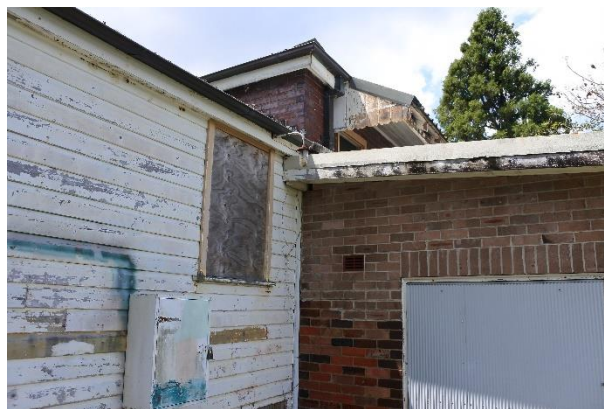
Figure 87 – View of west elevation, original eaves evident.

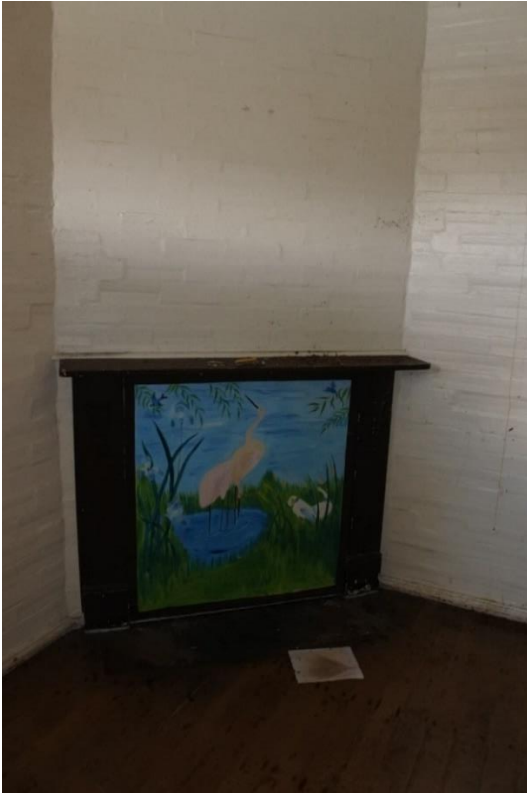
Figure 88 – View of fireplace within central room.

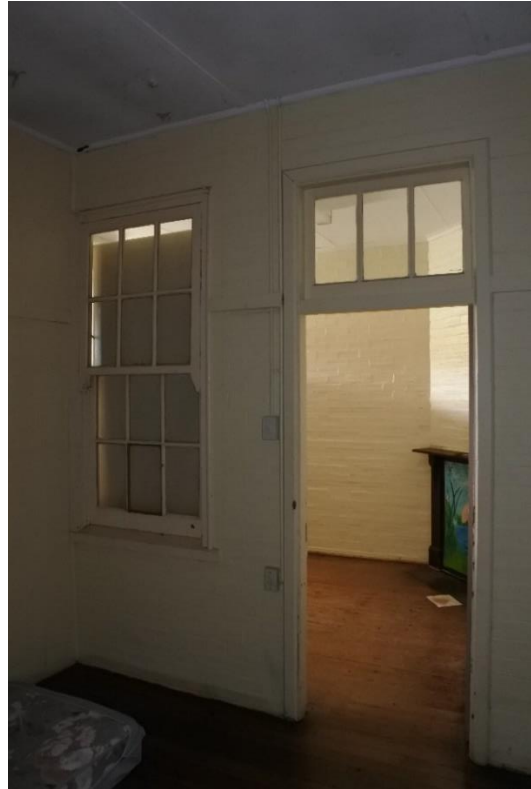
Figure 89 – View of original east doorway and window.

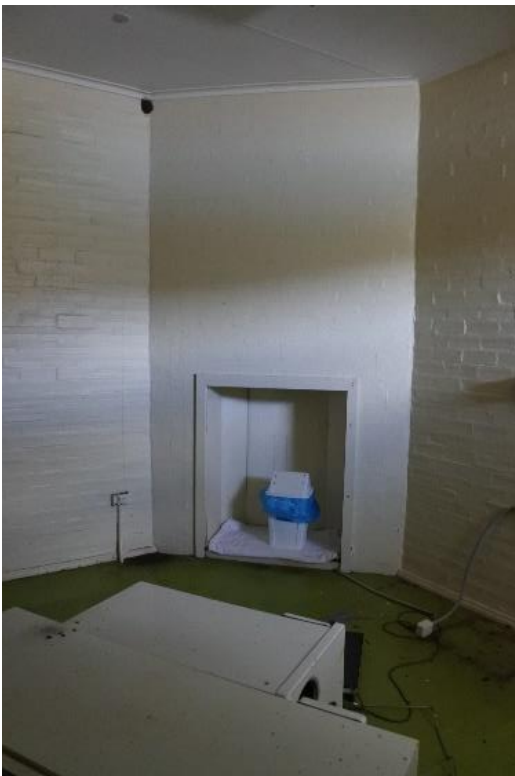
Figure 90 – View of fireplace within north-western room.

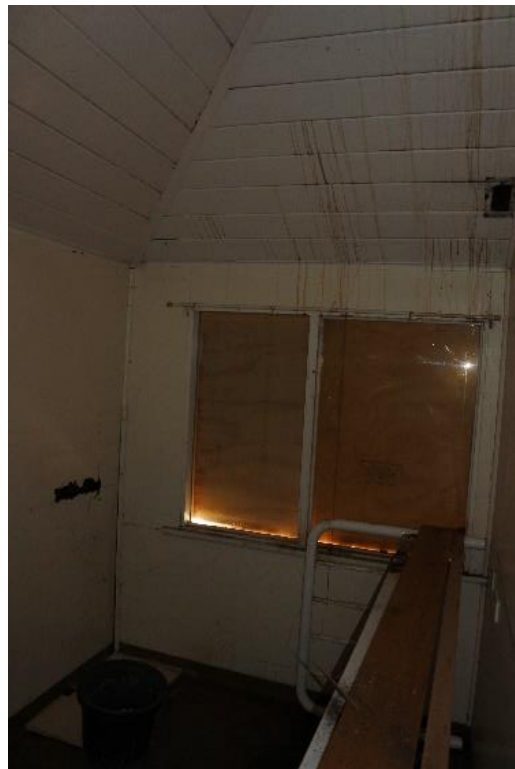
Figure 91 – View of enclosed verandah at south-western corner.

'Cottage 2' is a masonry building with a corrugated metal hipped roof. It was originally known as the *'Matron's Cottage'* and has been heavily modified with additions and alterations surrounding the original cottage. The cottage has had its chimneys removed. However, chimney breasts remain within the dwelling. The original cottage is clearly discernible and includes timber framed windows. The cottage has timber clad enclosed verandahs (with aluminium framed windows) to all elevations. There is a face brick addition to its south elevation. The cottage appeared in fair condition with visible graffiti and vandalism.
