CONSERVATION MANAGEMENT PLAN

Former Peat Island Centre,
Peat Island and Part Mooney
Mooney NSW 2083

Prepared for
**PROPERTY & DEVELOPMENT NSW (HOUSING &
PROPERTY, DEPARTMENT OF PLANNING,
INDUSTRY & ENVIRONMENT)**

20 October 2020

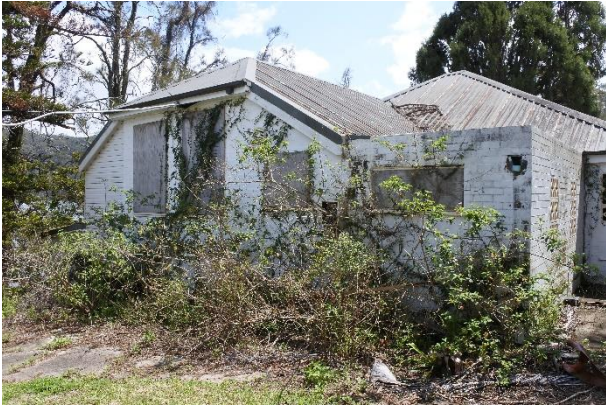
Figure 92 – View of south elevation.

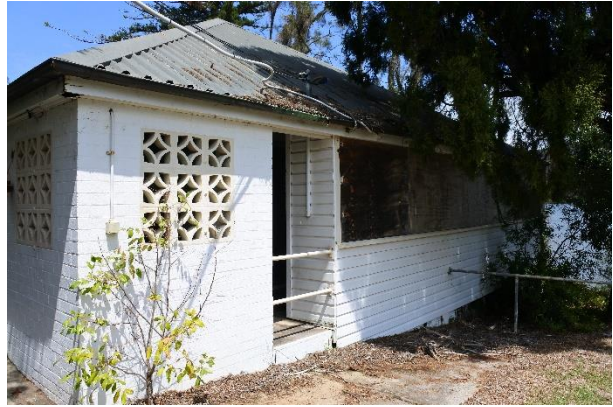
Figure 93 – View of north elevation

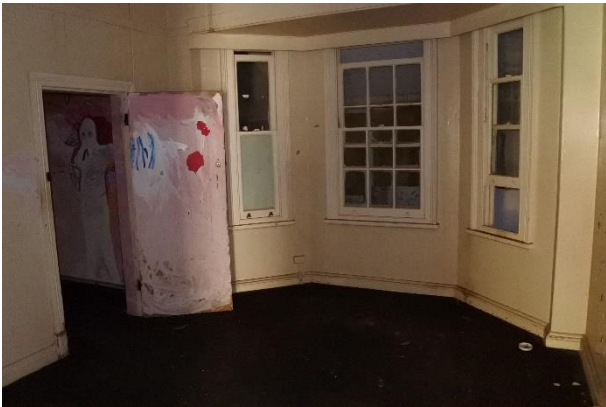
Figure 94 – View of bay window looking west.

'Cottage 1' is a masonry building with a corrugated metal hipped roof. The cottage has had its chimneys removed, however chimney breasts remain within the dwelling. The original cottage is clearly discernible, and includes timber framed windows, timber architraves and transom windows to some doors. The cottage also contains a distinctive bay window (facing an enclosed verandah) on its west elevation.

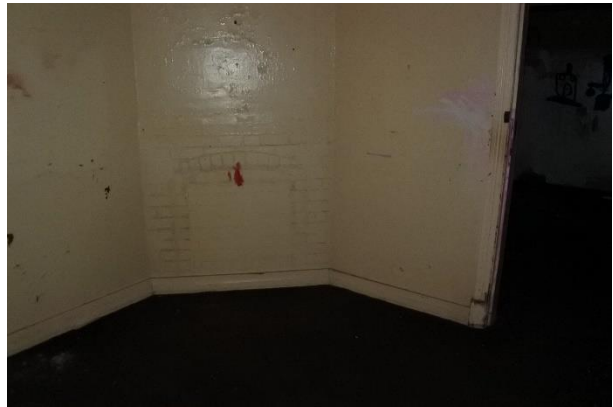
Figure 95 – View of bricked up fireplace within central room.

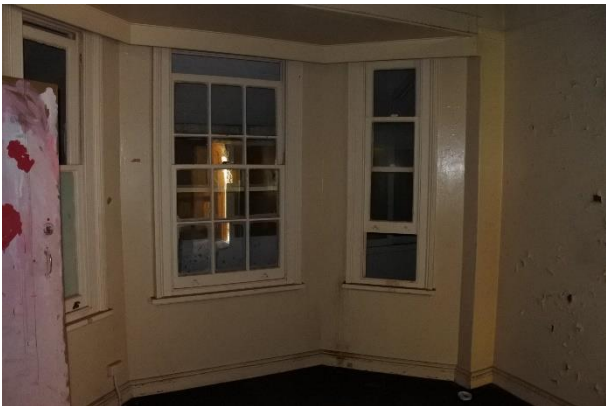
Figure 96 – View of bay window looking north-west.

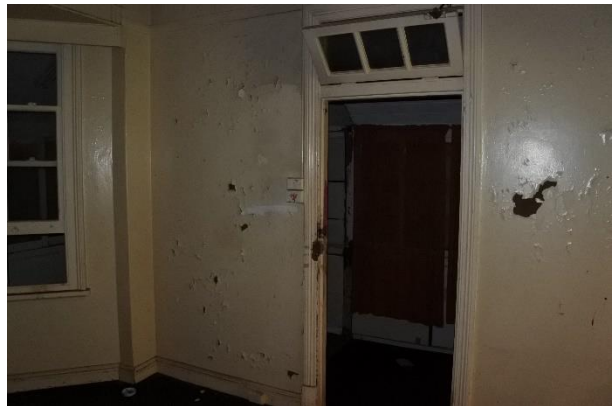
Figure 97 – View of original external doorway leading to northern enclosed verandah in central room.

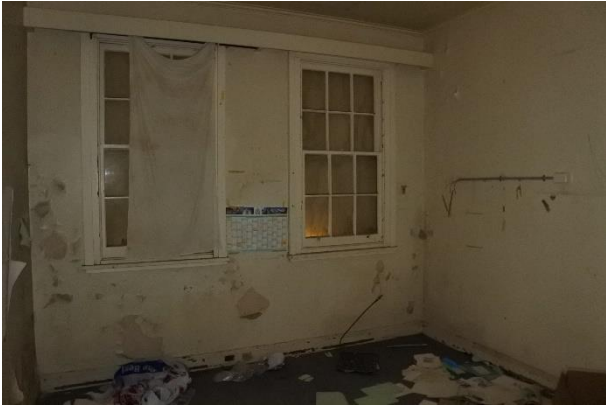
Figure 98 – View of original windows on north elevation.

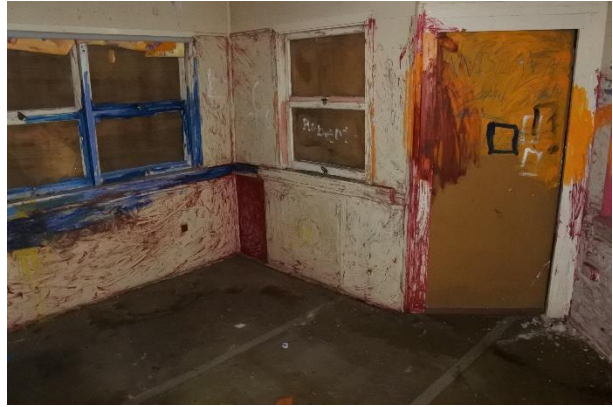
Figure 99 – View of enclosed verandah area on west

The cottage appeared in fair condition with visible graffiti and vandalism.

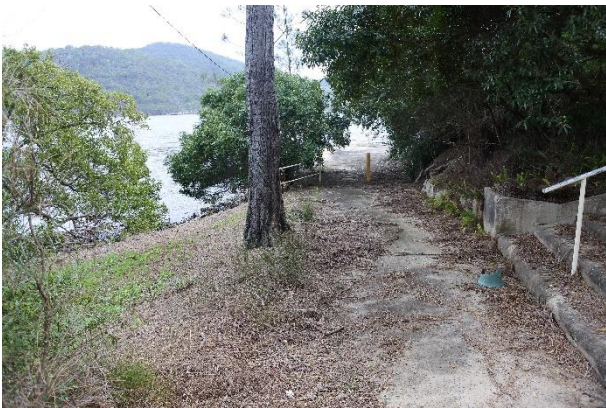
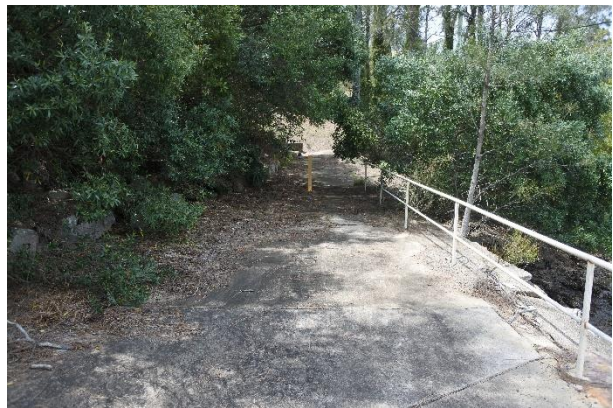
Figure 100 – View of concrete section of road leading to wharf.

Figure 101 – View of concrete section of road leading from wharf.

The road is constructed with sections of bitumen and concrete. The general alignment remains similar to original.

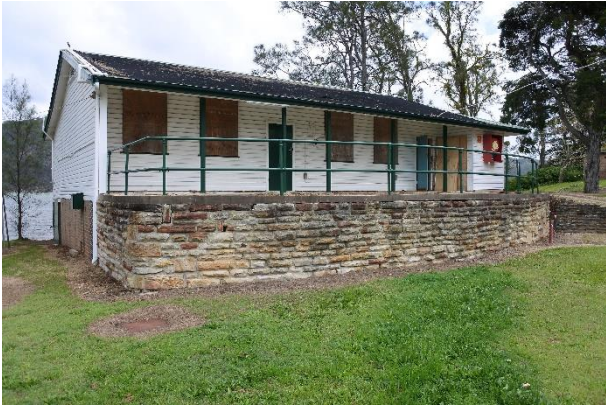
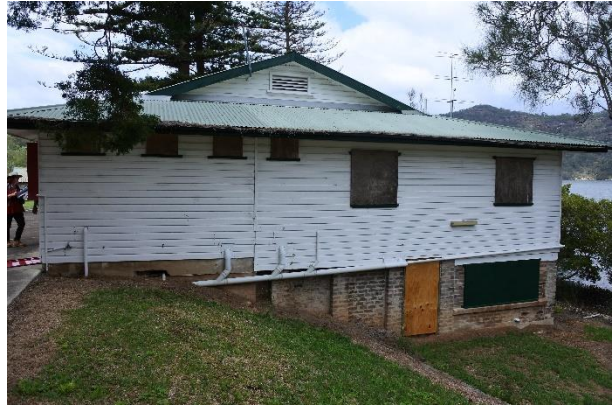
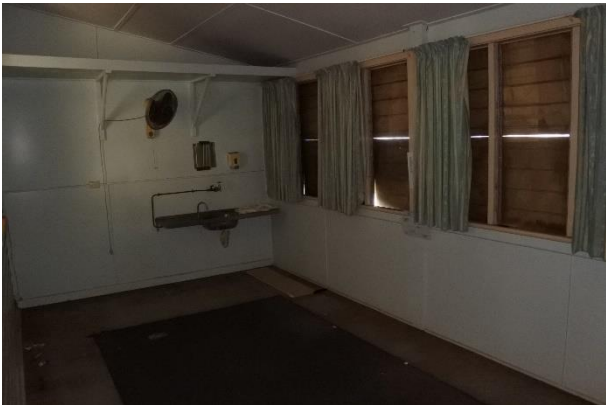
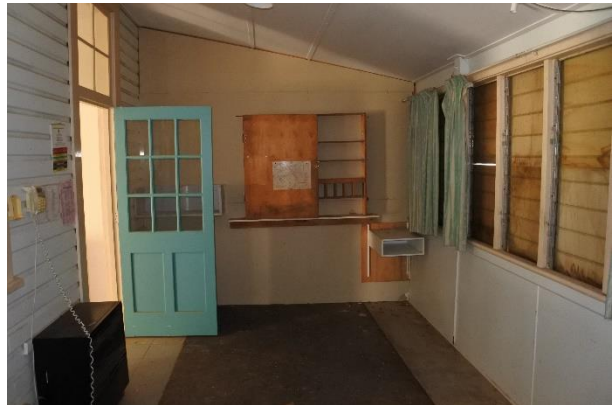
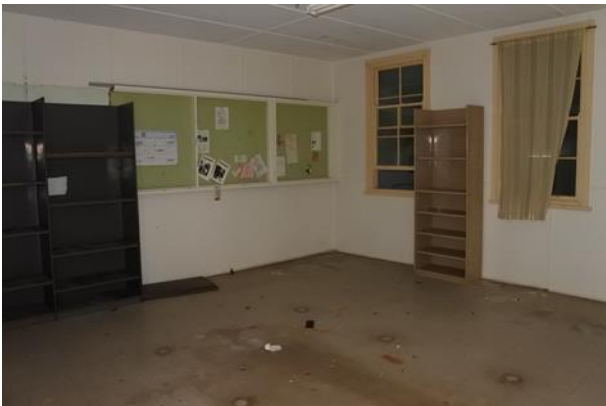
Figure 102 – View of the east elevation.

Figure 103 – View of the north elevation.

Figure 104 – View looking within the enclosed western verandah.

Figure 105 – View of the enclosed western verandah.

Figure 106 – View within the main room of the building.

The 'Staff Amenities' building (1947), is single-storey timber building with corrugated metal gable roof. The building has timber framed windows and verandahs on both its west (enclosed) and east elevations. The building sits on high brick piers with the subfloor being enclosed to create a basement. The east elevation of the building fronts on to a patio area, created by a decorative sandstone retaining wall. The building appeared to be in a fair condition.

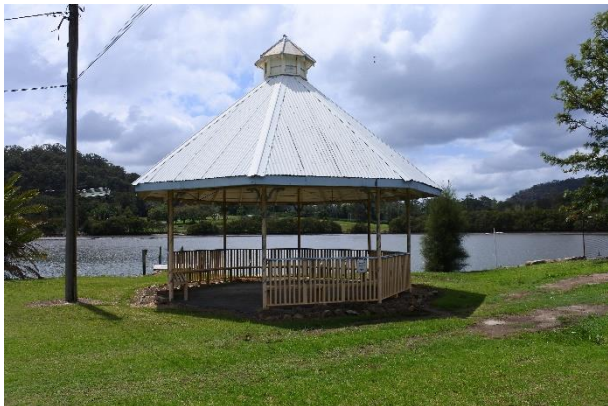
Figure 108 – View east showing rotunda.

The rotunda is a distinctive octagonal structure constructed in 1903 and relocated to its existing location in the 1930s. The structure is timber framed with a centre cupola. The structure was renovated in 2003. The balustrade (later addition material) is timber while the support posts are steel. The rotunda is in good condition.

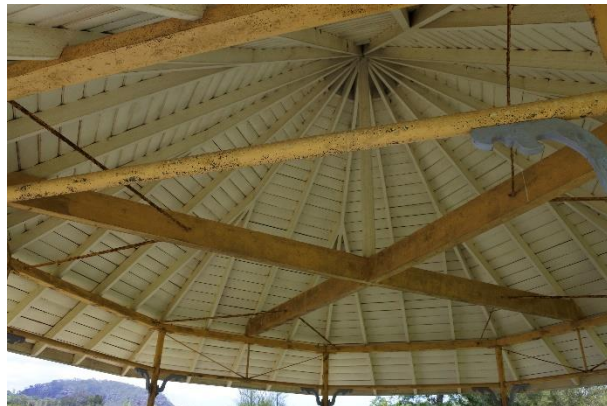
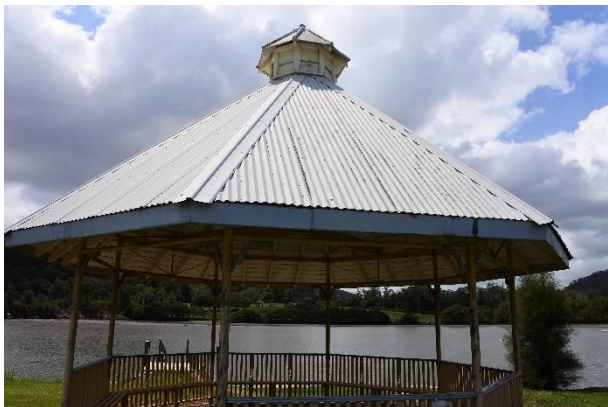
Figure 109 – Detail view of rotunda roof structure.

Figure 110 – View of rotunda roof structure.

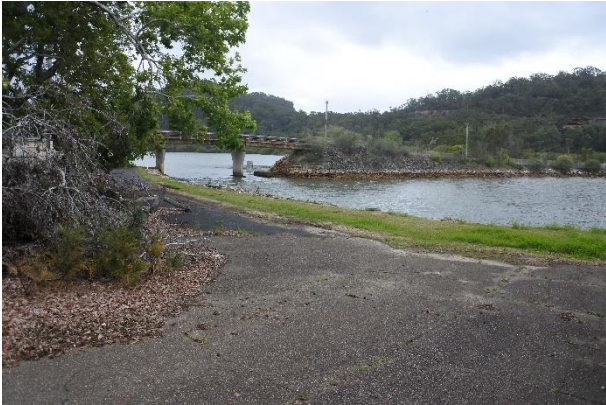
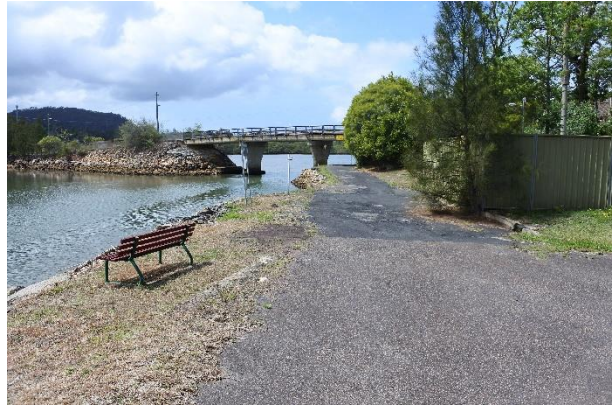
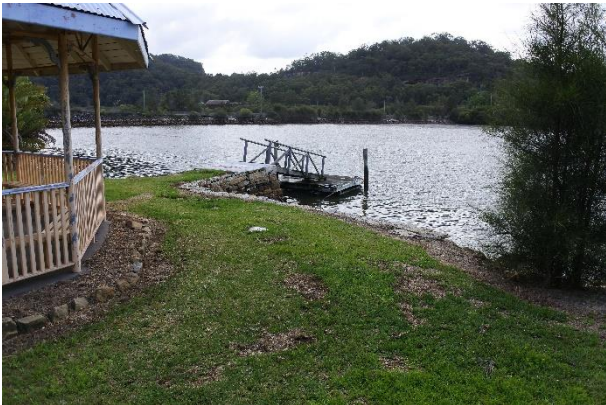
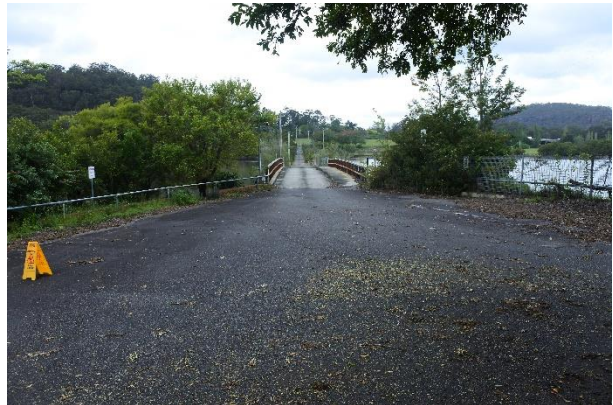
Figure 112 – View looking north from Peat Island.

Figure 113 – View looking south from Peat Island.

Figure 114 – View looking north from Peat Island showing causeway in context to its surrounds.

Figure 115 – View looking east across the causeway from Peat Island.

The causeway connects Peat Island to the mainland and is located on the east side of the island. The eastern portion of the causeway is reclaimed land and constructed of concrete, rubble and rocks. This reclaimed roadway is connected to the island by a concrete bridge in the west. Staff and patient labour was utilised in the reclamation and causeway construction works.

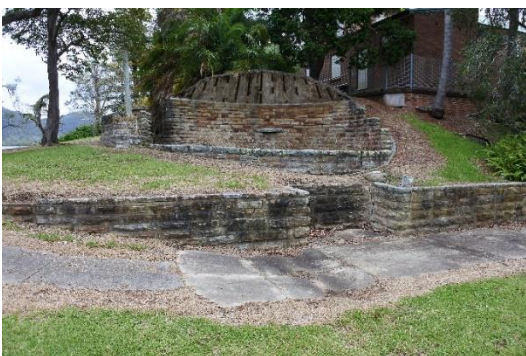
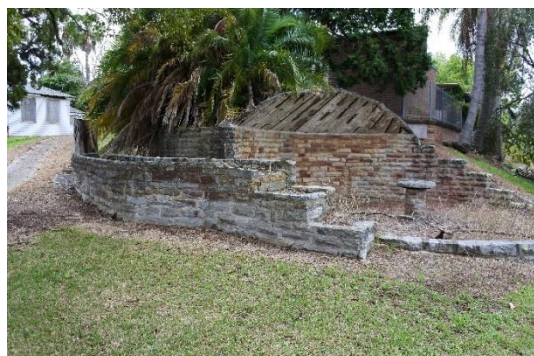
Figure 116 – View north showing music shell.

Figure 117 – View of music shell looking north-east.

An unusual open shelter constructed in a decorative 'shell' form. The shelter is located on the ridge, overlooking the southern open parkland of Peat Island. It is constructed from sandstone with a cantilevered concrete 'roof'. A sandstone retaining wall surrounds the shelter to the west and south. A sandstone plinth is located in the centre of the shelter. The design is reminiscent of larger 'music shells/ bowls'.

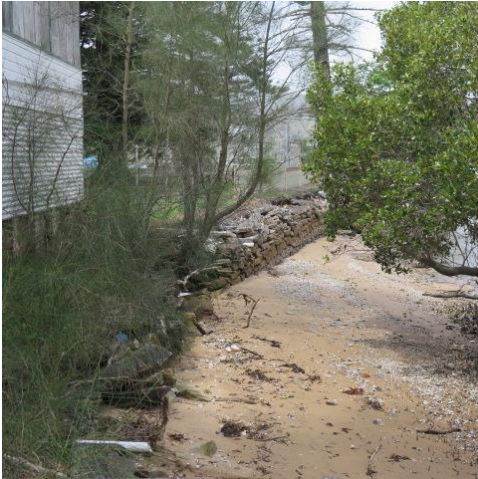
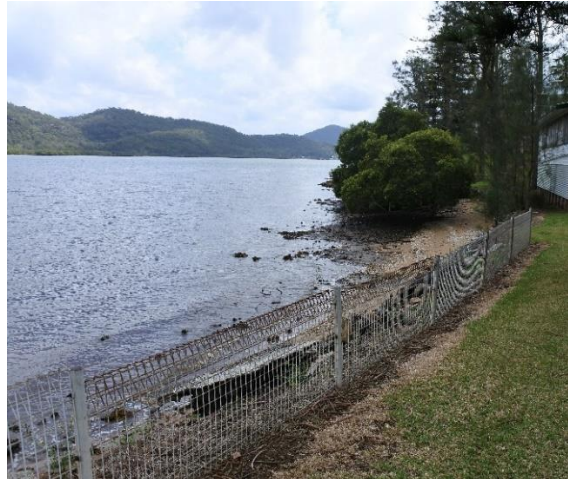
Figure 118 – View looking south along the beach.

Figure 119 – View looking north-west.

The retaining wall is located on the western side of the island behind the Staff Amenities building. Over time, the tides have created a small beach. The low see wall is dry packed and constructed of rock.

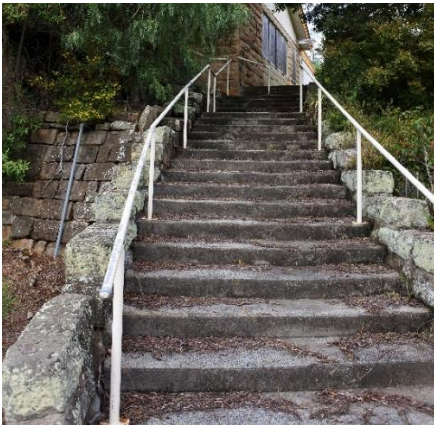
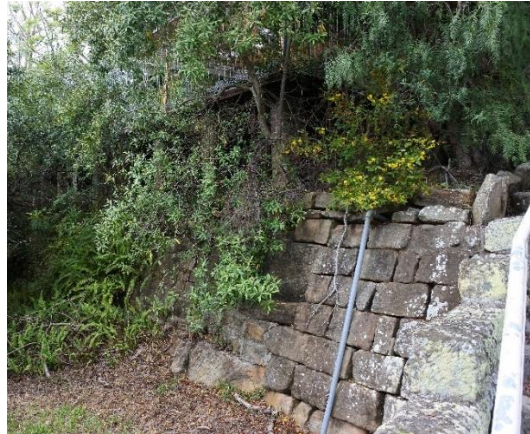
Figure 120 – View looking west up the stairs to Rizkella.

Figure 121 – View of the wall, east of the stairs.

The dry packed stone revetment wall can be seen on both the east and to the south-west of the stairs. It is likely both were constructed c.1930.

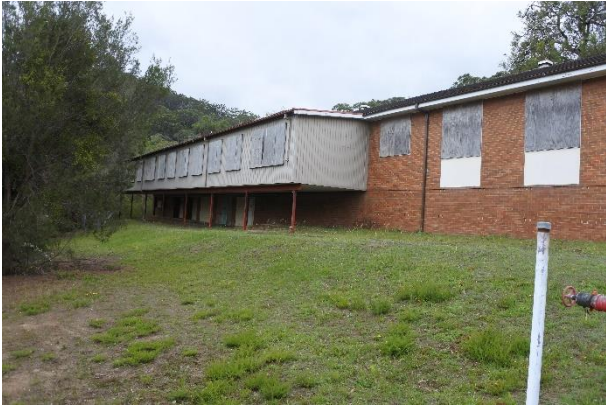
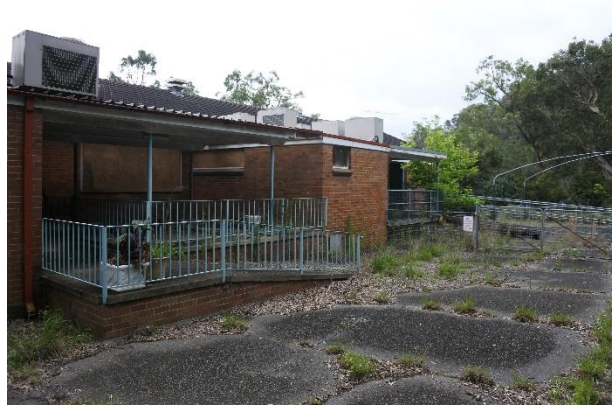
Figure 122 – View of the Sanbrook - west elevation.

Figure 123 – View of the Sanbrook - east elevation and concreted outdoor paving.

'Sanbrook' is a face brick structure with tiled roof and hopper style windows. An enclosed verandah, with corrugated metal skillion roof, is located on the west elevation. The building was originally constructed for short-term patients after 1960. Based on an external inspection, the building appeared to be in fair to good condition.

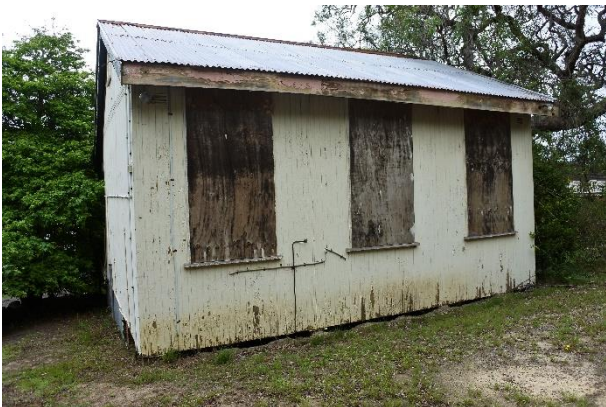
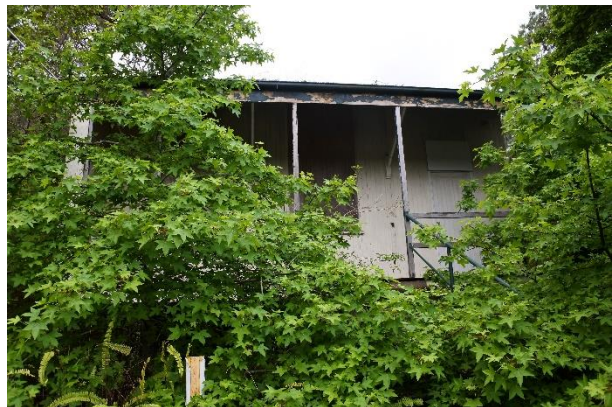
Figure 124 – View of the Sewing Room east elevation.

Figure 125 – View of the Sewing Room west elevation.

The 'Sewing Room' is not original to the site and was moved to this location in the 1960s from unknown origin. It was used as an additional classroom and later as an activity room. The structure is a timber framed building (clad in vertical timber boards) with a gable corrugated metal roof. It contains timber framed windows. It has a simple verandah on the west elevation. The exterior condition is fair.

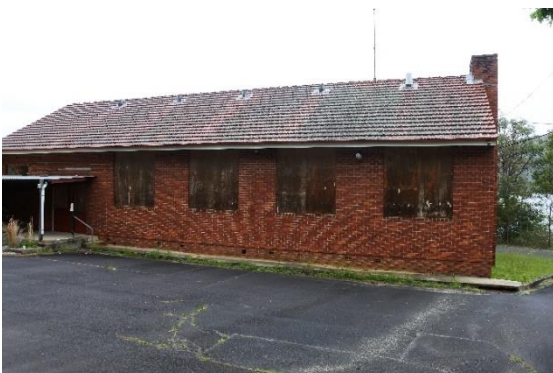
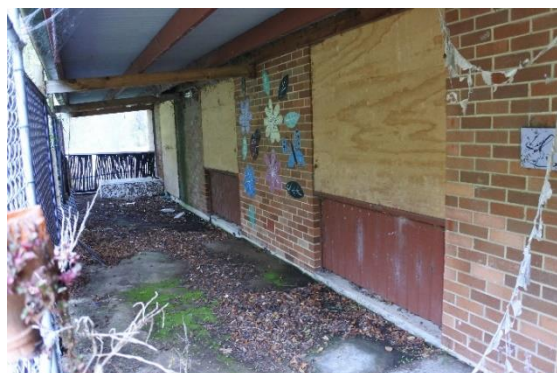
Figure 126 – View of the buildings north elevation.

Figure 127 – View of verandah on the north elevation.

The 'Recreation Hall' is a face brick building with a tiled gable roof on the northern end. A later addition to the

south has a corrugated metal low pitched gable roof. The original building (c.1950s) has a verandah on the west elevation, while the southern addition (c.1960s) has a verandah to its east elevation. The building appeared in to be in a fair to good condition from exterior inspection.

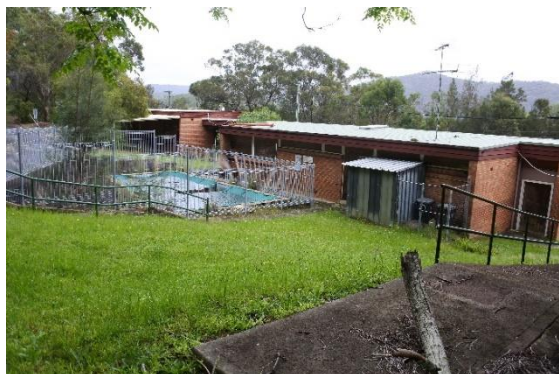
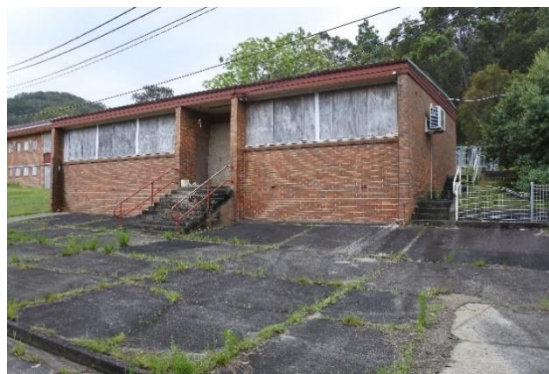
Figure 128 – View of the buildings north elevation.

Figure 129 – View of the buildings south elevation.

The ‘Carpenter’ building (c.1960s) is a face brick building with low pitched corrugated metal roof. The building has aluminium framed windows and has an inground pool to its rear. The building appeared in good condition from exterior inspection.

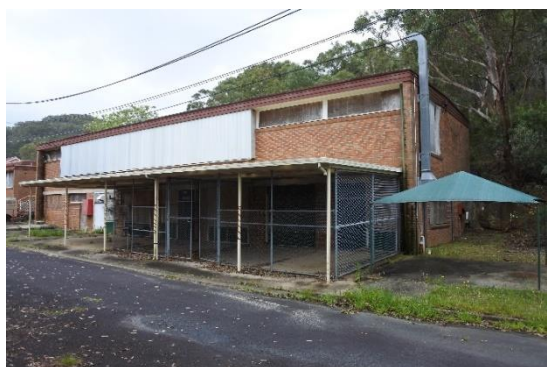
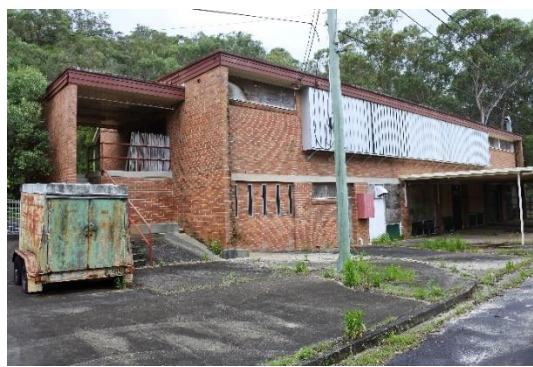
Figure 130 – View north of the building's south elevation.

Figure 131 – View east of the buildings south elevation.

The Industrial Therapy Unit (c.1960s) is a two-story face brick building with a single storey caged storage area to its west elevation. The building has a corrugated metal low pitched roof with a portico on its north elevation. The building appeared to be in good condition from an exterior inspection of the building.

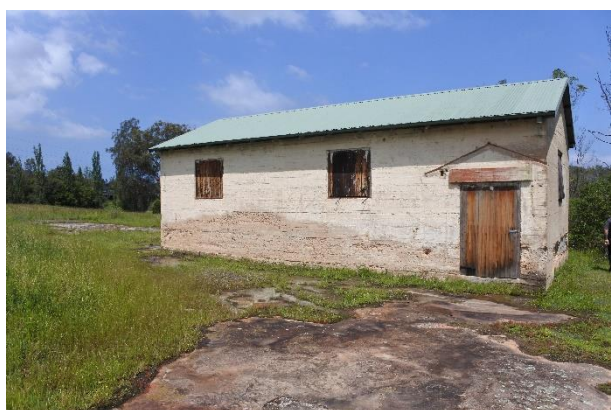
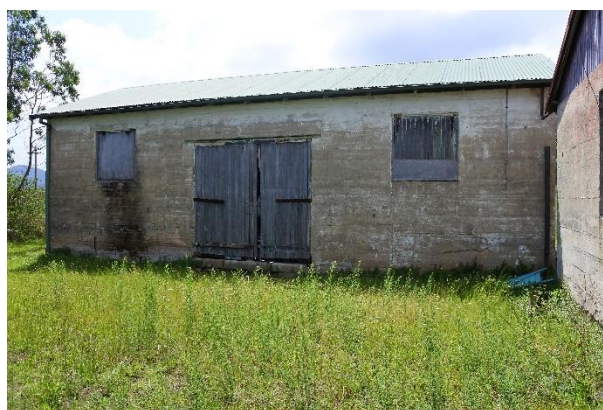
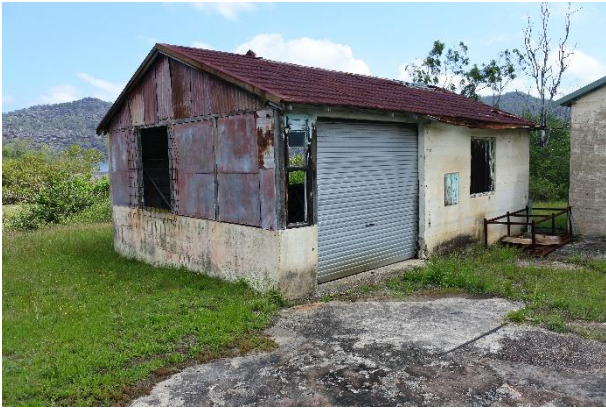
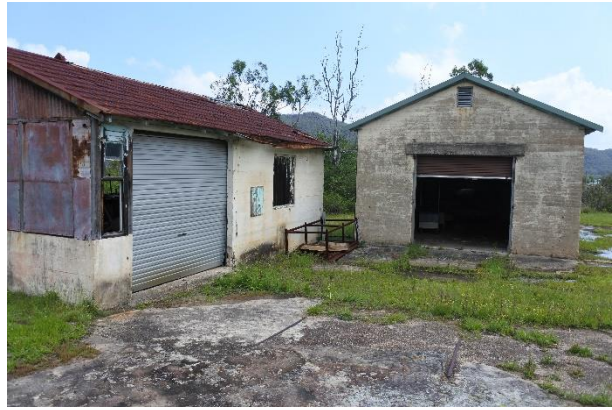
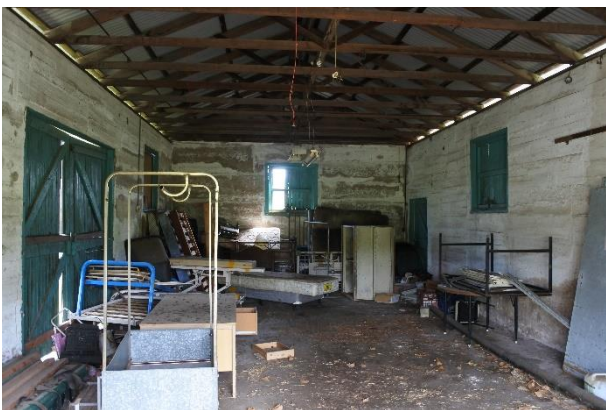
Figure 132 – View of larger buildings' north elevation.

Figure 133 – View of the larger buildings' south

elevation.

Figure 134 – View of the smaller buildings' north and east elevations.

Figure 135 – View of the east elevation of the larger building and the north elevation of the smaller building.

Figure 136 – View west within the larger building.

The condition of the buildings is intact overall. However, some concrete deterioration/flagging can be seen on the west elevation of the larger building. The timber panelled doors and windows are in various states of disrepair or missing. The east elevation of the smaller building requires replacement corrugated metal sheeting or an alternative material.

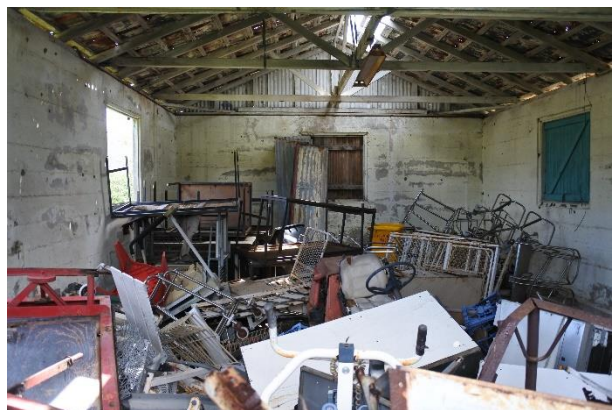
Figure 137 – View west in the smaller building.

The former two dairy buildings were constructed c1940s. The buildings are constructed of reinforced formed concrete. The smaller building, located to the south-east of the larger building, has an unusual pressed metal roof formed into tile like panels. The larger building may have originally had this roof material. It now has a recently installed corrugated metal roof. Both buildings have exposed timber roofing structures.

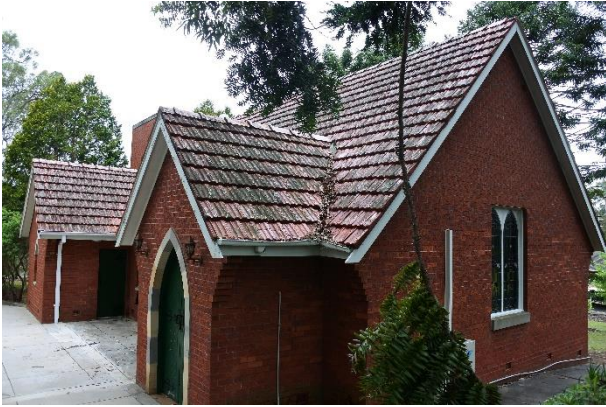
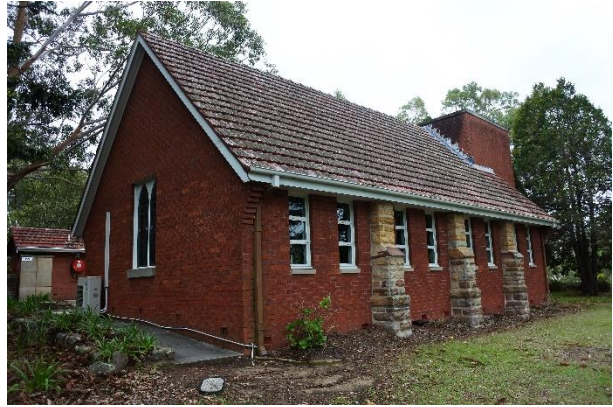
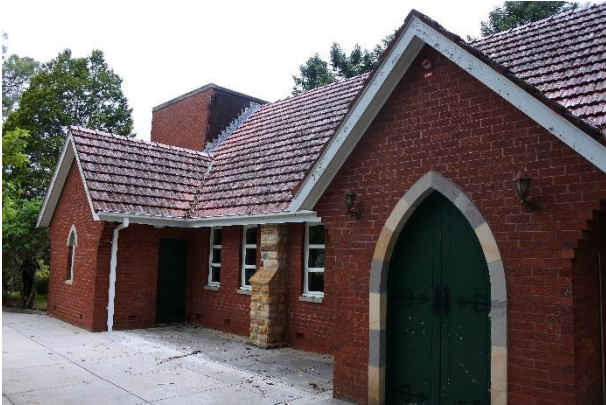
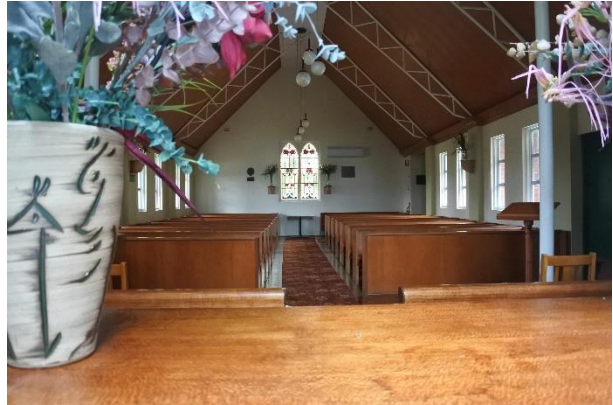
2.2.4.1. Chapel – Reference 34

The chapel, like its neighbouring buildings in the *Chapel Precinct*, was designed by the Government Architects Office. It was constructed in 1959-60. The building is masonry with terracotta tile roof. It has a square tower located on its east elevation. The north and south elevations are characterised by sandstone buttresses.

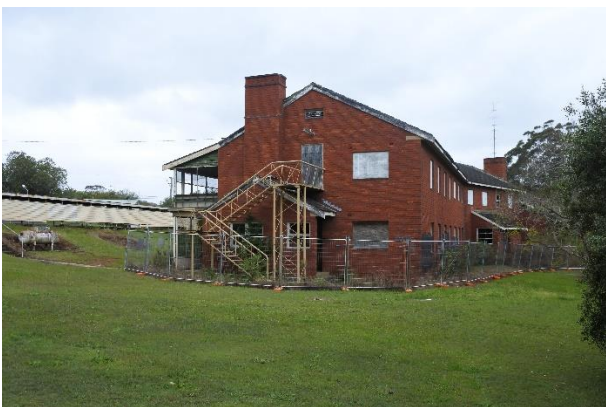
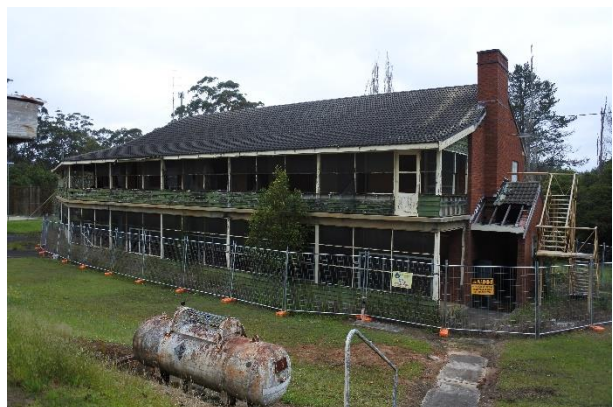
2.2.4.2. Staff Quarters – Reference 36

Designed by the Government Architects Office and constructed in 1956. The two-storey v-shaped masonry building has a concrete tiled roof and a chimney on both the east and west elevations. The north elevation has a verandah and balcony running its entire length. The building was originally built as nurses' quarters. The building appears to have been vandalised, including fire damage.

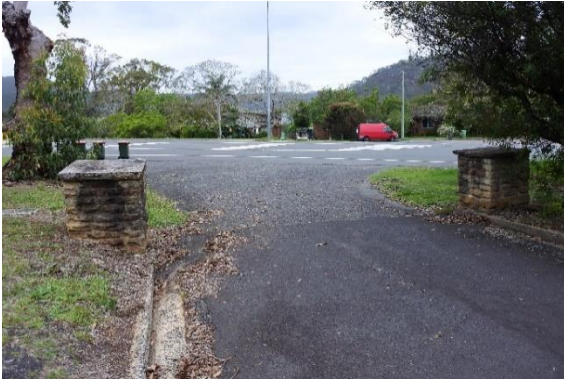
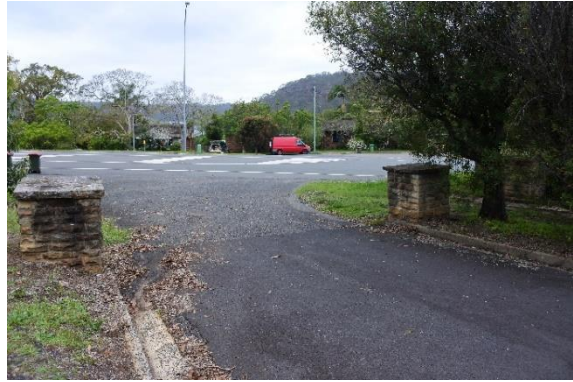
2.2.4.3. Entry Gates – Reference 44

The entry gateway would have been the main access point prior to the construction of the M1 Motorway. There are three sandstone plinths, two on either side of the carriageway and a third, providing pedestrian 'access' to the south.

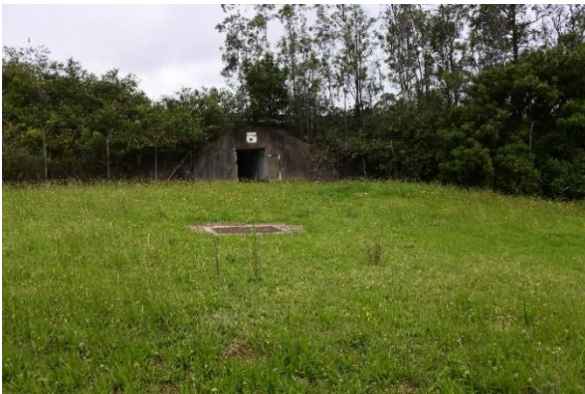
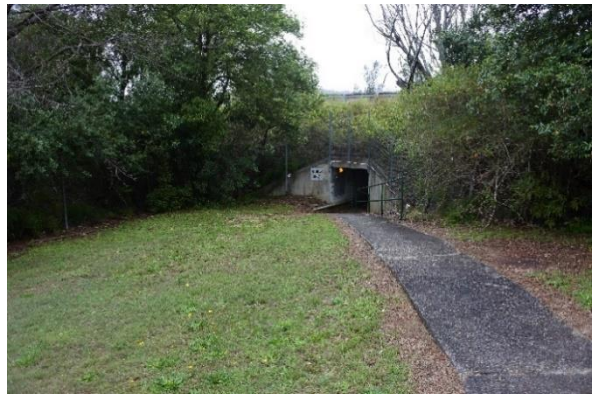
2.2.4.4. Pedestrian Tunnel – Reference 47

The pedestrian tunnel was constructed in the 1970s when the motorway was constructed. The reinforced concrete tunnel connects the Mooney Mooney Foreshore Precinct with the Chapel Precinct via a concrete path.

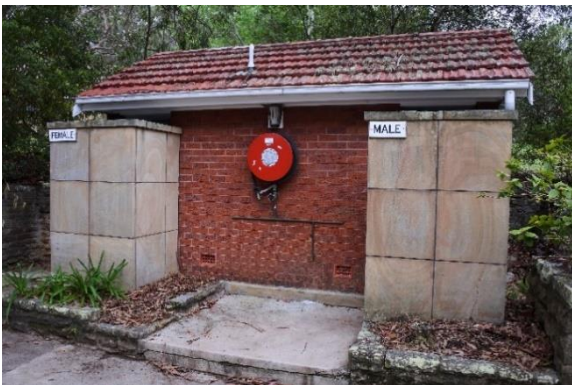
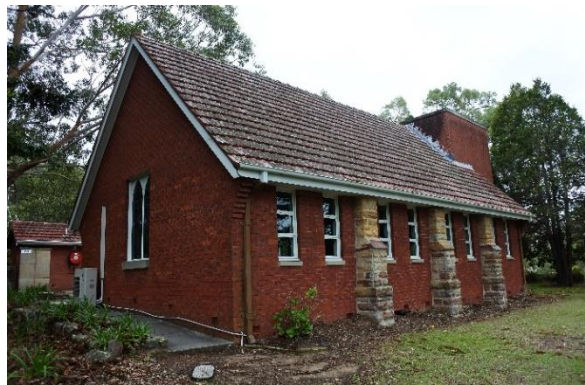
2.2.4.5. Lavatory Block – Reference 49

The 1960 lavatories are adjacent to the north-west corner of the chapel. Matching with the chapel, they are masonry in construction with a terracotta tiled roof. There are sandstone panelled privacy screens leading into the male and female lavatories. The lavatories are integrated within the chapel setting and curtilage.

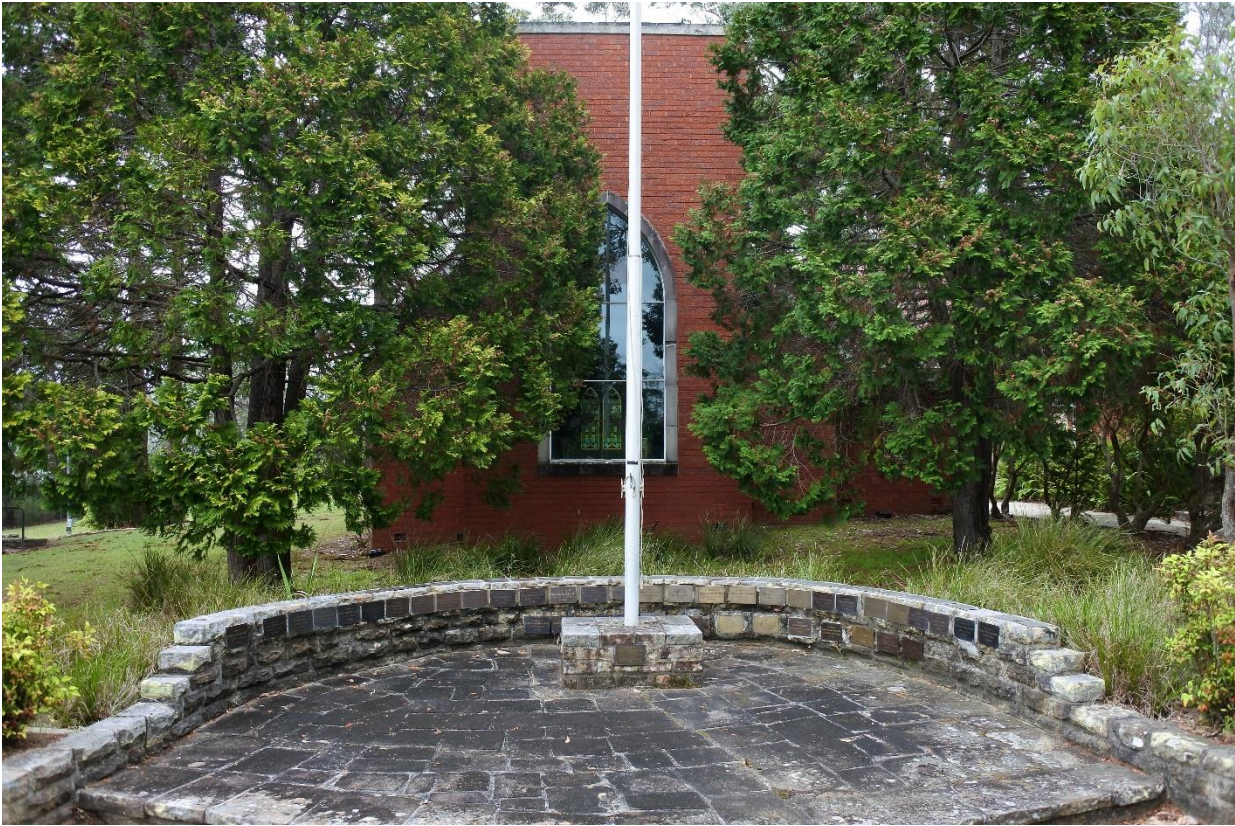
Figure 150 - View looking west, showing flagstaff area memorial.

The memorial surrounds the flagstaff in a semi-circular form. The memorial consists of stone pavers with sandstone wall which contains small bronze plaques in memory of former staff and patients who have since passed away.

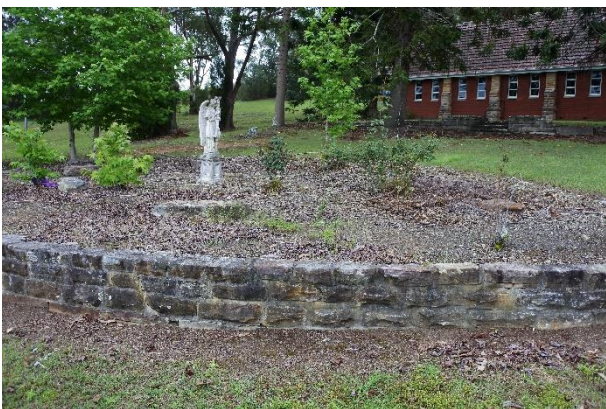
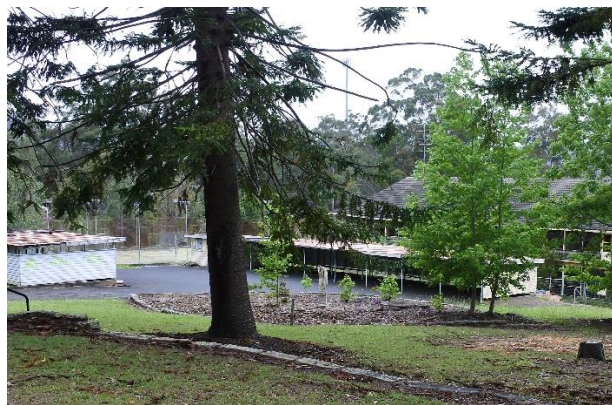
2.2.4.7. Memorial Garden (Rose Garden) – Reference 51

The memorial rose garden was established in the c.1960. It is oval in shape with low sandstone retaining wall. The garden has a statue of an angel, along with some remnant rose plants.

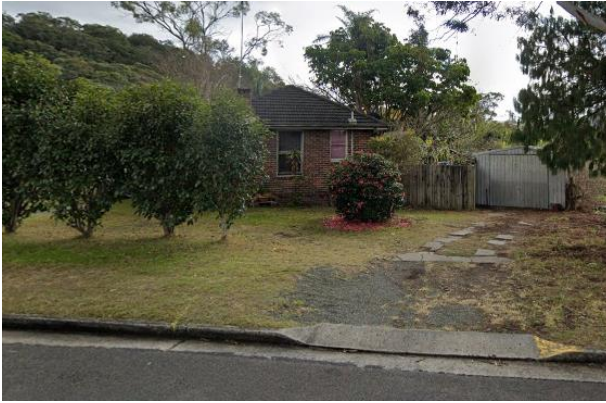
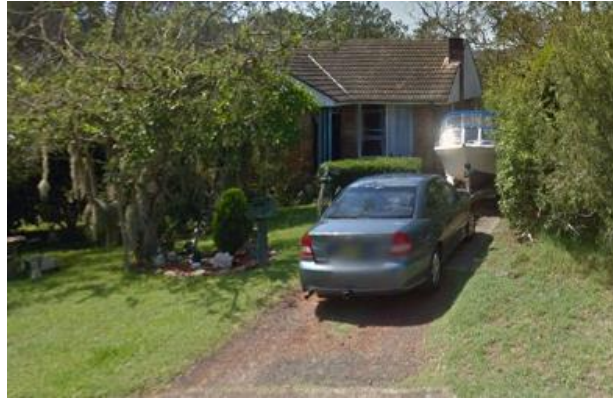
2.2.5.1. Staff Cottages – Reference 40 and 41

The post-war staff cottages are located to the north and east of Kowan Street and are masonry in construction with roofing of concrete tile. The cottages are currently inhabited and are in good condition.

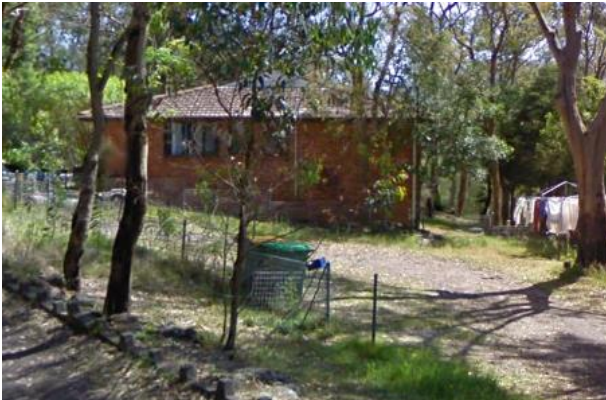
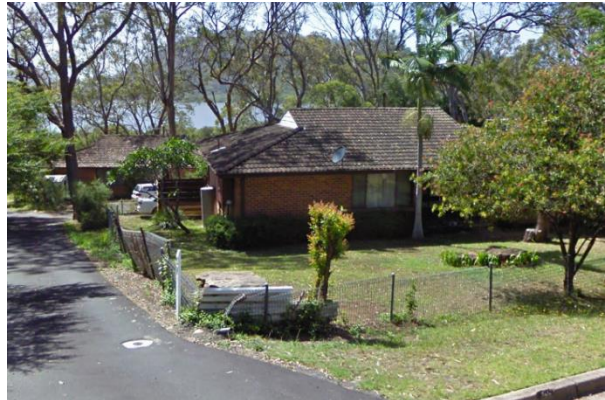
2.2.5.2. Staff Cottages – Reference 43

The mid to late 1970s staff cottages are located to the east of Kowan Street and are masonry in construction with roofing of concrete tile. The cottages are currently inhabited and are in good condition.

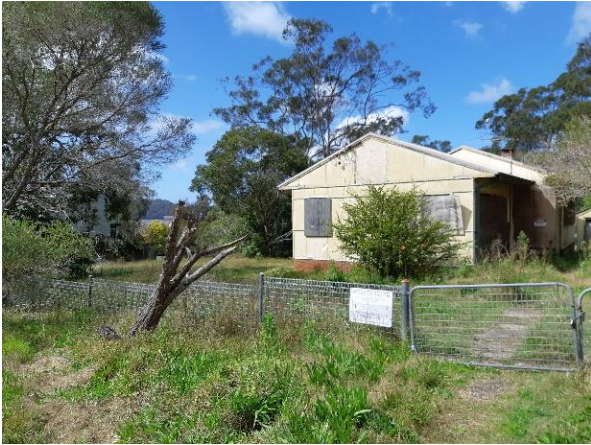
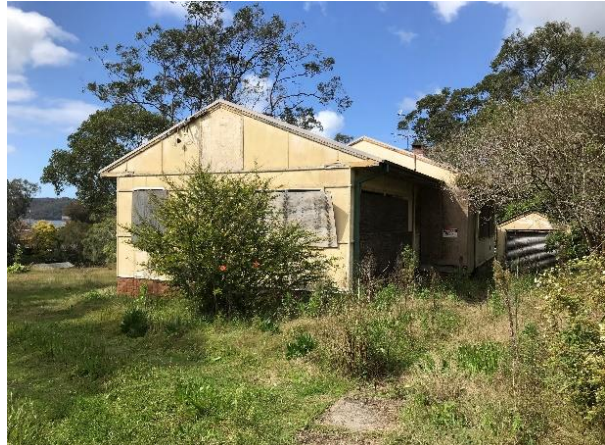
2.2.5.3. Former Principal's Residence & Garage – Reference 70

The post-war former Principal's Residence and garage are located to the north of Precinct D and are masonry and fibro in construction. The cottage and garage are currently uninhabited and are in poor condition.

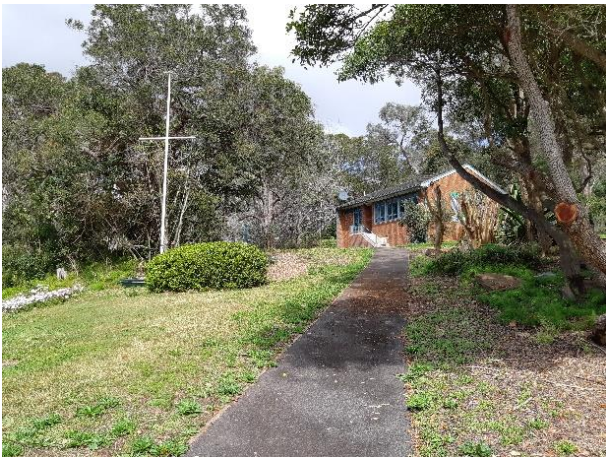
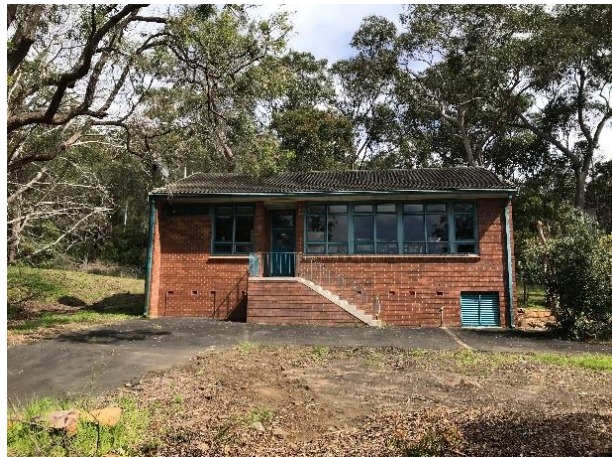
2.2.5.4. Brick school building – Reference 71

The early 1960s brick school building is located to the north of Precinct D and is masonry in construction with roofing of terracotta tile. The school building is currently disused and is in good condition.

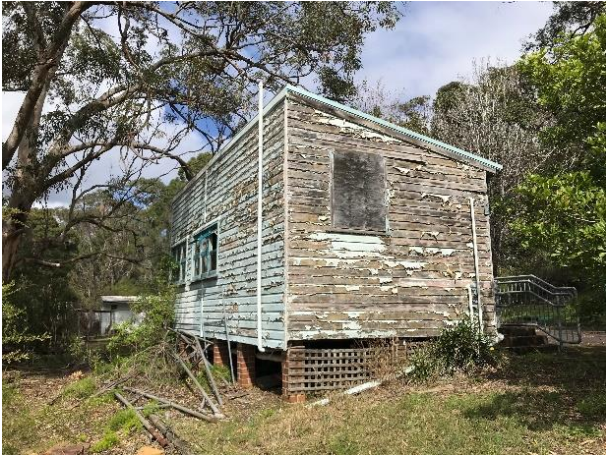
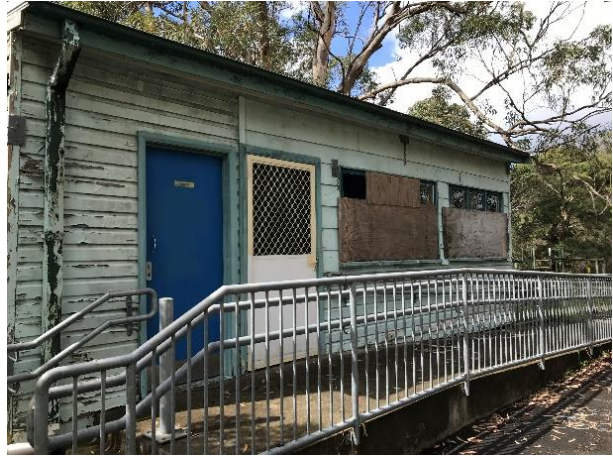
2.2.5.5. Timber weatherboard school building – Reference 72

The early 1960s timber weatherboard school building is located to the north of Precinct D. The school building is currently disused and is in poor condition.

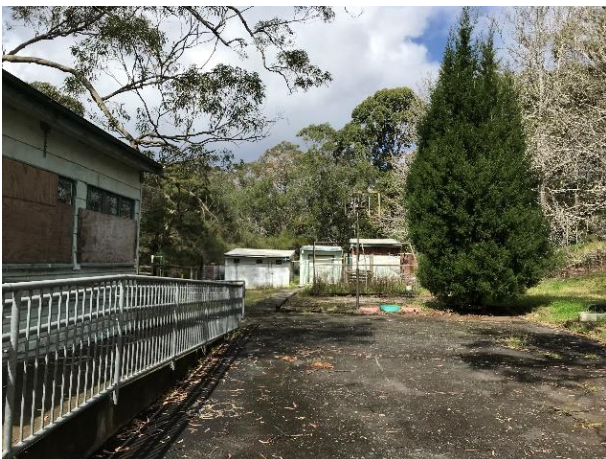
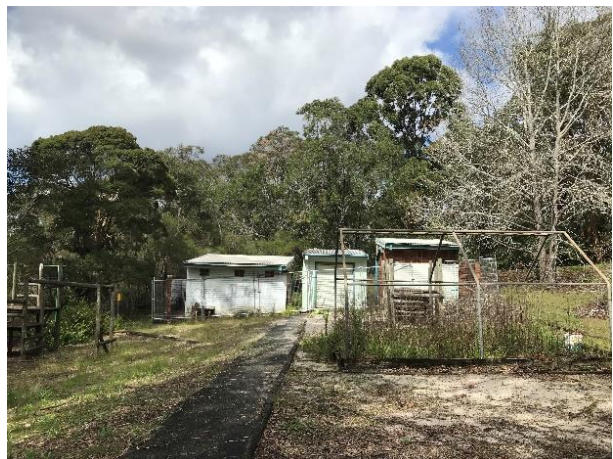
2.2.5.6. Amenities blocks – Reference 73

The early 1960s amenities blocks are located to the south of the timber weatherboard school building and is masonry in construction with roofing of corrugated iron. The buildings are currently disused and in fair condition.

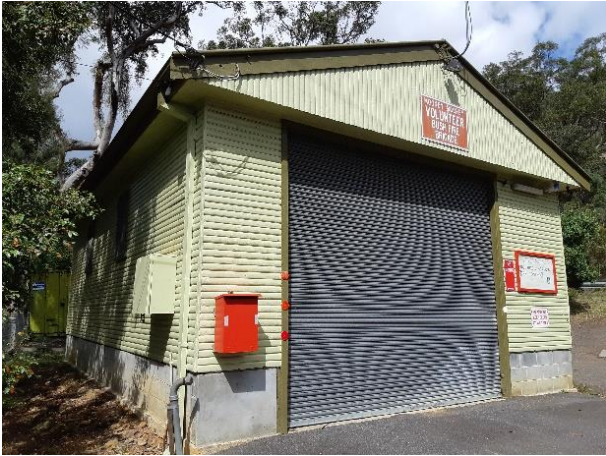
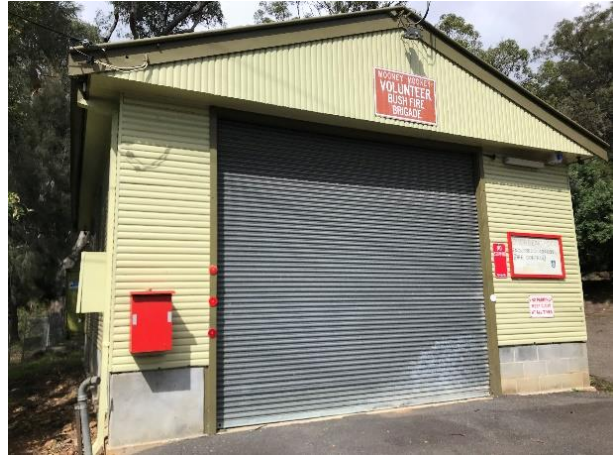
2.2.5.7. Fire Station – Reference 74

The 1947-61 (modified later) Fire Station is located to the north of Precinct D and is concrete and weatherboard in construction with roofing of corrugated iron. The Fire Station is currently in used and is in good condition.

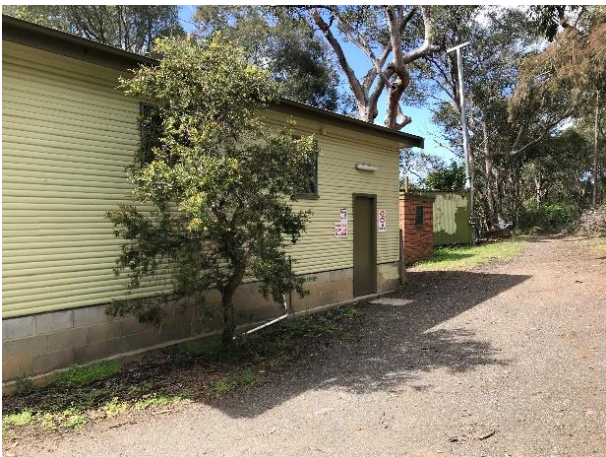
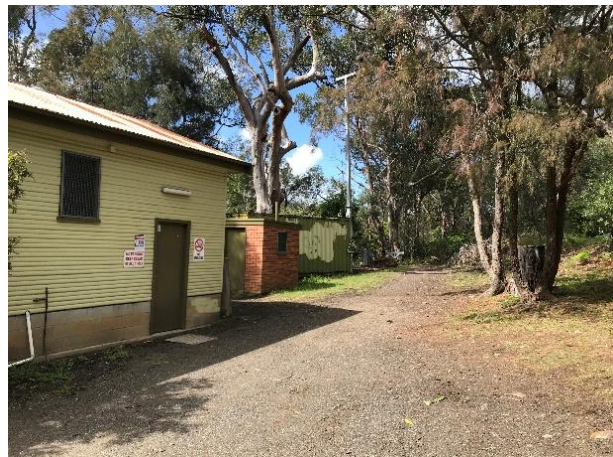
2.2.5.8. Fire Station Amenities – Reference 75

The 1947-61 (modified later) Fire Station amenities are located to the rear of the Fire Station and are masonry in construction with roofing of corrugated iron. The amenities are currently in used and in good condition.
