CONSERVATION MANAGEMENT PLAN

Former Peat Island Centre,
Peat Island and Part Mooney
Mooney NSW 2083

Prepared for
**PROPERTY & DEVELOPMENT NSW (HOUSING &
PROPERTY, DEPARTMENT OF PLANNING,
INDUSTRY & ENVIRONMENT)**

20 October 2020

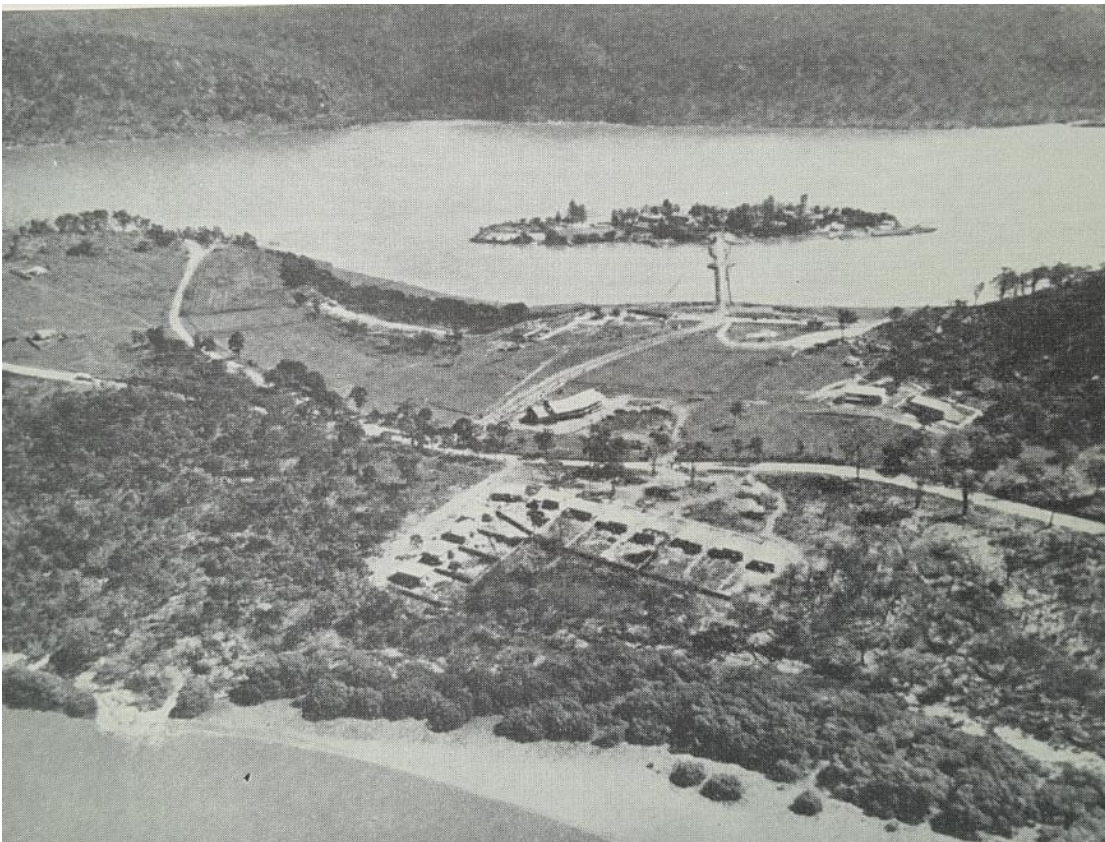
Figure 195 – Oblique aerial view of Mooney Mooney showing Peat Island in centre background, 1957.

In 1954-55, a new school building was opened, along with a new bridge and approach. In the end of June 1956, Peat and Milson Islands had a combined hospital population of 598.³² Figure 195 comprises an aerial view of the Peat and Milson Islands Hospital, especially the buildings erected on the mainland at Mooney Mooney.

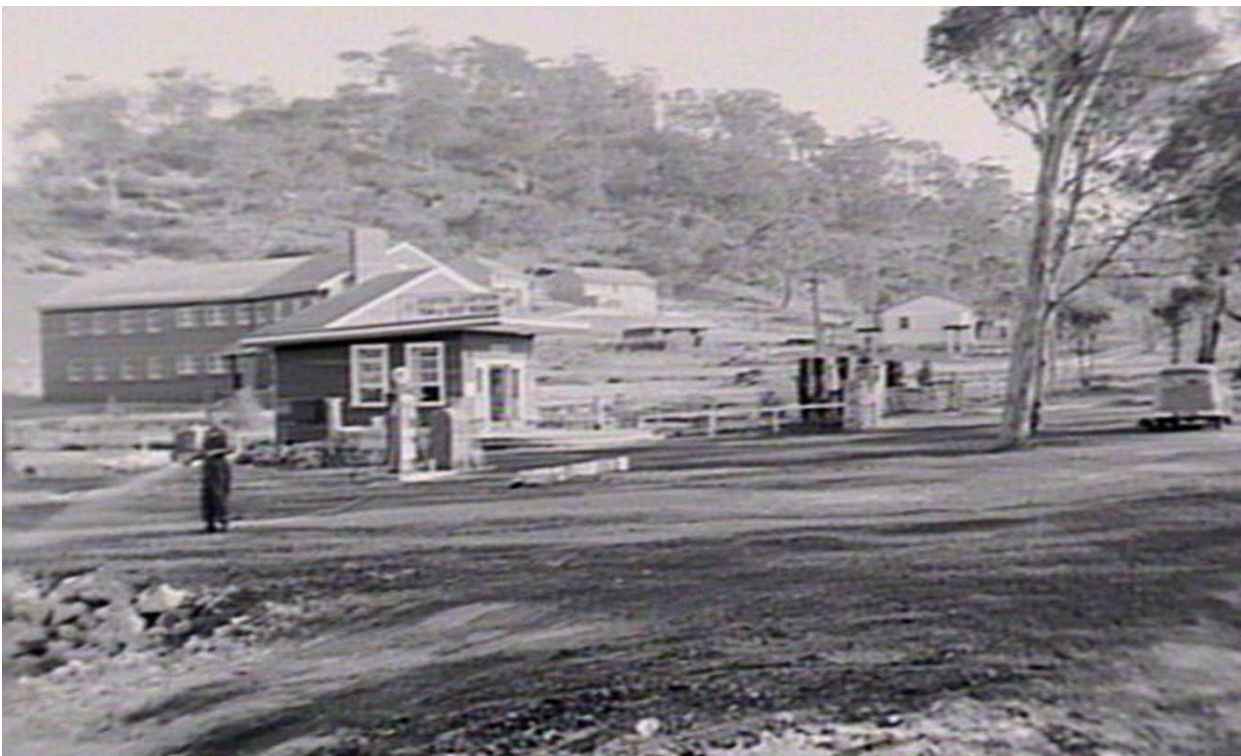
Figure 197 – Roadside canteen for Peat Island Hospital, 1957.

The area east of the Old Pacific Highway was developed from the 1950s to provide additional accommodation for the staff working on the hospitals on Peat and Milson Island. The photograph of the Pacific Highway, Mooney Mooney in the mid-1950s (Figure 197) shows the former canteen and entry drive, whilst the chapel has not yet been built. The photograph suggests that the building of the new freeway necessitated moving the vehicular entry to the north. The first canteen building was demolished and rebuilt in 1967. It sold fuel and takeaway food until 2010.

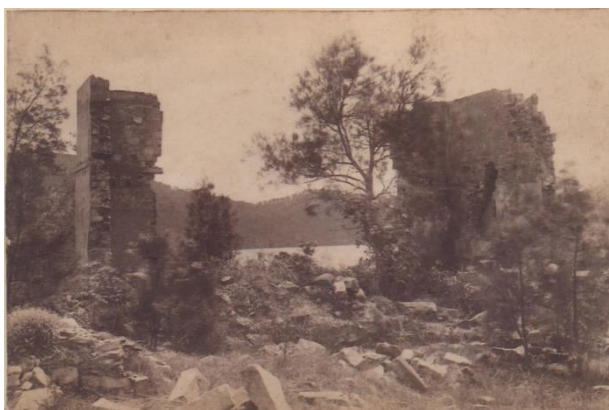
Figure 209 – Ruins of George Peat's house "Fairview", overlooking the Hawkesbury River at Mooney Mooney, about 1880.

*...The dwelling at Fairview Point was burnt down while vacant some time after his death. Today, a few crumbling stones mark the spot, but fortunately a photograph of the building, while still retaining some of its original appearance, was taken [in 1880] after the fire. This discloses a two-storey house of respectable dimensions. The stones contained in these ruins were removed at a later date and used in the erection of a church upon an adjacent island in the river. Today little else remains upon the old property at Fairview Point but the ruins of the house, an ancient and picturesque colonial oven, and the gravestone of Peat's daughter.*³⁹

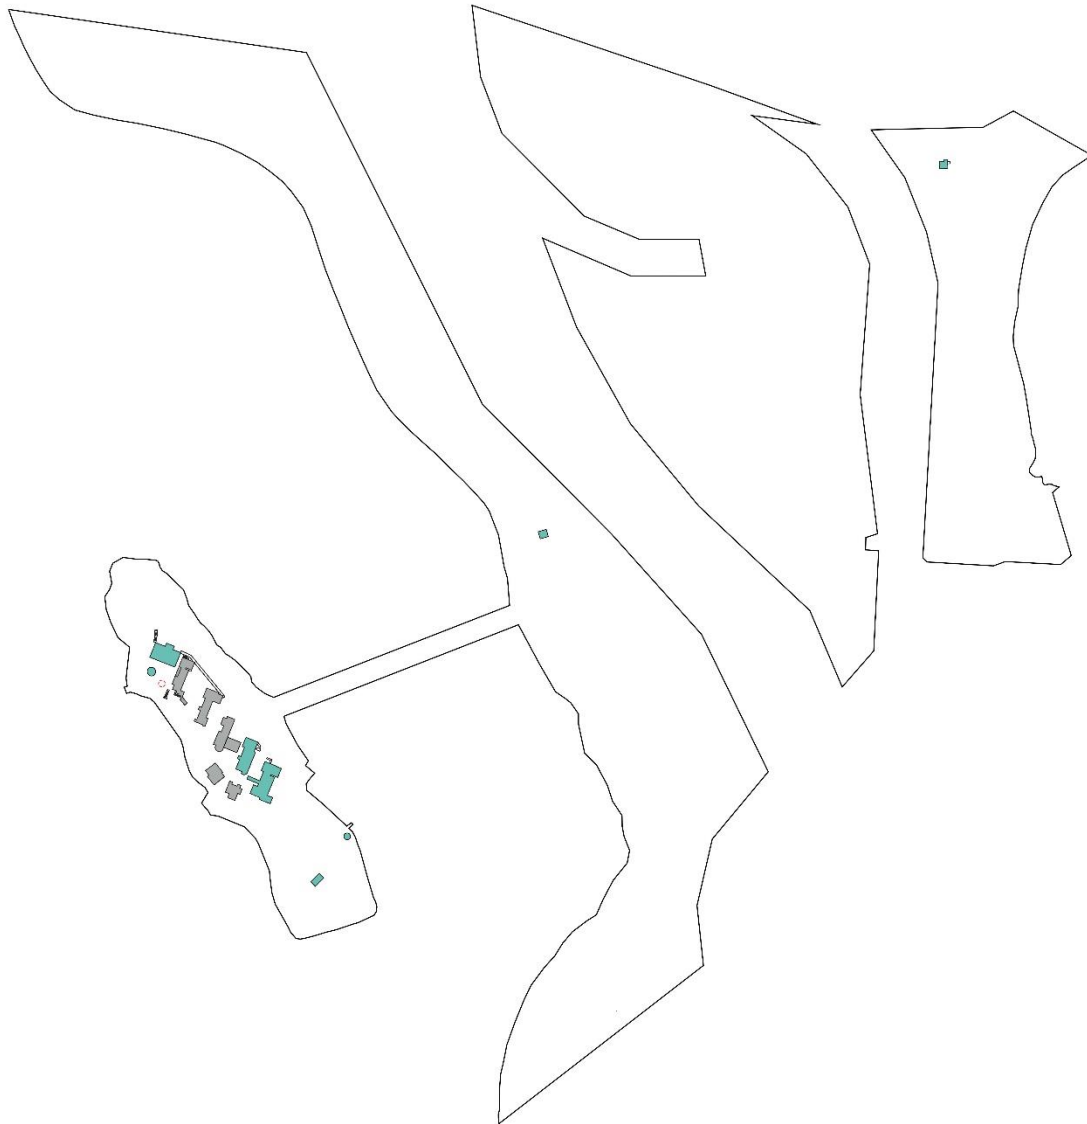
PHASE OF DEVELOPMENT

Phase 2: 1910-1945

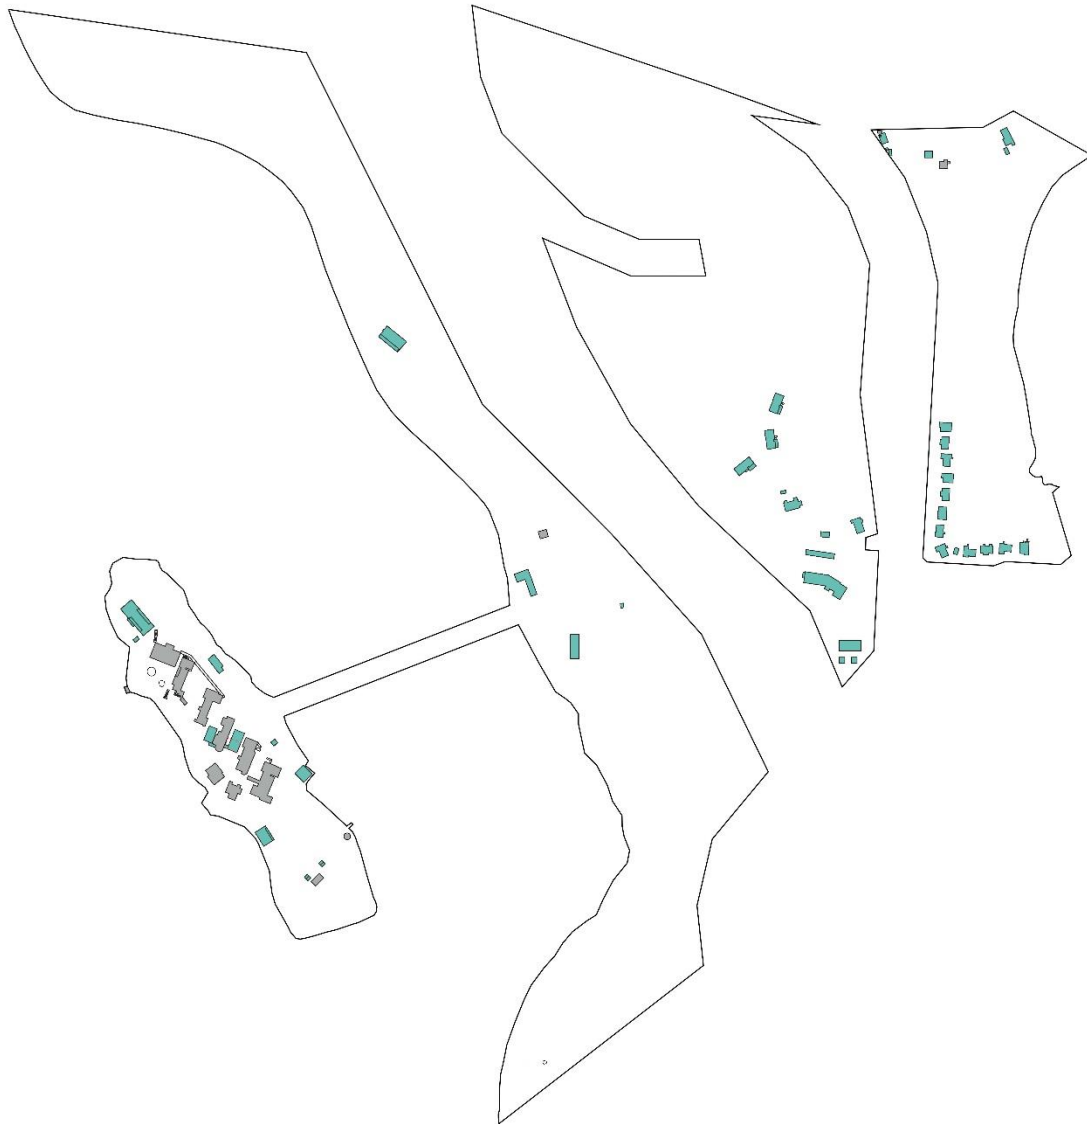
PHASE OF DEVELOPMENT

Phase 3: 1945-1960

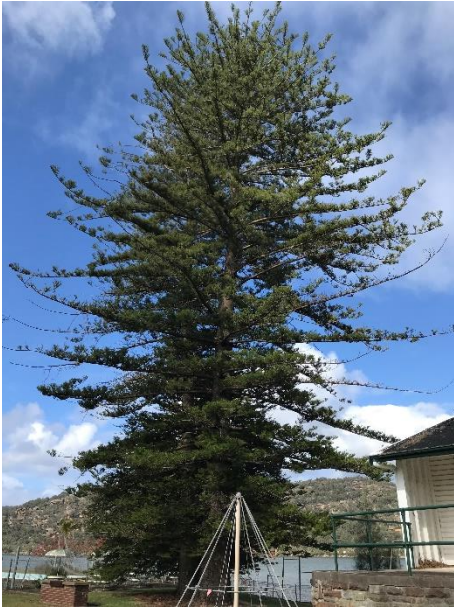
Figure 219 – Norfolk Island Pines.

While many elements of the landscape including vegetation and built elements, contribute to the landscape setting, only a small number of these elements are of heritage significance for their ability to demonstrate the values of the place or interpret the former use of the place. The Norfolk Island Pines are considered to be of high heritage significance as intentional introduced plantings which are typical of this form of institution and are key to establishing significant view lines and location markers from distances. Other plantings on the Island are considered to be less significant. Native mangrove vegetation is important to the place given its island nature within the Hawksbury River.

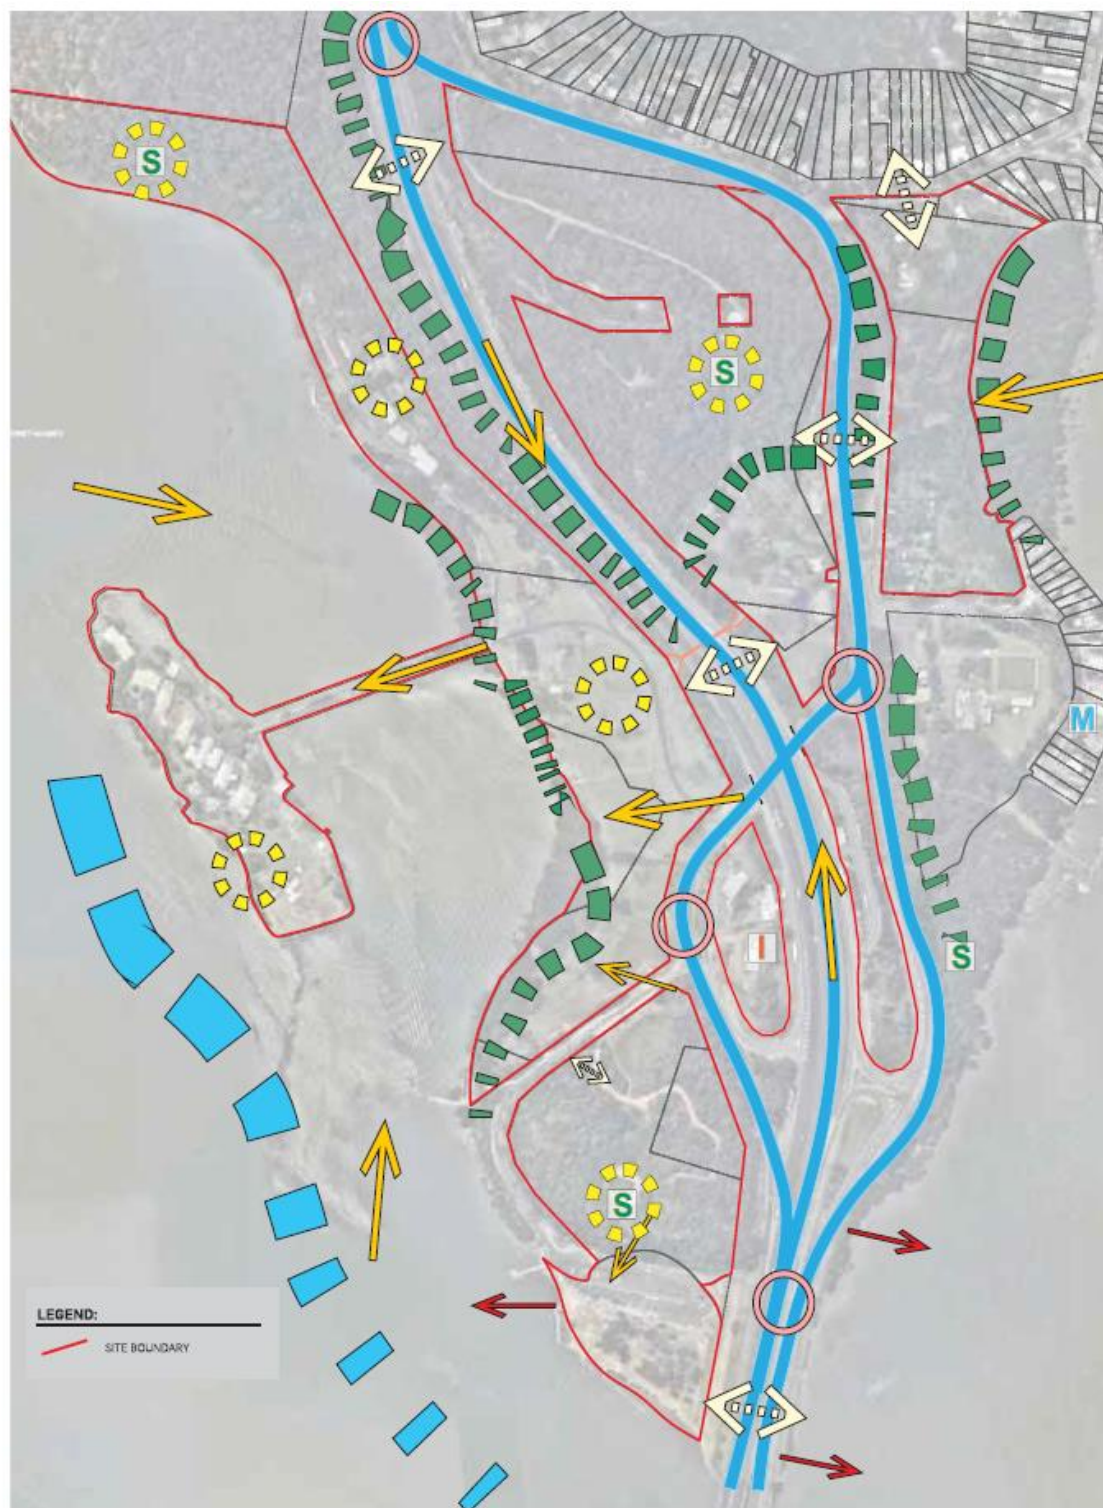
An extract of the 2016 Visual Analysis report is included hereunder identifying the principal visual characteristics of the former Peat Island Centre.

Figure 3
Visual Exposure

The naturally wooded, steep feature locally described as "Tank Hill" is the most prominent feature of the site and would be visible from the waterways east, north and west of the site. At the south of the site is a smaller but locally prominent naturally vegetated small hill that is also visible from the waterways east of the road corridors and road bridges. The hills are predominantly proposed to be preserved in their existing character as national parks and nature reserves, or public recreation areas and would remain visible, but unchanged.

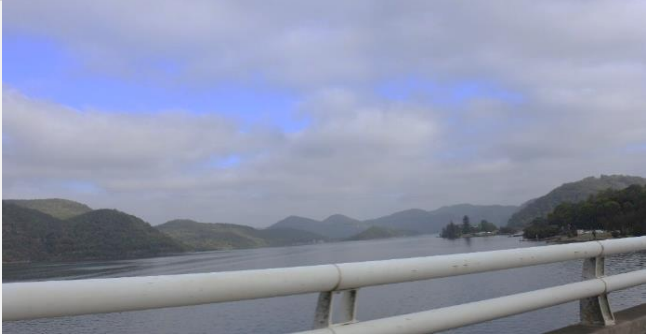
No.	Description	Level of Significance	Photo of View
1	View north west from the freeway bridge across the Hawkesbury River – this view provides a holistic view of Peat Island on approach from Sydney in the broader context of the River and the surrounding development. Distinctive marker trees on Peat Island are visible.	Moderate

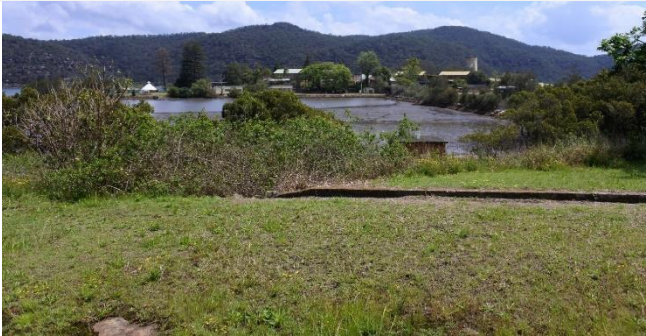
2	View south-west towards Peat Island from Precinct B: Mooney Mooney Foreshore, looking at the approach from the mainland towards the causeway and Peat Island. This is a historic view of the principal approach to the Island following construction of the causeway.	High

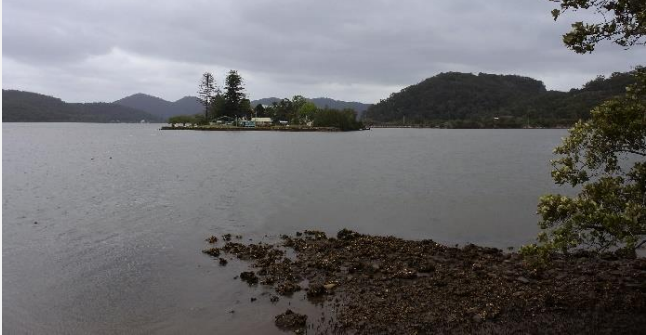
3	View north-west from the Mooney Mooney foreshore in Precinct B at Deerubbun Reserve point/Peats Ferry Road, looking towards Peat Island in the Hawkesbury River. This view provides an uninterrupted view of the Island's eastern point showing open fields, marker trees and built development in the background.	High

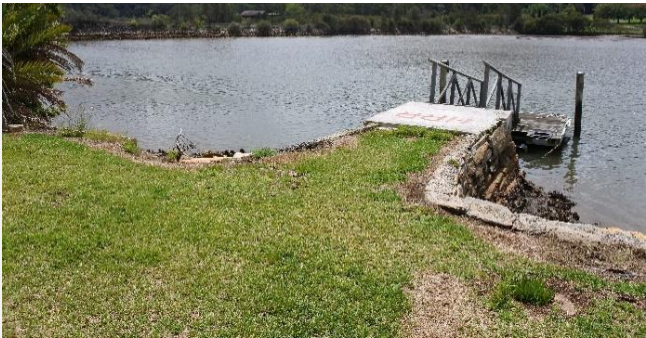
No.	Description	Level of Significance	Photo of View
4	View north-east from the Hawkesbury River facing the original wharf and loading dock area on the western side of the Island – this was the original disembarkment point for all patients and staff arriving at the island and would provide a view of the typical approach experiences by these people.	High	Not available
5	View east from the wharf on the eastern side of the Island facing Precinct B: Mooney Mooney Foreshore. This is an outward view from the Island towards the nearest mainland area and would have been a typical view for patients and staff on the Island.	Little

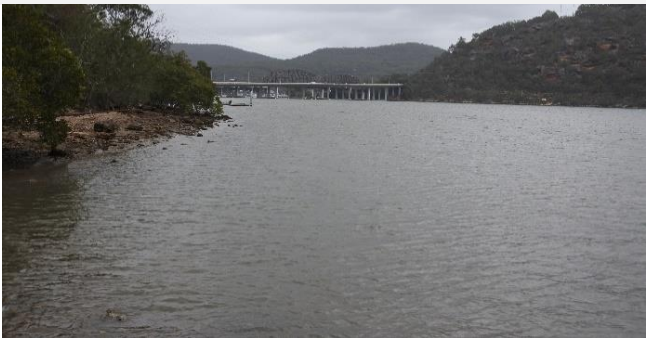
5	View south from Peat Island's eastern banks. This is an outward view from the Island towards the Hawkesbury River bridge and would have been a typical view for patients and staff on the Island.	Little

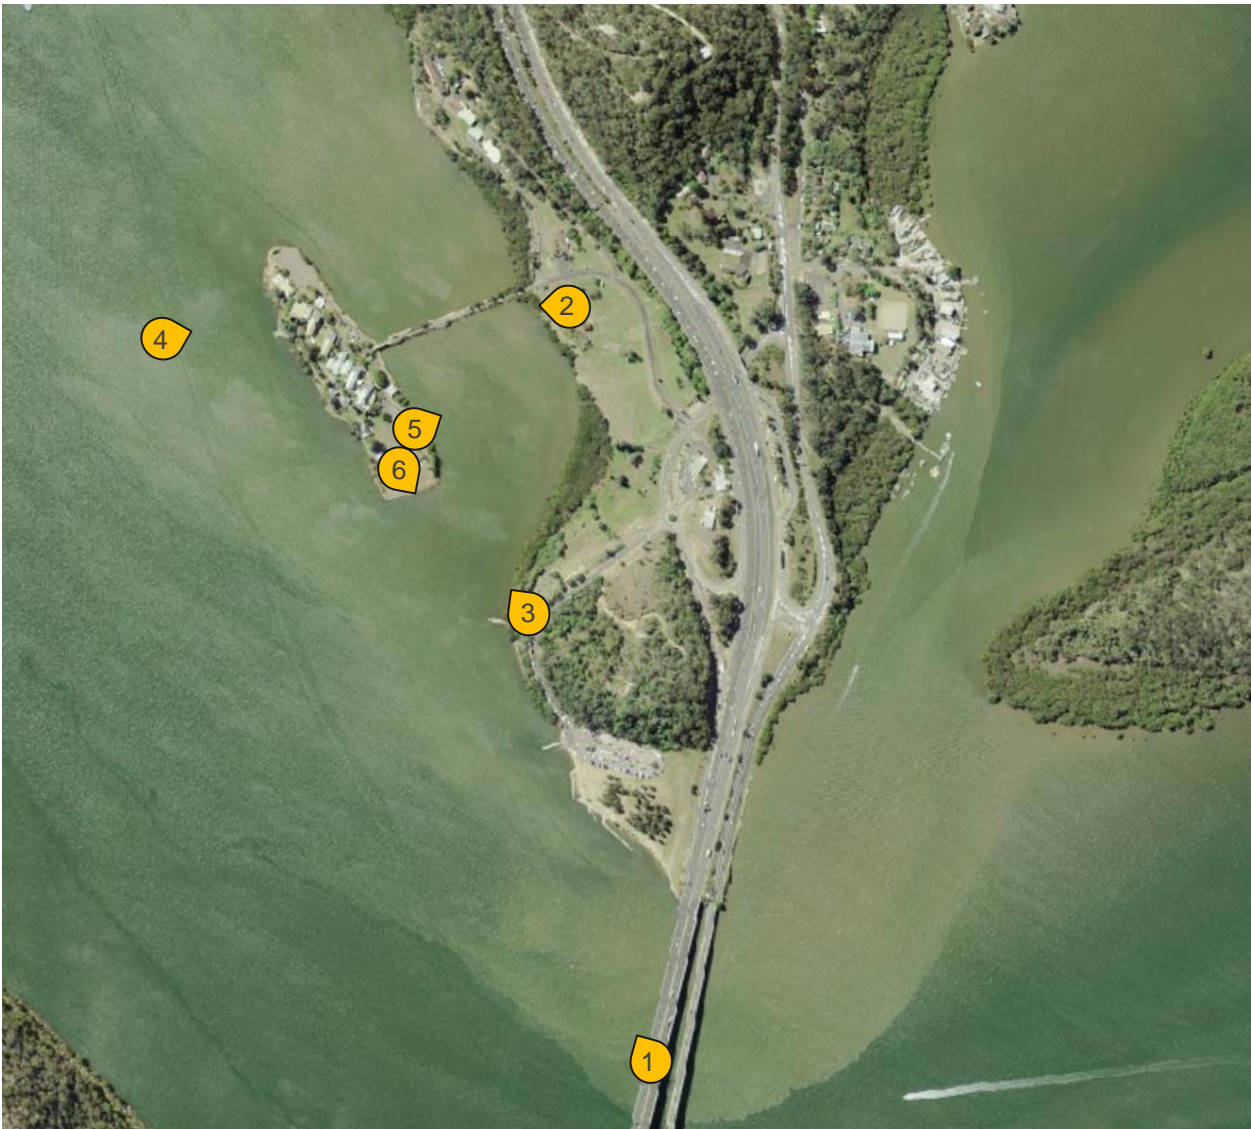
Figure 232 – Aerial showing significant views

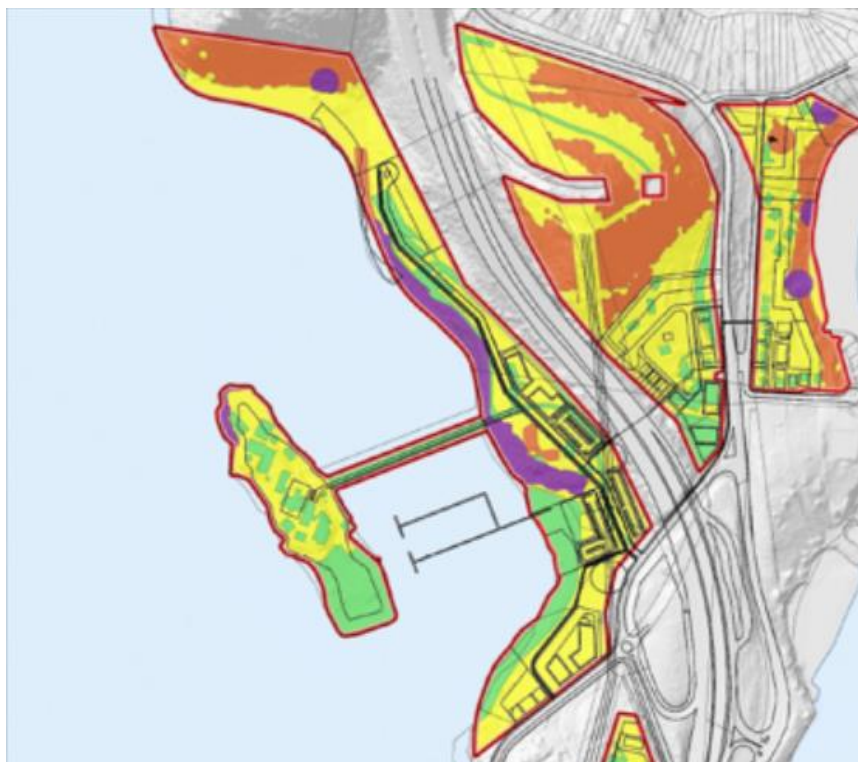
Figure 236 - Aboriginal cultural heritage constraints for the study area.

- 2. High-Risk Areas, and Areas Requiring Further Investigation:** The high-risk areas and areas requiring further assessment (corresponding to areas of very high, high and moderate archaeological potential) also form some constraints to the proposed development. Where development impact must occur within high risk areas or areas requiring further assessment, Property and Development NSW should prepare an Aboriginal Cultural Heritage Assessment (ACHA) in accordance with Heritage NSW standards and guidelines, and with further investigation in the form of archaeological test excavation being implemented, prior to development approval/s. It is recommended that a requirement for Aboriginal archaeological test excavation in areas of very high, high and moderate archaeological potential (as shown in Figure 2), subject to development impact, be incorporated into any Concept Plan General Terms of Approval (GTAs) (or equivalent). This will ensure that the potential Aboriginal heritage impact of the proposed development is appropriately investigated, assessed and managed into the future.

- 3. Areas with Few/No Aboriginal Constraints:** Areas with few Aboriginal constraints propose the lowest risk to the development, and no site-specific design and/or planning recommendations are required. Property and Development NSW should assess each development proposal on a case by case basis, and in accordance with relevant Heritage NSW standards and guidelines, including the Due Diligence Code of Practice for the Protection of Aboriginal Objects in New South Wales.
