Doyalson Wyee RSL Club Limited
care of
Urbis Pty Ltd

Interim Environmental Management Plan
49-65 Wentworth Avenue and
80, 90, 100 and 110 Pacific Highway
Doyalson, NSW

57611/125365 Rev 0

JBS&G Australia Pty Ltd

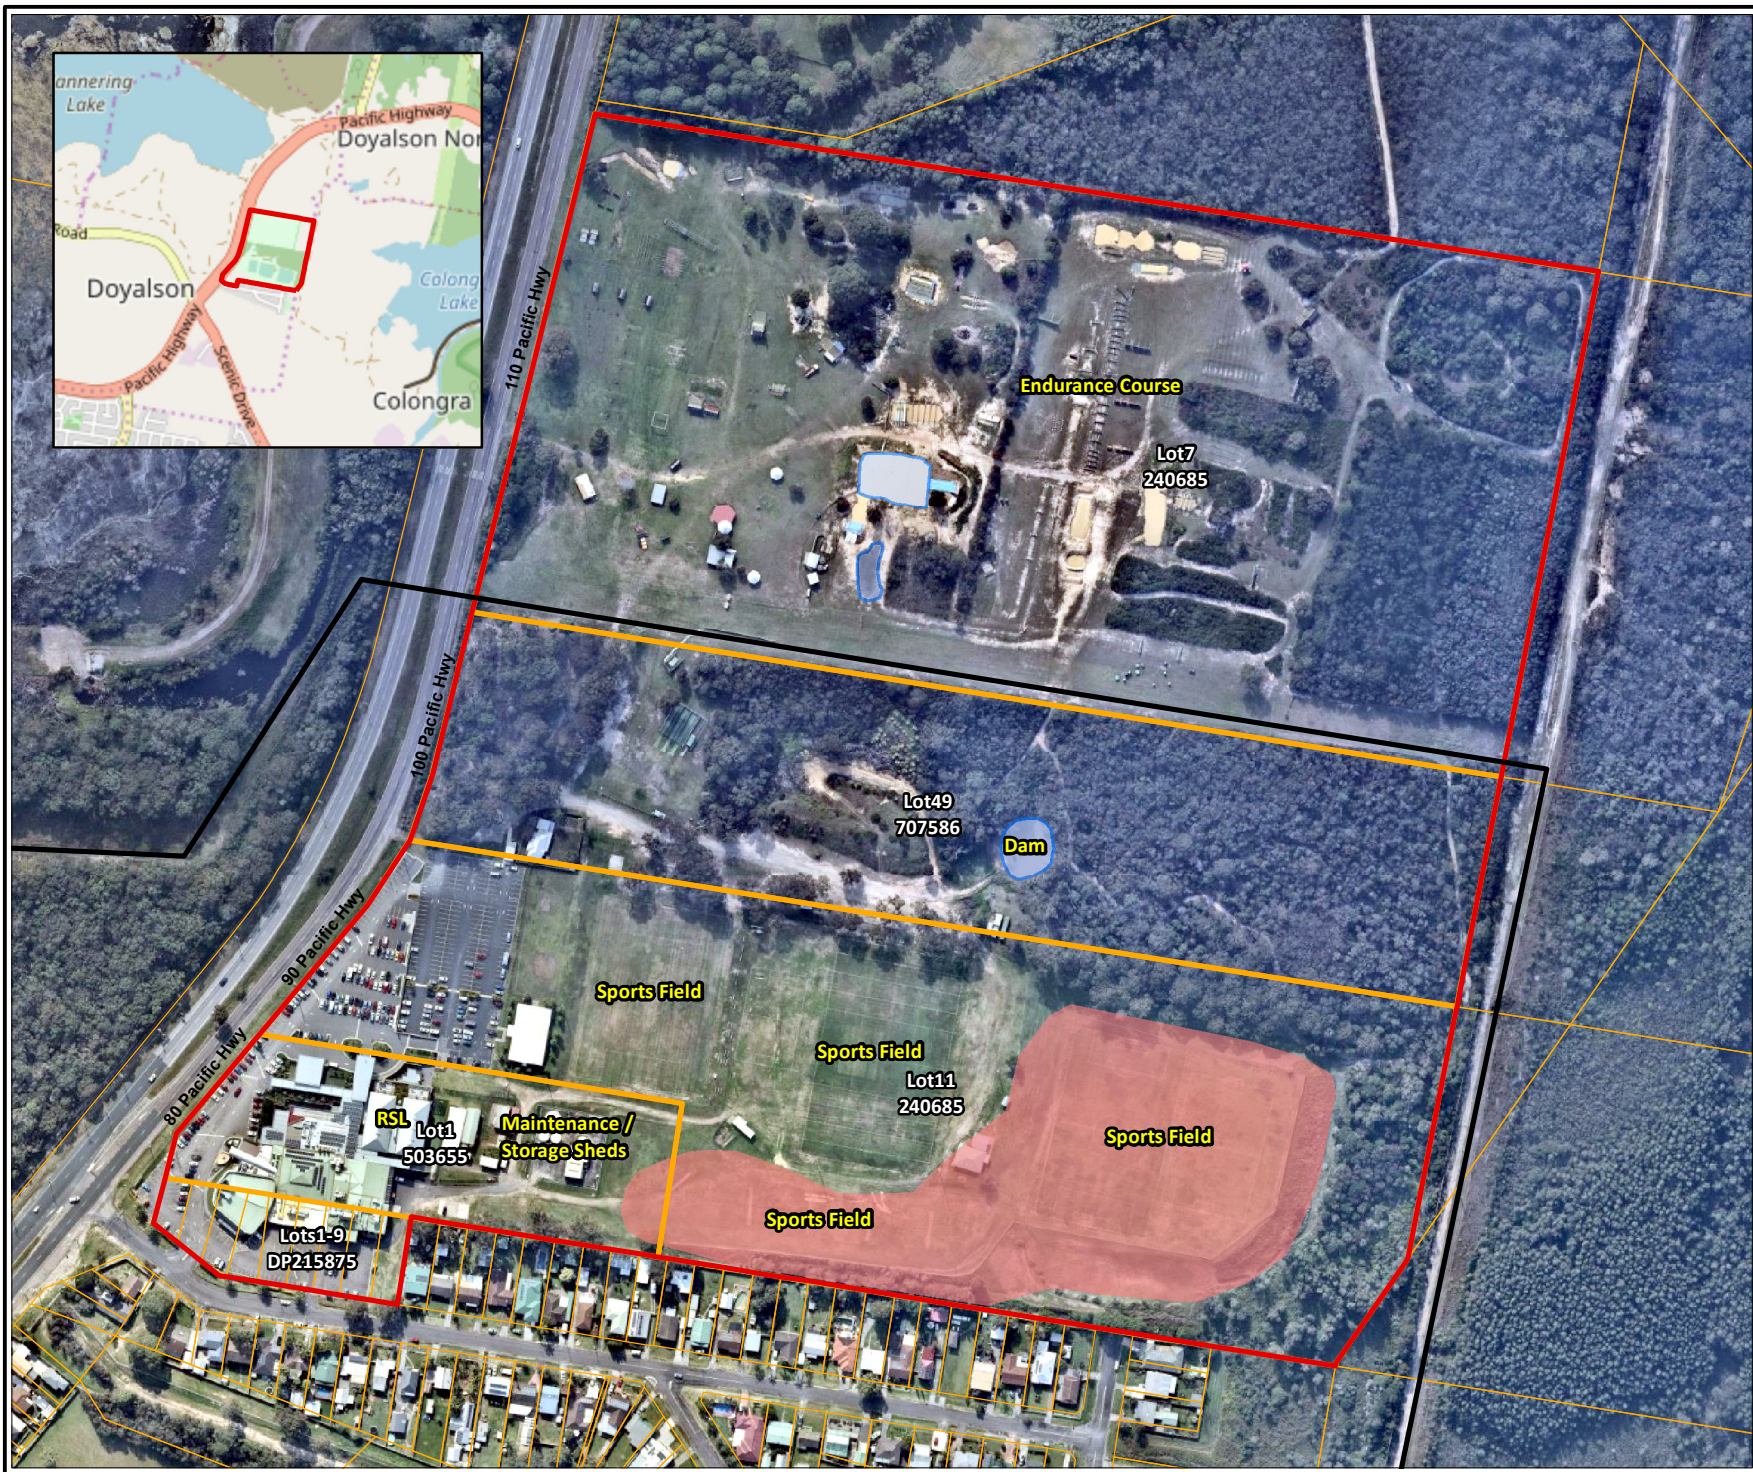
FIGURE 1

- Legend**
- Approximate Site Boundary
 - Cadastre
 - Jemena Gasline
 - Surface Water
 - Management Area

**SITE LOCATION, LAYOUT
AND FEATURES**

JBS&G Australia Pty Ltd (JBS&G) was engaged by Doyalson Wyee RSL Club (the client) via Urbis Pty Ltd (Urbis) to prepare an interim environmental management plan (IEMP) for a portion of the property located at 49-65 Wentworth Ave and 80, 90, 100 and 110 Pacific Highway, Doyalson, NSW (the site). The site is legally defined as Lots 1 to 9 Deposit Plan (DP) 215875, Lot 1 DP 503655, Lot 11 DP 2400685, Lot 49 DP 707586 and Lot 7 DP 240685 and occupies a total area of approximately 35 hectares (ha) as shown in **Figure 1**.

The location and layout of the site are shown in **Figures 1**, respectively, and summarised in **Table 2.1**. The layout and extent of the management area is shown as the orange-brown area in **Figure 2**.

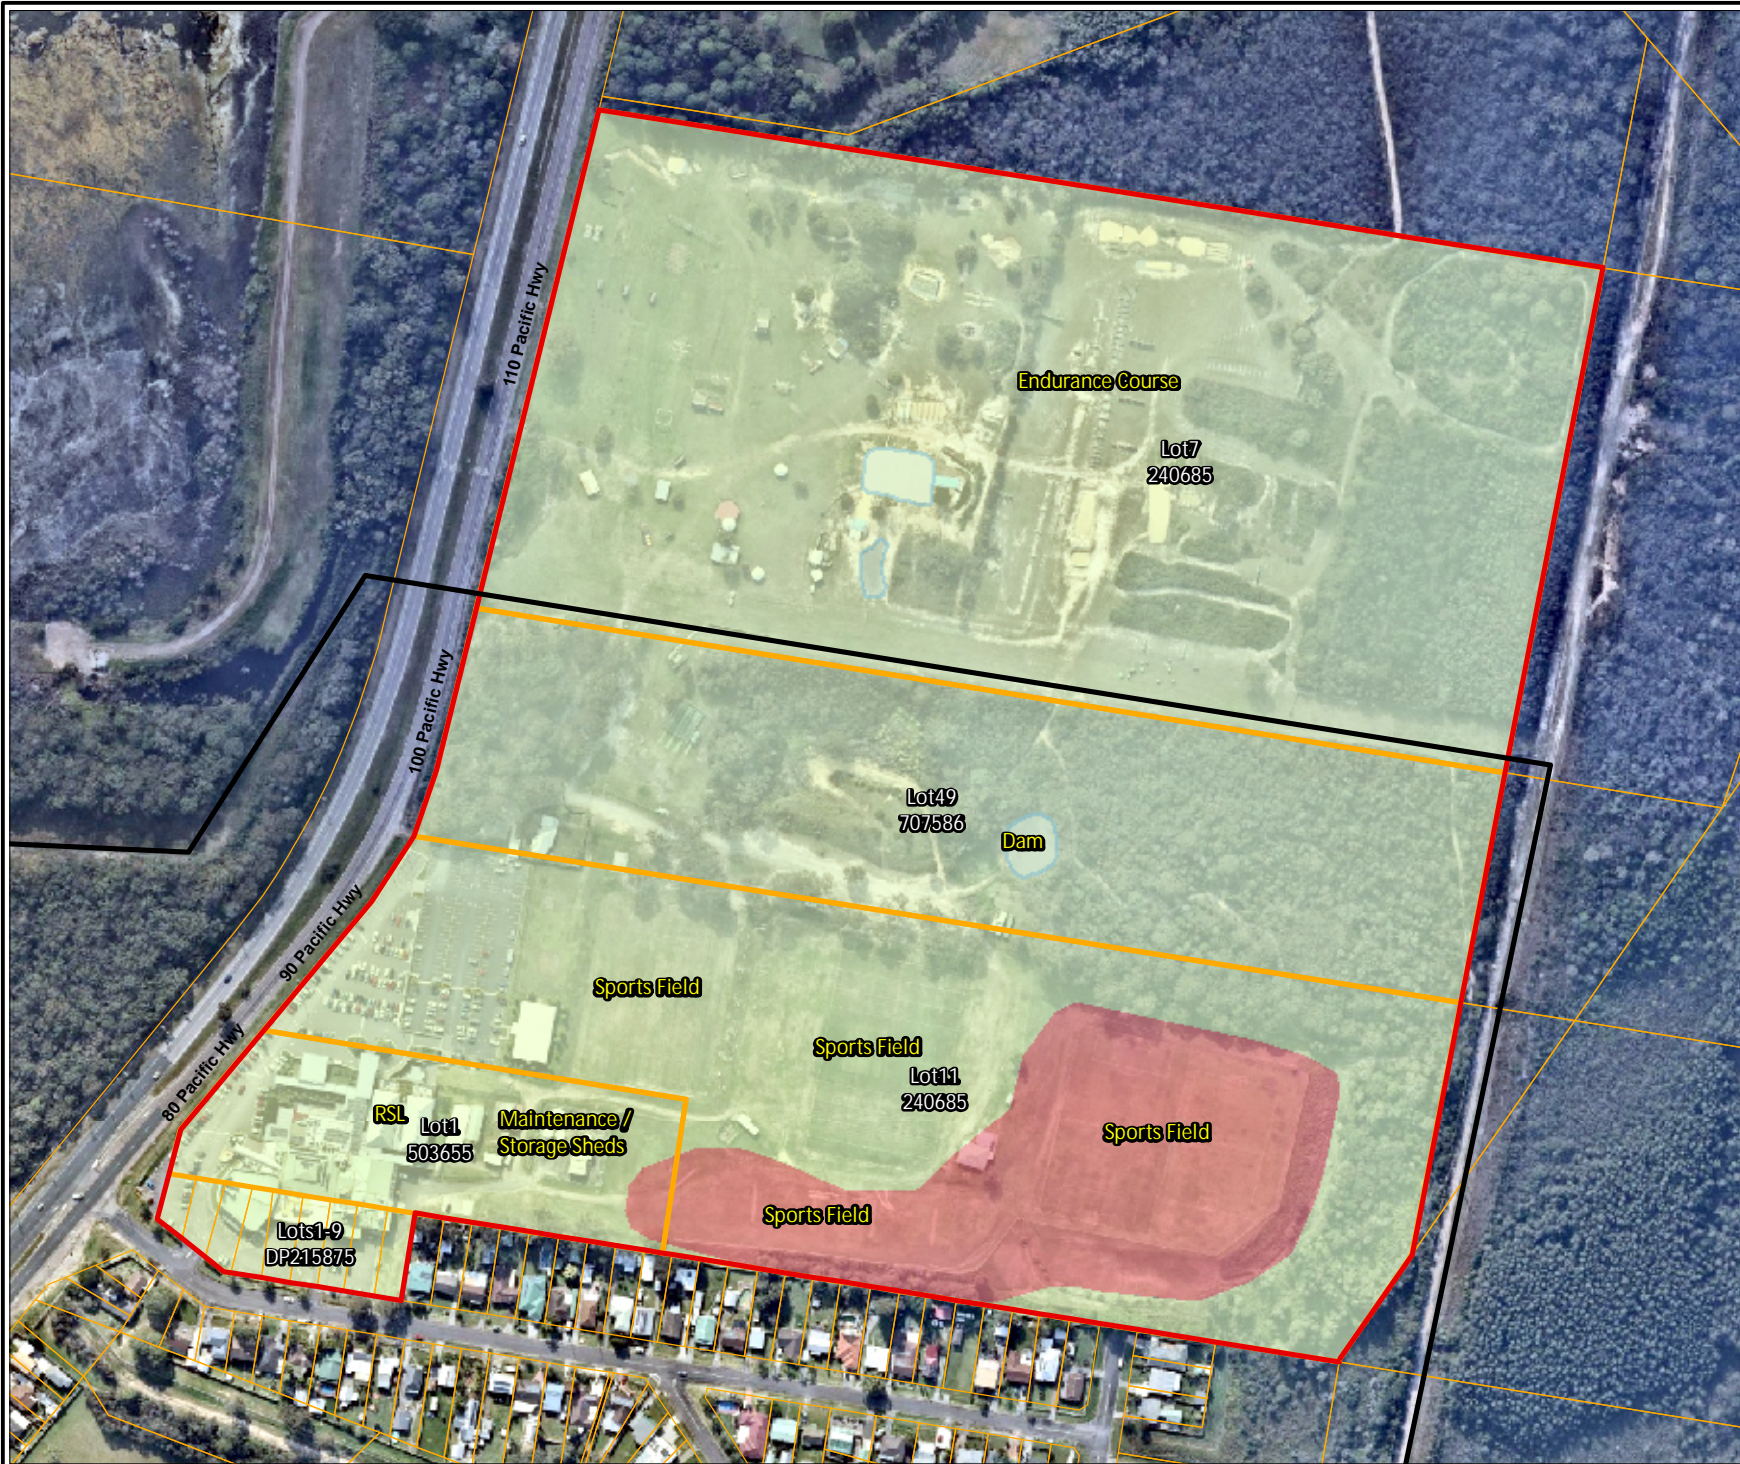
- Approximate Site Boundary
- Cadastre
- Jemena Gasline
- Surface Water
- Soils free of Asbestos
- Management Area
(Impacted fill with 0.3m capping of environmentally suitable soils)

The management area (orange-brown area shown on **Figure 2**) consisted of grassed level playing fields surrounded to the south, east and north of the eastern portion by a tall chain link fence. The

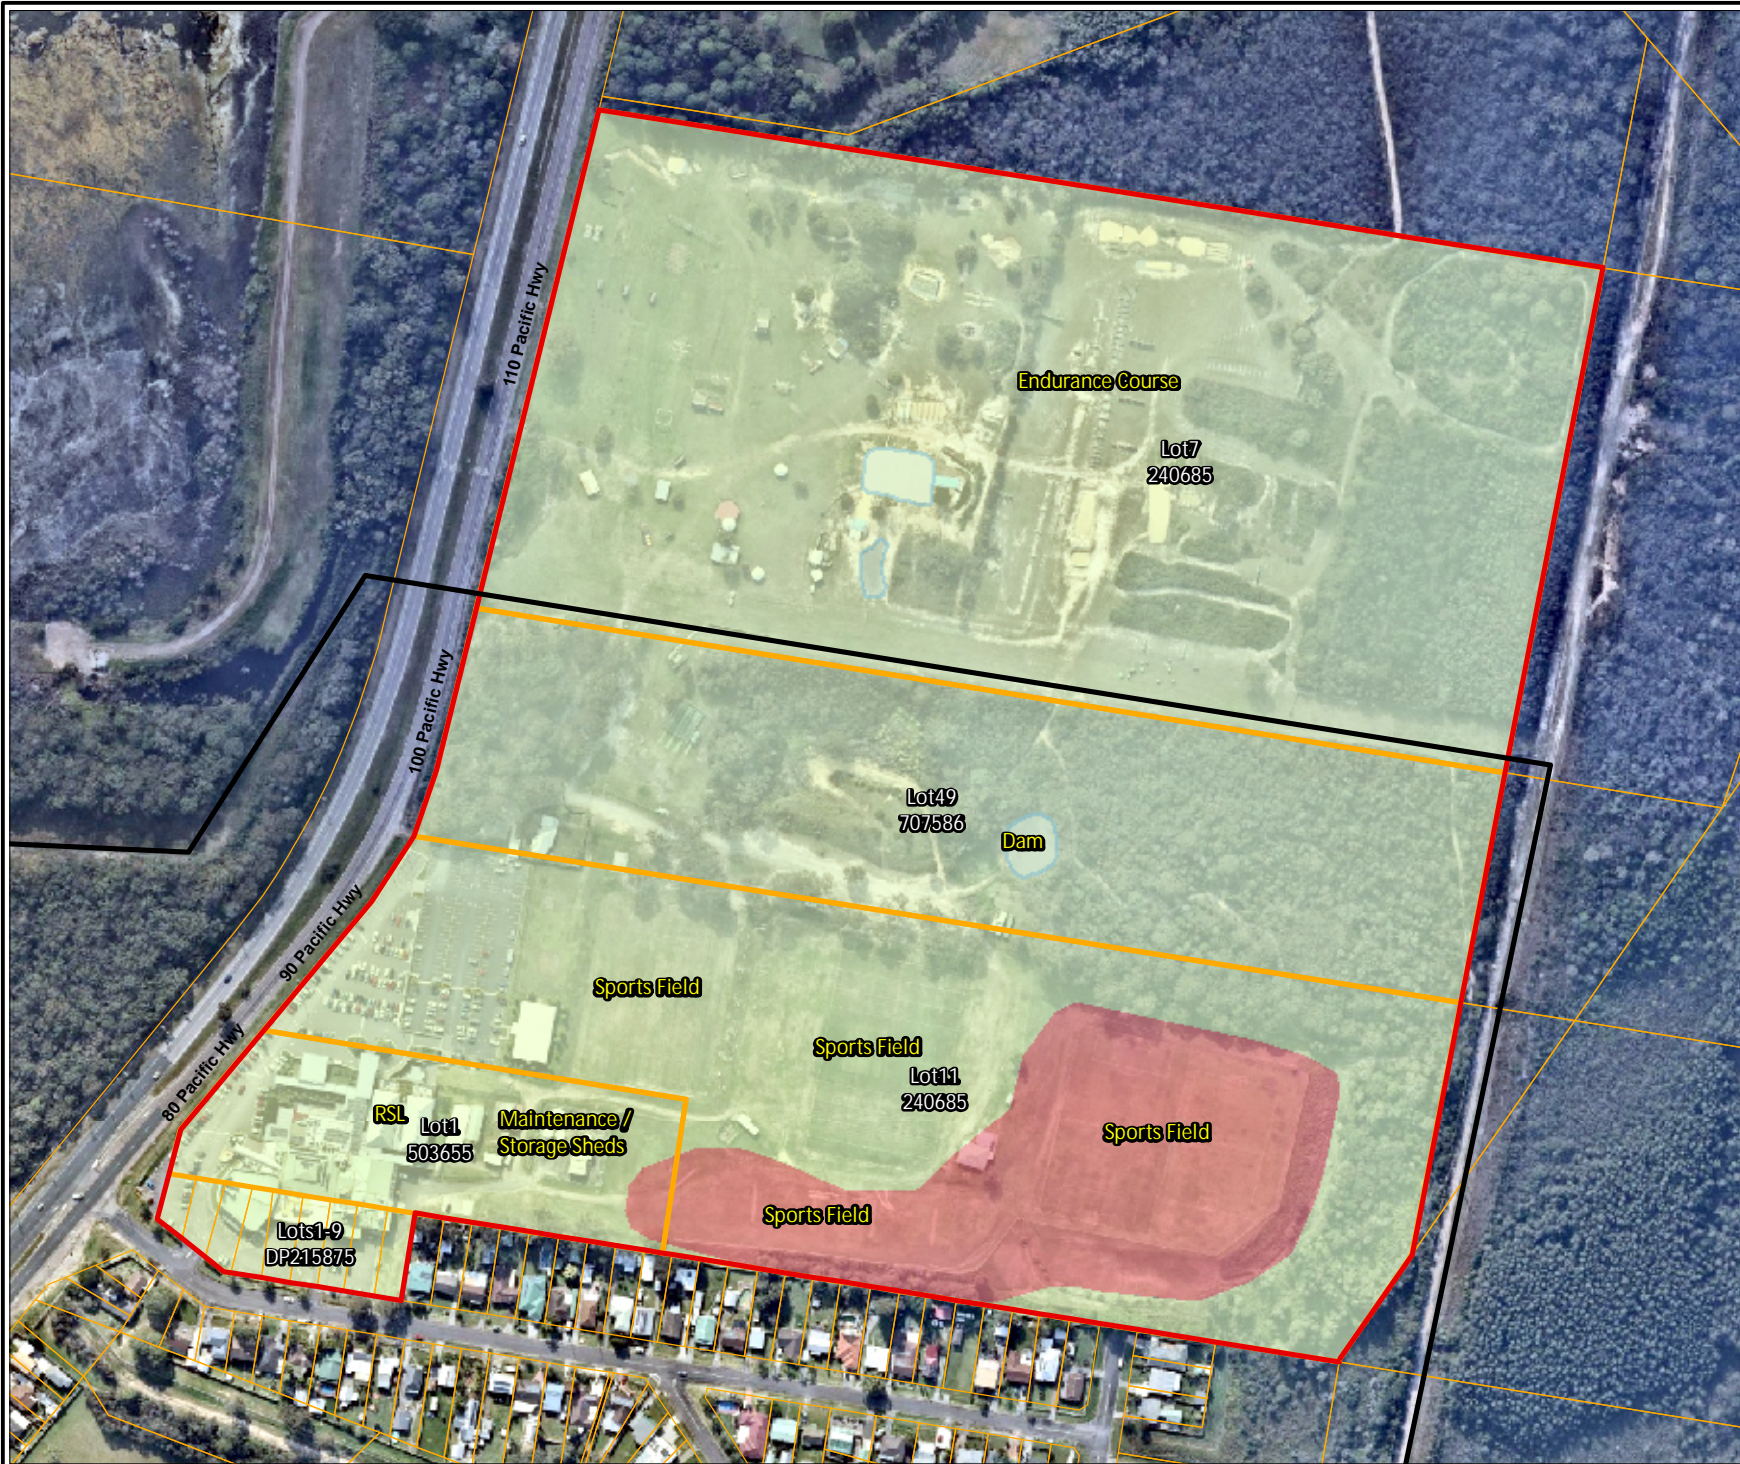
APPENDIX A1

- Approximate Site Boundary
- Cadastre
- Jemena Gasline
- Surface Water
- Soils free of Asbestos
- Management Area
(Impacted fill with 0.3m capping of environmentally suitable soils)

**EXTENT OF INFERRED
ASBESTOS IMPACTED SOIL**

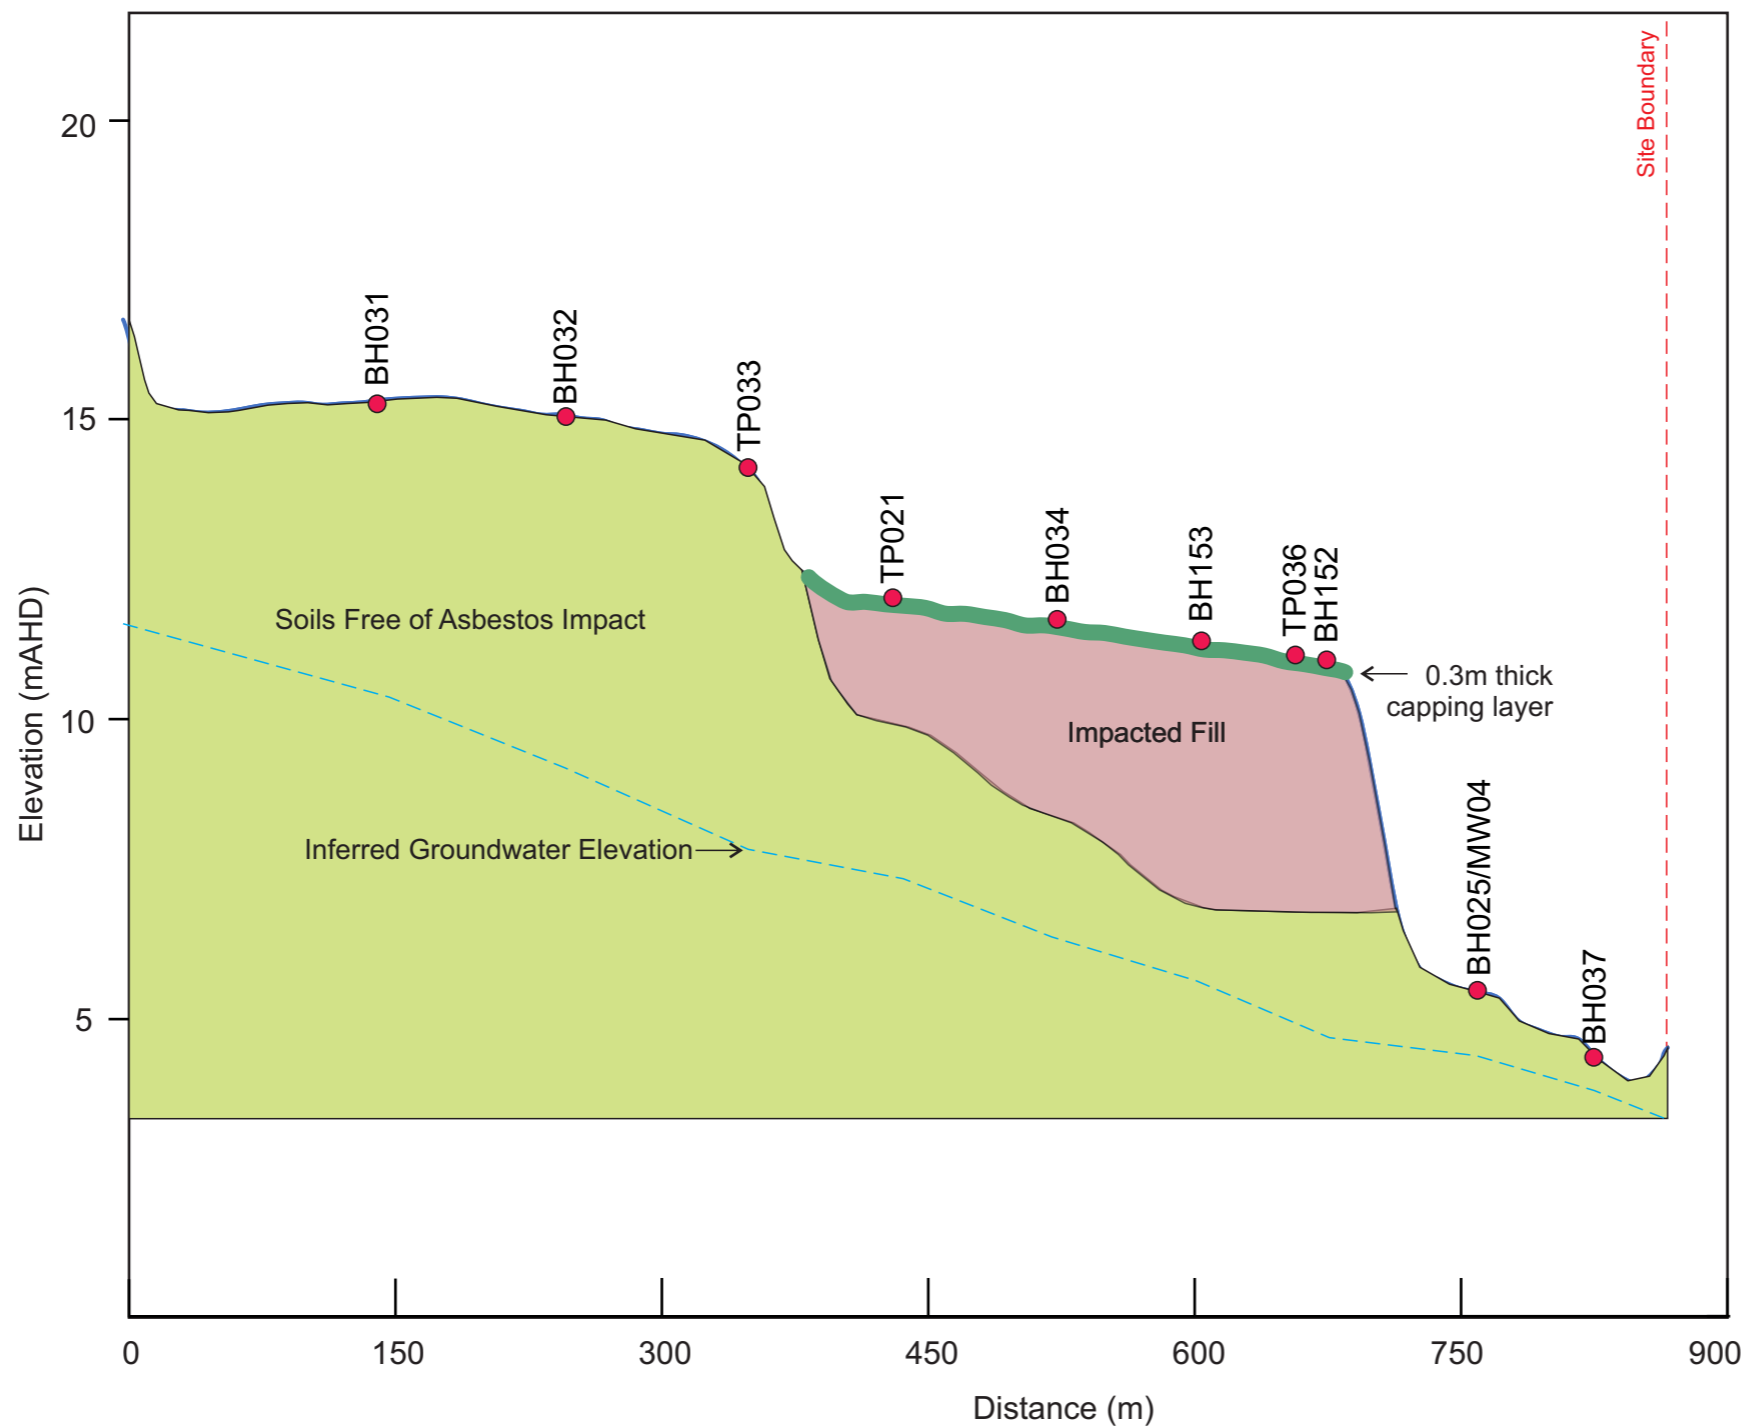
FIGURE A2:

- Legend:**
- - - Cross Sectional - Transect A-A1
 - Approximate Site Boundary
 - Soils free of Asbestos Impact
 - Management Area
- Sample Locations**
- Borehole
 - ⊕ Borehole/Monitoring well
 - Surface water
