PHASE I ENVIRONMENTAL SITE ASSESSMENT WITH TARGETED SOIL SAMPLING AND TESTING

Cooks Road Glenworth Valley
NSW 2250

**PREPARED FOR: GLENWORTH VALLEY OUTDOOR
ADVENTURES**

PROJECT NUMBER: 21097

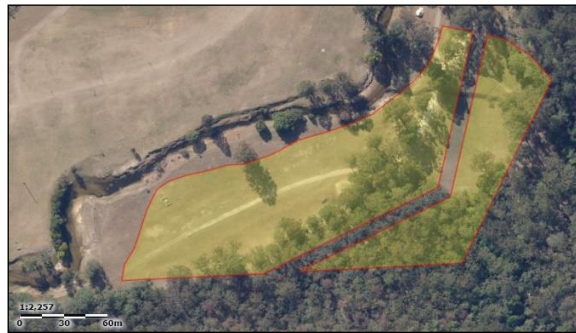
Lot 19 in DP755221

- No infrastructure
- River flat, flank of valley with tall open eucalypt forest in the central north and south-east parts of the lot
- Access track through axis of river flat
- No significant contamination observed
- No potential sources of contamination observed

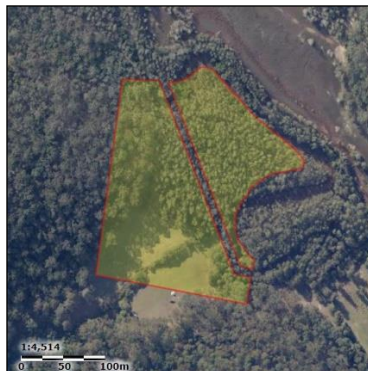
Lot 20 in DP755221

- No infrastructure
- River flat, mangroves and flank of valley with tall open eucalypt forest
- No significant contamination observed
- No potential sources of contamination observed

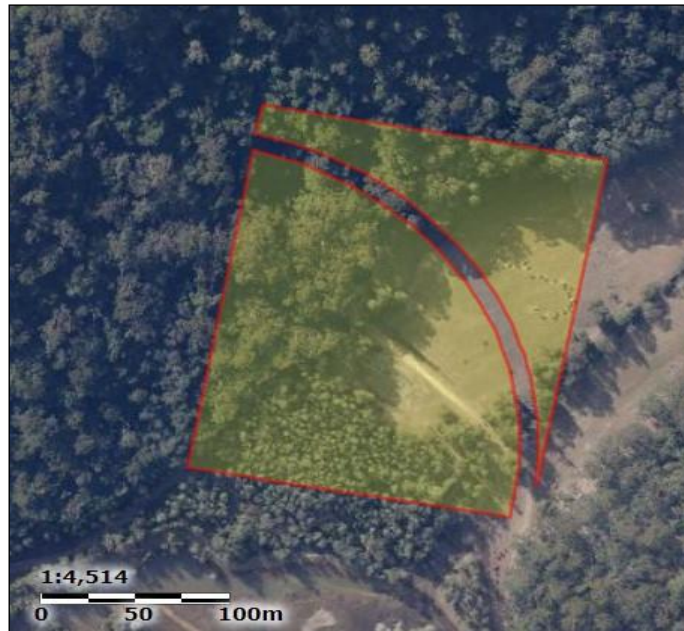
Lot 21 in DP755221

- No infrastructure
- River flat, mangroves and flank of valley with tall open eucalypt forest
- Access track on river flat in south-eastern part
- No significant contamination observed
- No potential sources of contamination observed

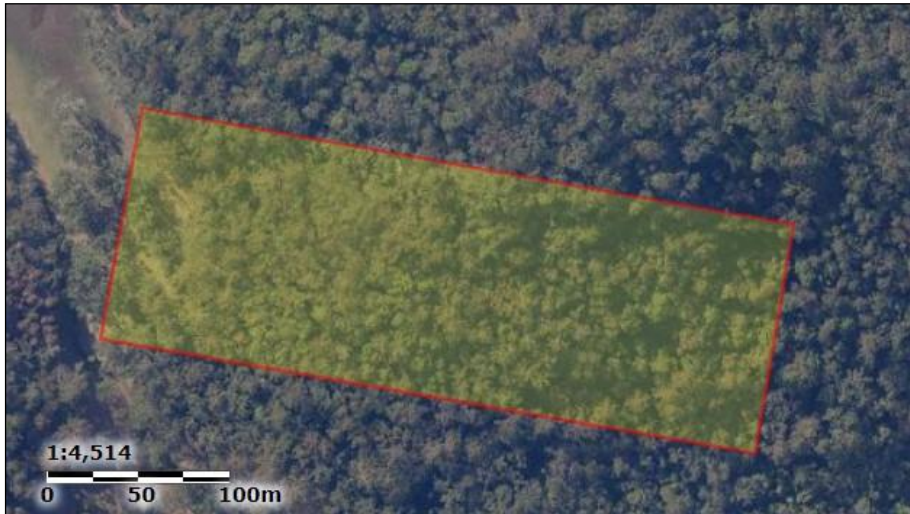
Lot 24 in DP755221

- No infrastructure
- Minor river flat in west and flank of valley with tall open eucalypt forest
- No significant contamination observed
- No potential sources of contamination observed

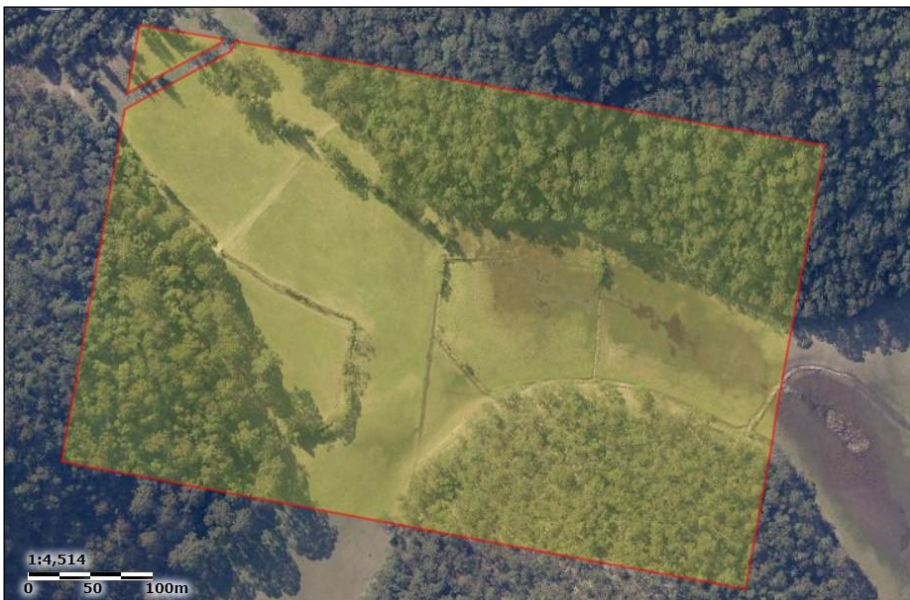
Lot 25 in DP755221

- No infrastructure
- Mainly river flat and flanks of valley with tall open eucalypt forest
- Access track across river flat in north-western part
- No significant contamination observed
- No potential sources of contamination observed

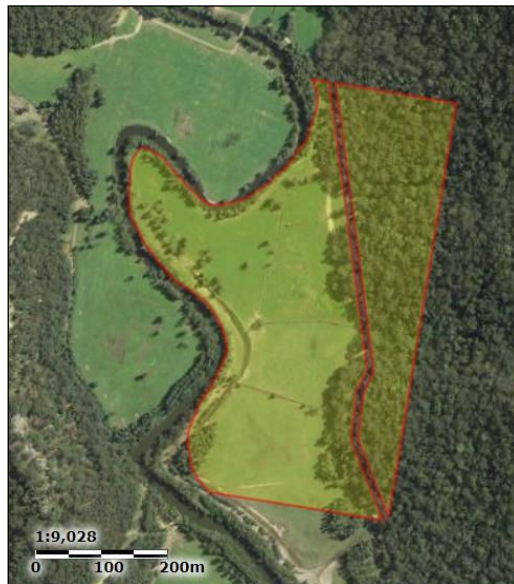
Lot 30 in DP755221

- No infrastructure
- Mainly river flat and flank of valley with tall open eucalypt forest to east
- Access track along forest edge in eastern part
- No significant contamination observed
- No potential sources of contamination observed

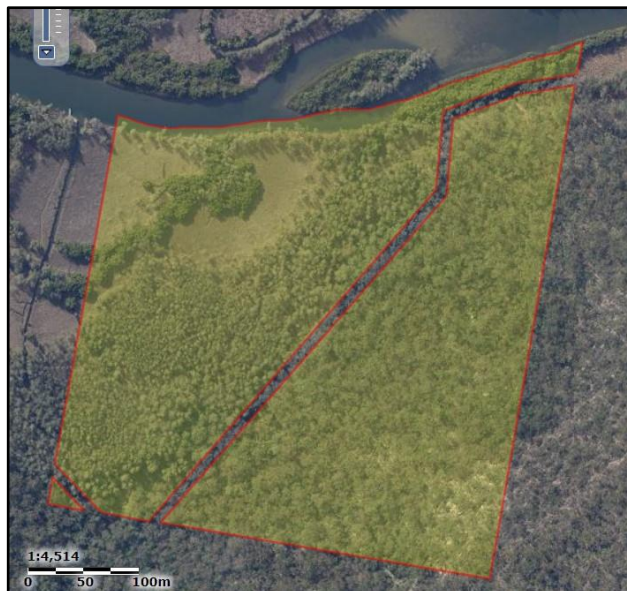
Lot 31 in DP755221

- No infrastructure
- Mainly river flat and flanks of valley with tall open eucalypt forest
- No significant contamination observed
- No potential sources of contamination observed

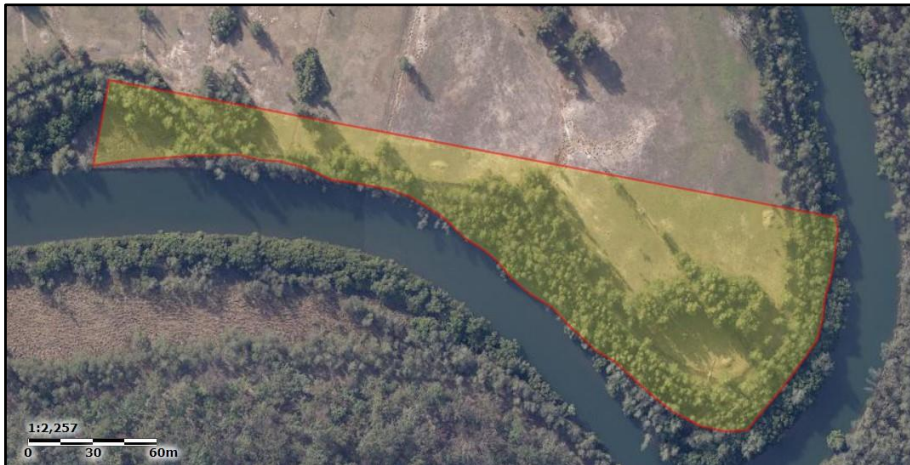
Lot 32 in DP755221

- No infrastructure
- Mainly river flat and mangroves?
- No significant contamination observed
- No potential sources of contamination observed

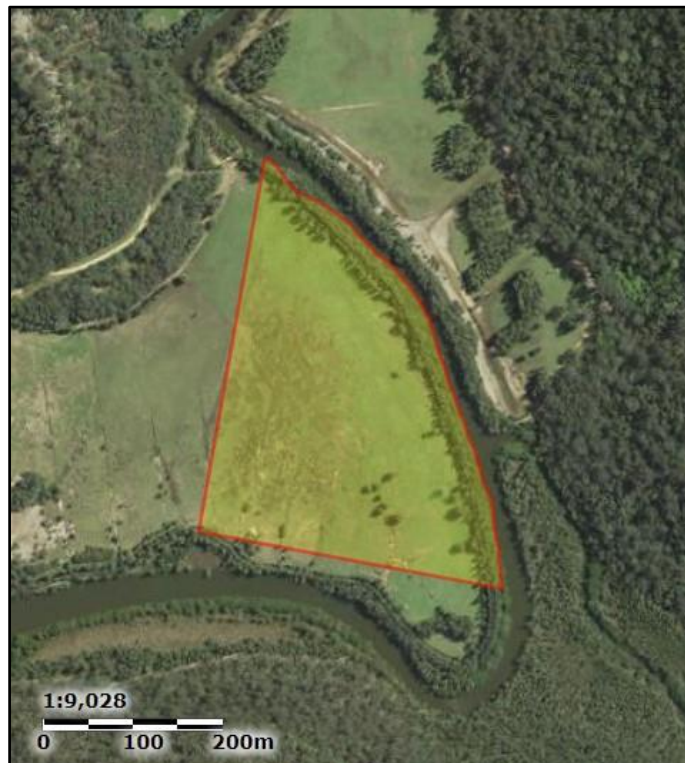
Lot 33 in DP755221

- No infrastructure
- Mainly river flat
- No significant contamination observed
- No potential sources of contamination observed

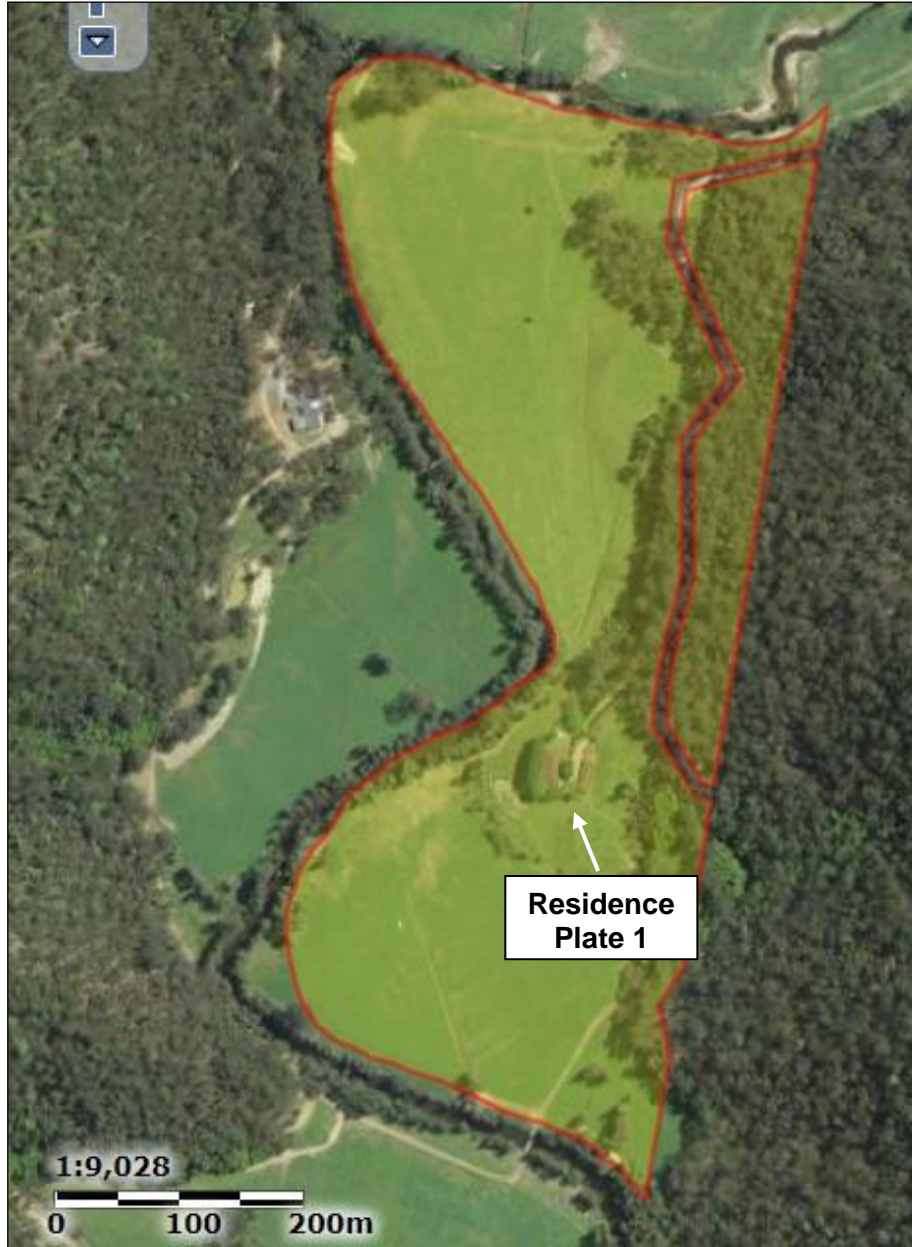
Lot 37 in DP755221

- Dwelling and pool (**Plate 1**)

- Mainly river flat and flank of valley with tall open eucalypt forest to east
- Access track to dwelling and in southern part
- No significant contamination observed
- Potential source of contamination associated with an On-Site Sewage Treatment system (OSSM) that treats all wastewater generated from the dwelling. The OSSM is Council approved with a current permit to operate. There are no signs of imminent or present failure of the OSSM.

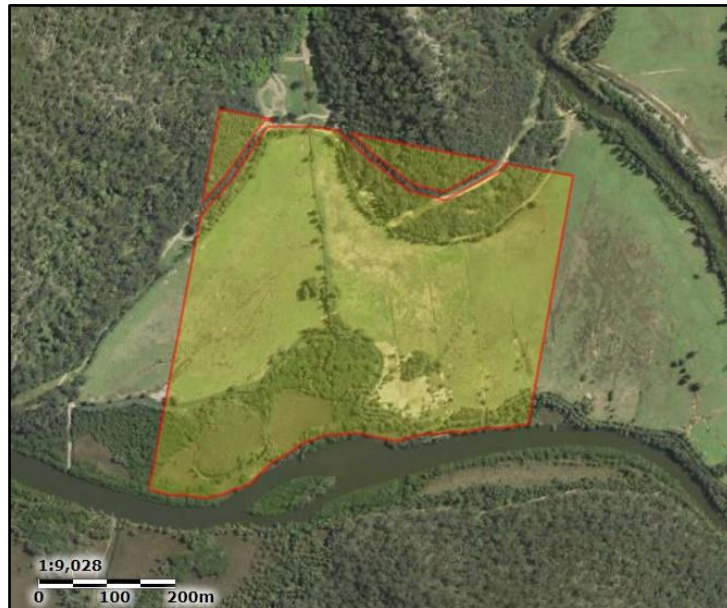
Lot 50 in DP755221

- No infrastructure
- Mainly river flat and mangroves in the southern part
- Access track in central northern part and in north-east
- No significant contamination observed
- No potential sources of contamination observed

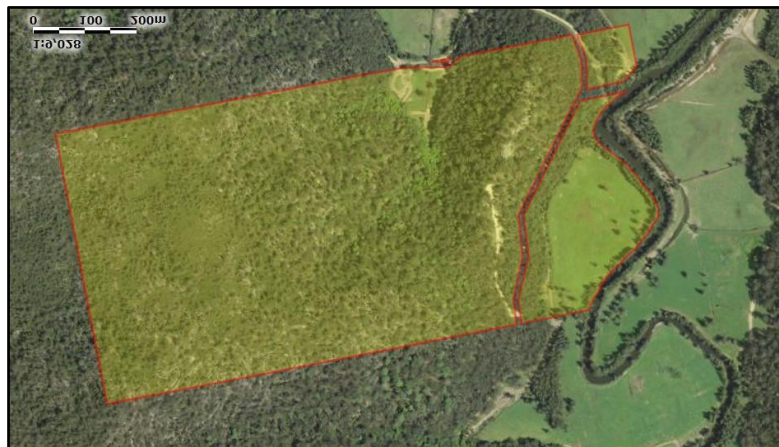
Lot 53 in DP755221

- No infrastructure
- Mainly flank of valley with tall open eucalypt forest and minor river flat in the eastern part
- Access track dissects eastern part at base of valley flank
- No significant contamination observed
- No potential sources of contamination observe

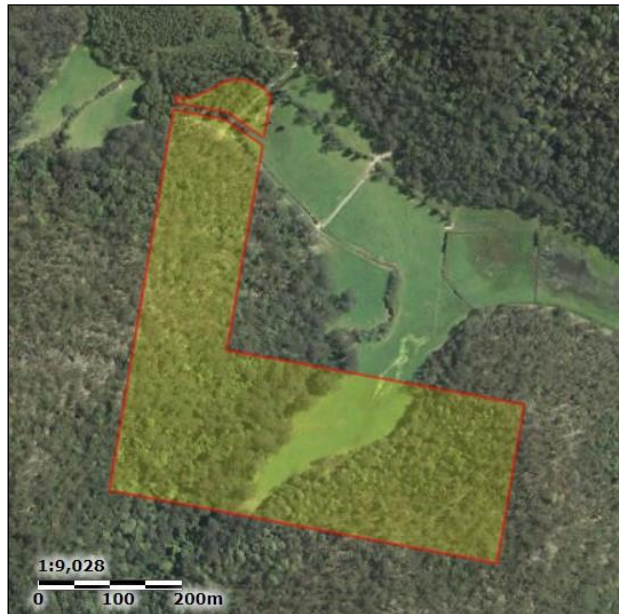
Lot 64 in DP755221

- No infrastructure
- Mainly flank of valley with tall open eucalypt forest and minor river flat
- Access track in northernmost part
- No significant contamination observed
- No potential sources of contamination observed

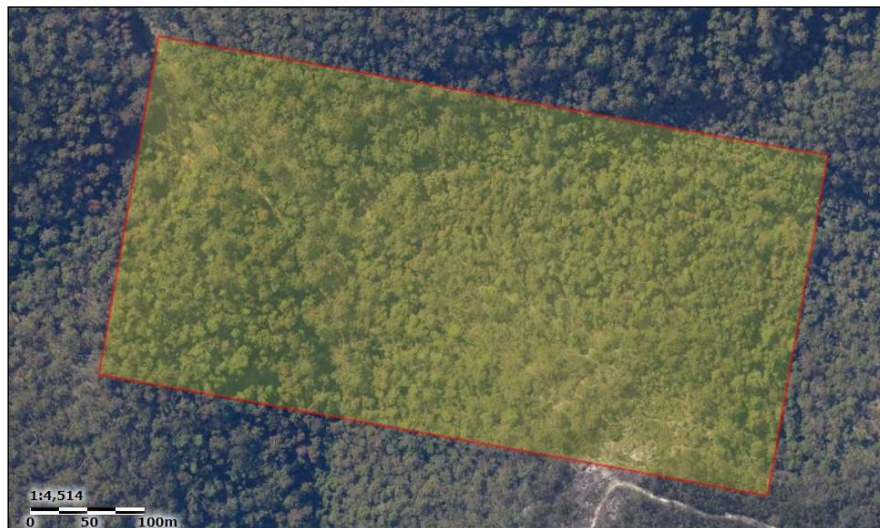
Lot 65 in DP755221

- No infrastructure
- Tall open eucalypt forest
- Access track to south-east of site
- No significant contamination observed
- No potential sources of contamination observed

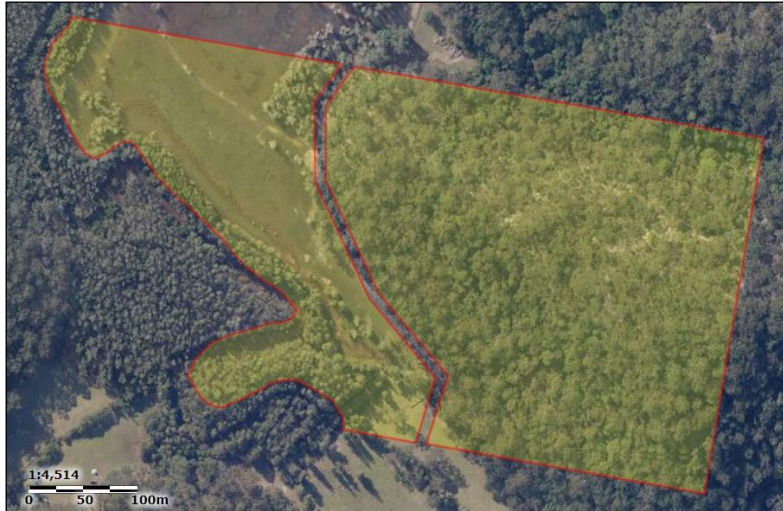
Lot 68 in DP755221

- No infrastructure
- River flat in western part and flank of valley with tall open eucalypt forest in eastern part
- Access track in north-western part
- No significant contamination observed
- No potential sources of contamination observed

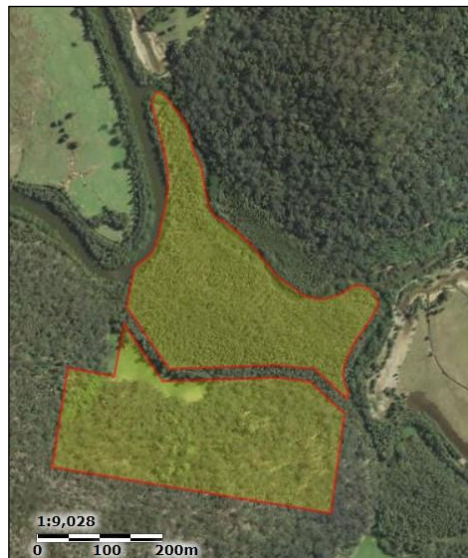
Lot 81 in DP755221

- No infrastructure
- Mangroves and flank of valley with tall open eucalypt forest to the south
- No significant contamination observed
- No potential sources of contamination observed

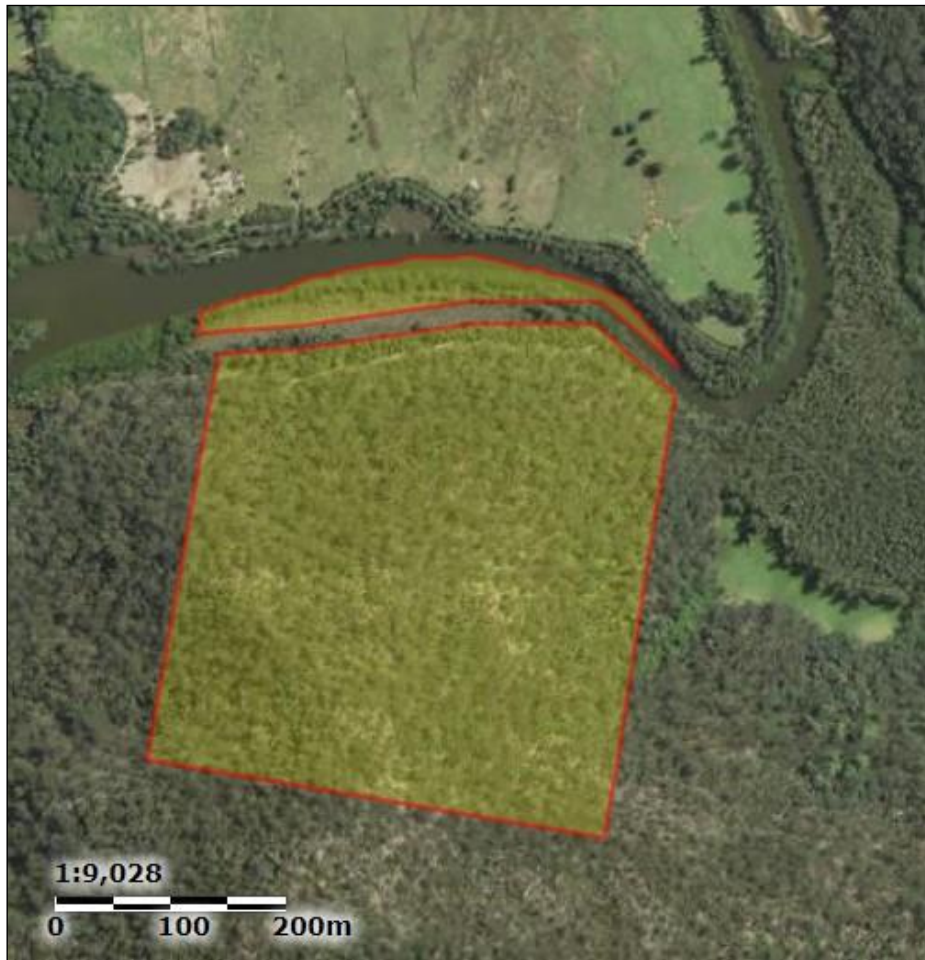
Lot 82 in DP755221

- No infrastructure
- Dominantly flank of valley with tall open eucalypt forest to the south with mangroves in northernmost part
- No significant contamination observed
- No potential sources of contamination observed

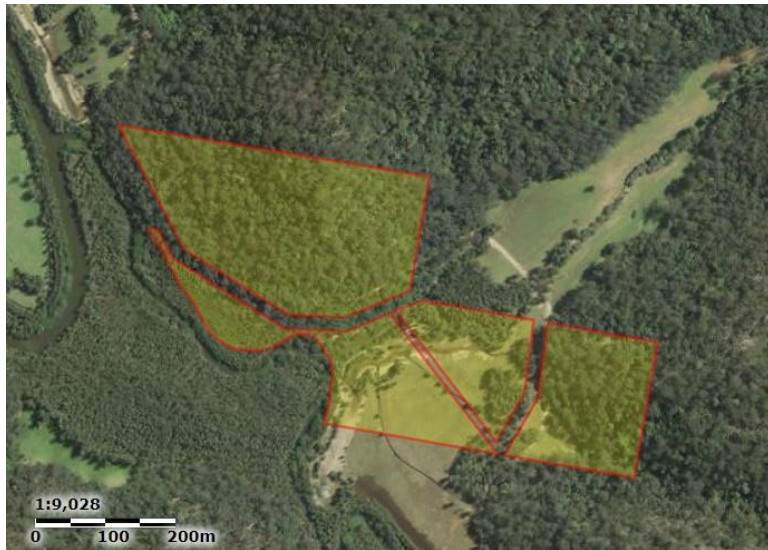
Lot 85 in DP755221

- No infrastructure
- Dominantly flanks of valley with tall open eucalypt forest to the north-west and eastern parts with mangroves in south-western part and river flat in the central southern part
- Access track in central southern part
- No significant contamination observed
- No potential sources of contamination observed

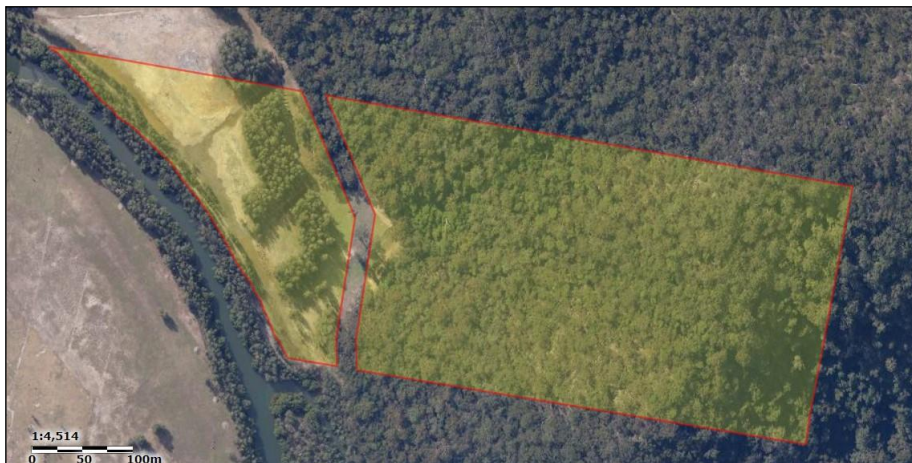
Lot 86 in DP755221

- No infrastructure
- Dominantly flank of valley with tall open eucalypt forest to the east and river flat in the westernmost part
- No significant contamination observed
- No potential sources of contamination observed

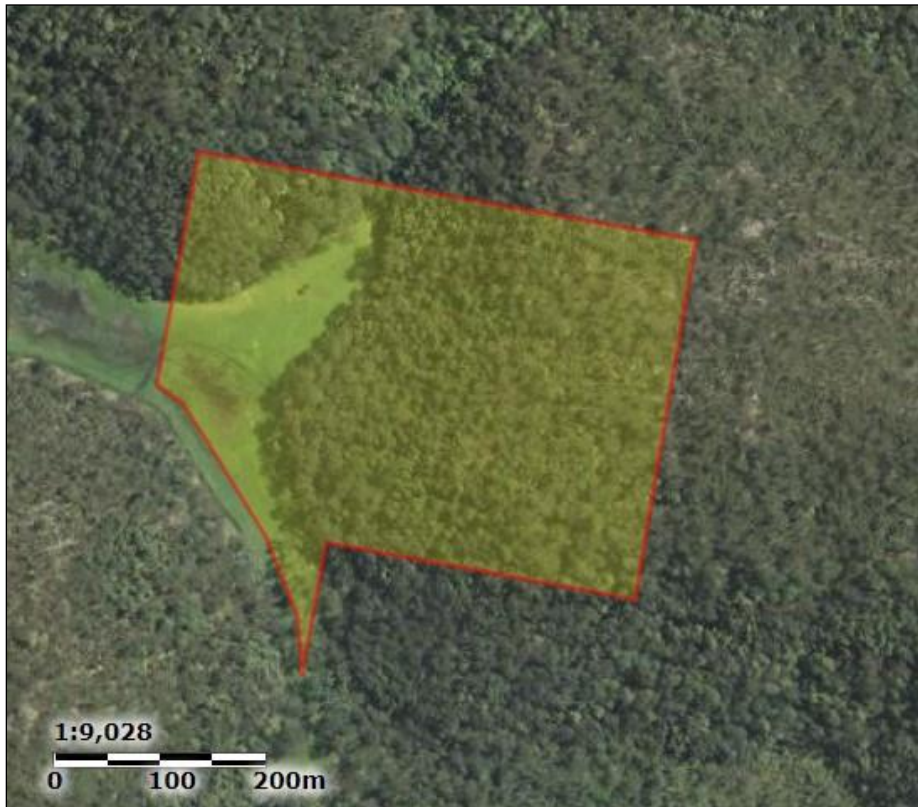
Lot 87 in DP755221

- No infrastructure
- Dominantly flank of valley with tall open eucalypt forest to the east and north-west and river flat in the south-western part
- No significant contamination observed
- No potential sources of contamination observed

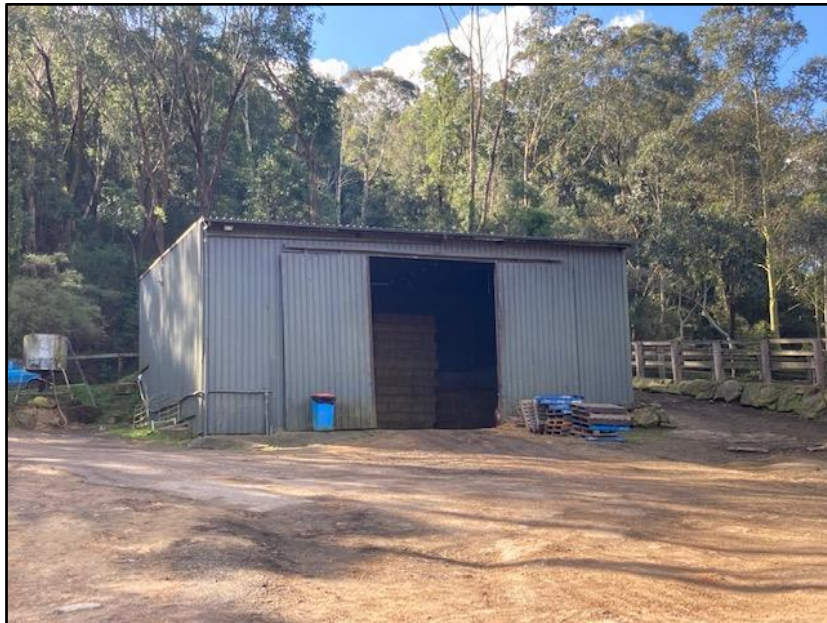
Plate 7 Hay Shed and Above Ground Fuel Storage

- Access tracks peripheral to, and across river flats
- No significant contamination observed
- A potential source of contamination is associated with an On-Site Sewage Treatment system (OSSM) connected to the function centre, administration/office, cottage and dwelling and two 1,500 L above ground storage tanks located adjacent to the hay shed.

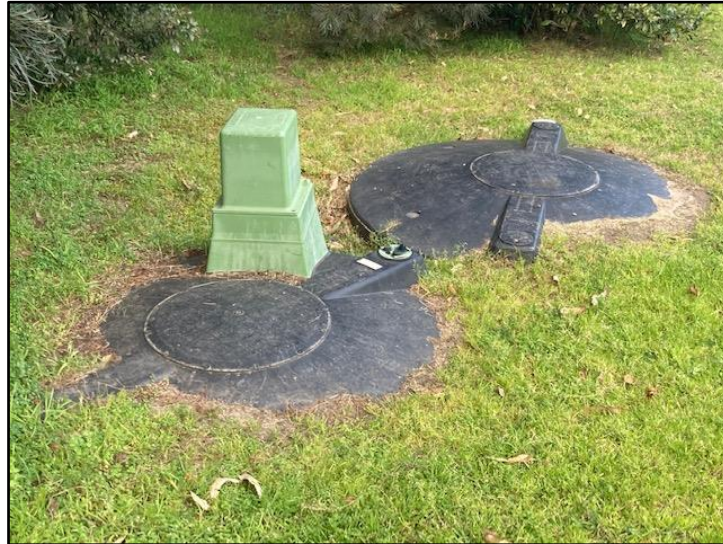
Plate 15 Wastewater Treatment Tank - Administration

The OSSMs treat all wastewater generated from the various infrastructure. The OSSMs are Council approved with current permits to operate. There are no signs of imminent or present failure of the OSSM. Details of the OSSMs are as follows:

1. Primary treatment at office/administration in a dual poly tank treatment system with disposal via absorption trench (**Plate 15**)

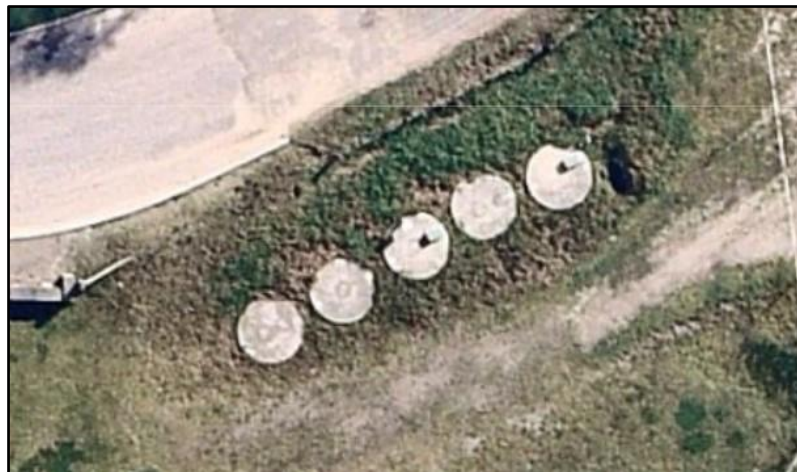
2. Secondary treatment of all wastewaters generated from the function centre in a recently installed commercial five-tank aerated wastewater treatment system (**Plate 16**). Treated wastewater is discharged via sub-surface drip irrigation north of the facilities.

Plate 16 Wastewater Treatment Tanks – Function Centre

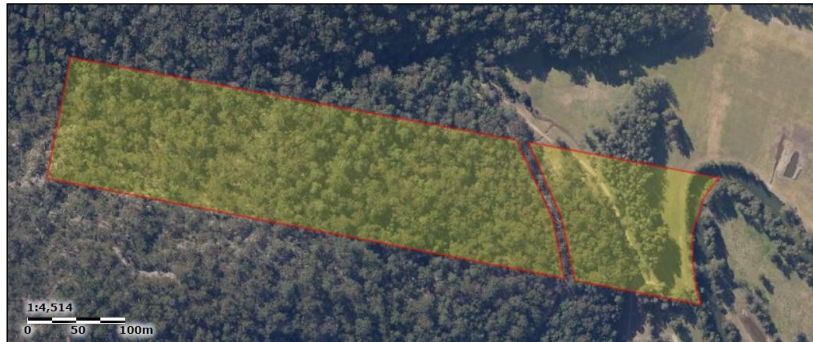
Lot 91 in DP755221

- No infrastructure
- Access track in easternmost part of lot proximal to flank of valley with tall open eucalypt forest to the west
- No significant contamination observed
- No potential sources of contamination observed

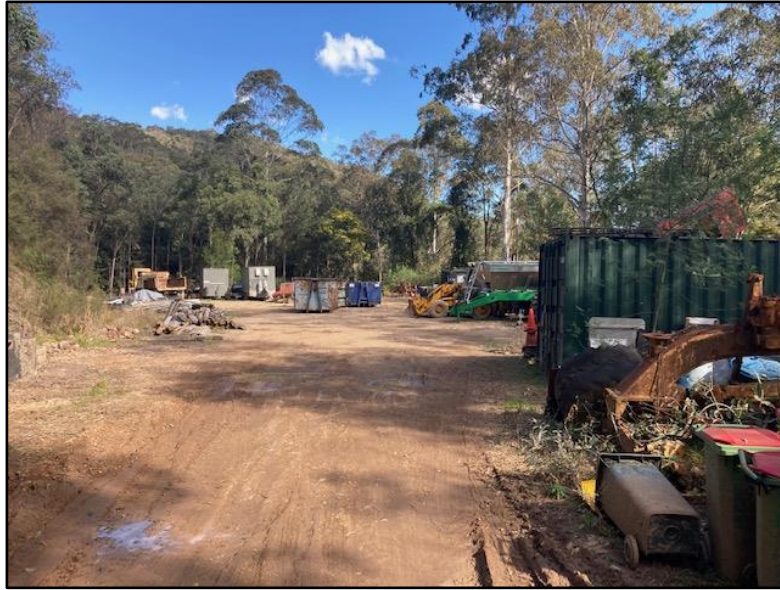
- Flank of valley with tall open eucalypt forest in the eastern and central parts and river flat in western part of lot
- A sinuous access road winds down from the east into Glenworth Valley. A network of access tracks crosses the river flats in the western part
- An equipment and machinery depot with several storage sheds and shipping containers (**Plate 21**). No fuel storage visible

Plate 21 Equipment and Machinery Depot

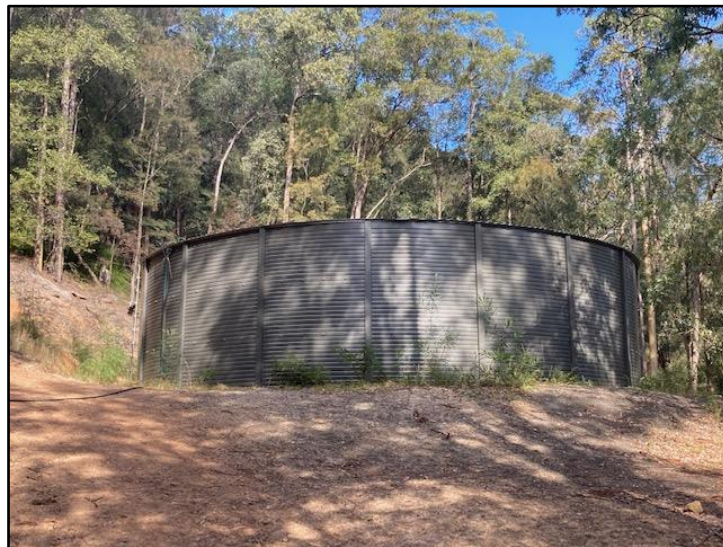
Plate 22 Water Storage Tank

- A large volume water storage tank is located on the eastern side of the Glenworth Valley access road (**Plate 22**)

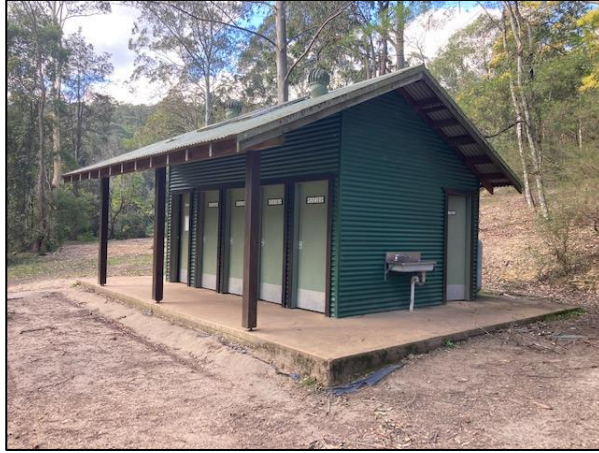
Plate 23 Toilet Amenities

A potential source of contamination is associated with two composting toilet systems and a 'pump out' system installed as amenities for campers (Plates 23, 24 and 25). The amenities are Council approved with current permits to operate. There are no signs of imminent or present failure of the amenities.)

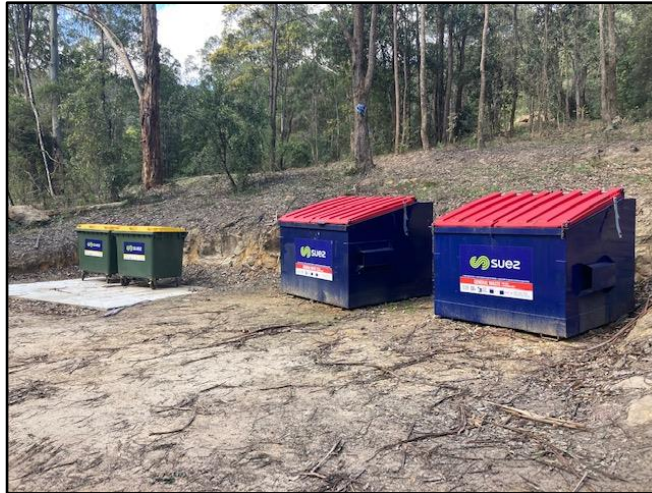
Plate 26 Waste Storage Centre

Temporary waste storage centres located in dedicated accessible locations are shown in **Plates 26 and 27**.

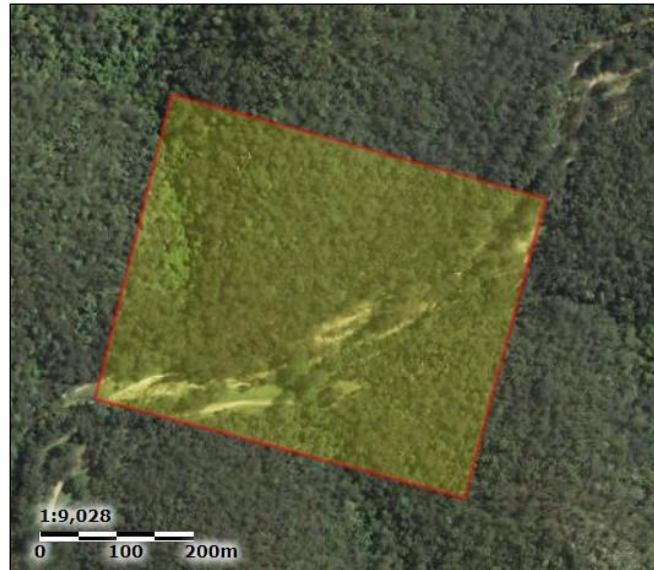
Lot 23 in DP755253

- No infrastructure
- Majority of tall open eucalypt forest with narrow river flat
- No significant contamination observed
- No potential sources of contamination observed

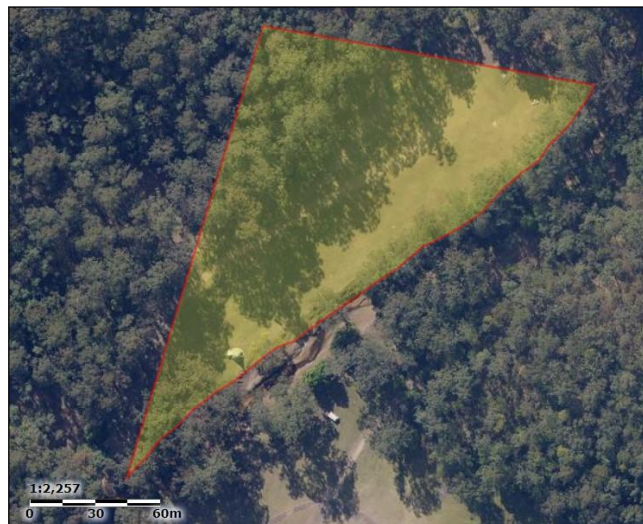
Lot 32 in DP755253

- No infrastructure
- Access track dissects the lot on edge of river flat
- Flank of valley with tall open eucalypt forest to the west and river flat in the eastern part
- River flat used for campers
- No significant contamination observed
- No potential sources of contamination observed

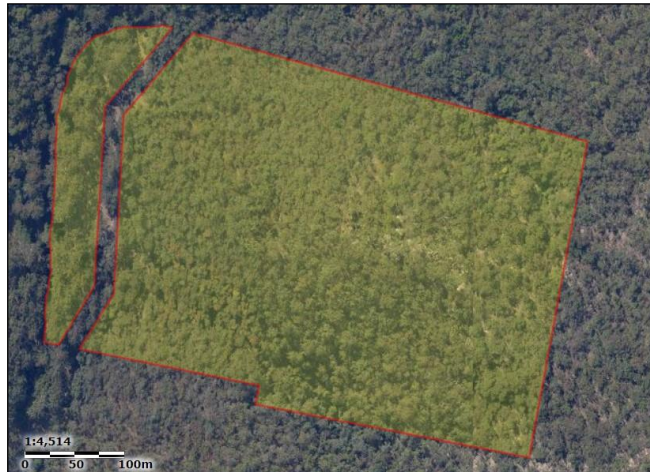
Lot 73 in DP755253

- No infrastructure
- Tall open eucalypt forest
- No significant contamination observed
- No potential sources of contamination observed

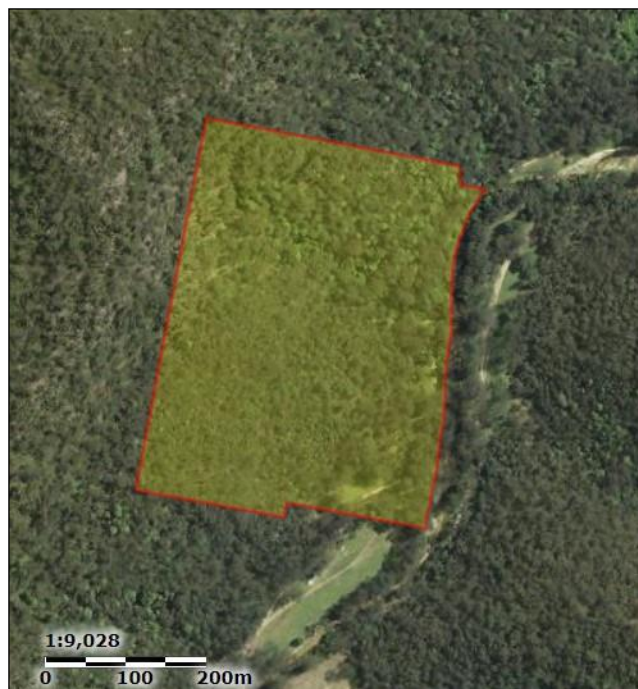
Lot 75 in DP755253

- No infrastructure
- Tall open eucalypt forest
- No significant contamination observed
- No potential sources of contamination observed

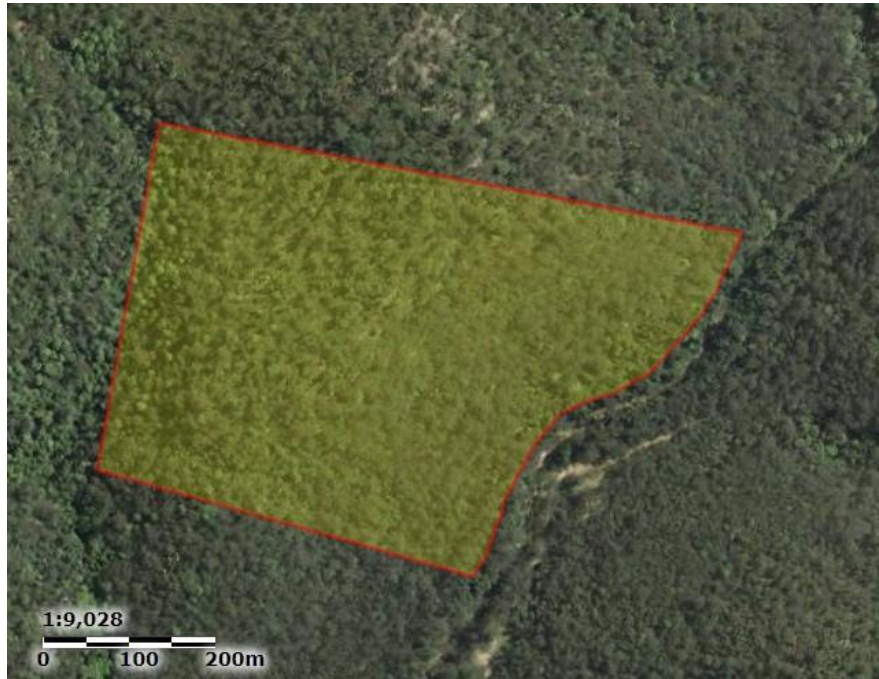
Lot 76 in DP755253

- No infrastructure
- Tall open eucalypt forest
- No significant contamination observed
- No potential sources of contamination observed

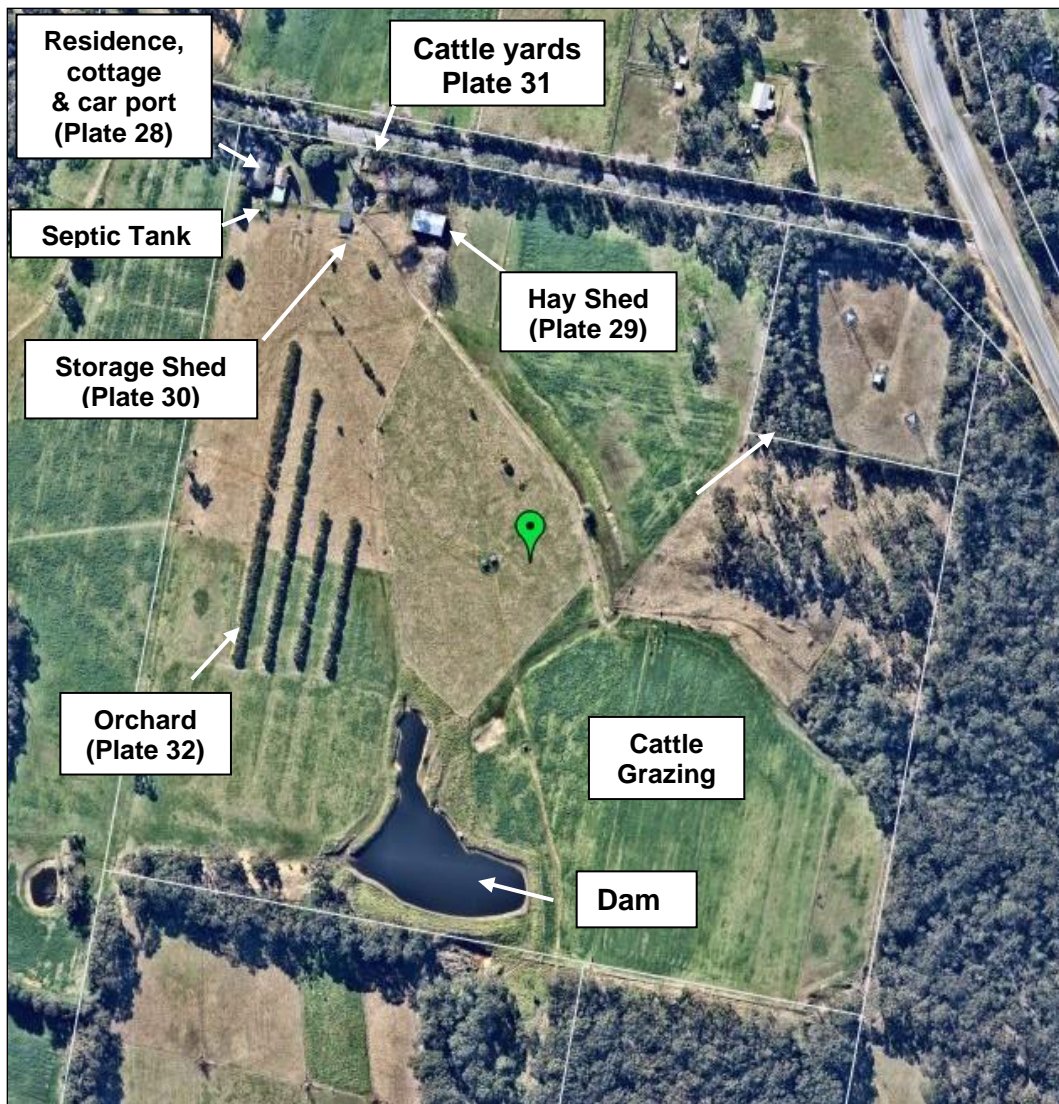
Built improvements on the property include a dwelling house, garage/ storage area, a storage shed, machinery/hay shed and a small set of cattle yards on Cooks Road adjacent to the entry to the Site. Other improvements include fencing and an irrigation system fed from the on-site dam. The location of built improvements is shown on the enclosed aerial photo acquired by satellite in August 2021.

- Plateau area underlain by sandy loam soil developed atop strongly weathered Hawkesbury Sandstone.
- Historically cleared for grazing and agriculture. Remnant vegetation in the north-east
- Access tracks throughout farm
- Brick dwelling and adjacent weatherboard cottage, and car port
- Operational citrus orchard
- Evidence of cropping and cattle grazing
- Farm dam in the southern central part of the lot
- Infrastructure and ancillary structures

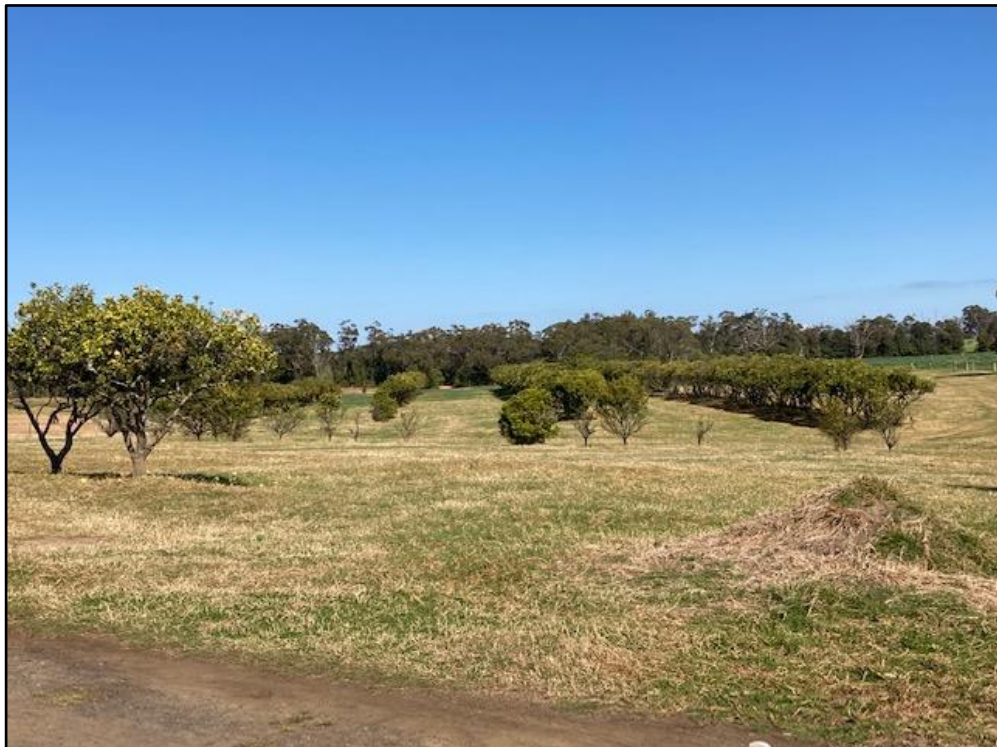
Plate 32 Orchard

Based on the results reviewed during this assessment, *Larry Cook Consulting* has identified potential contamination sites in Lot A associated with the soil material peripheral to the main storage shed and close to the citrus rows in the 'old' orchard. Field investigations comprising site investigations and manual excavation of soil did not identify any visible (stains/leachate) or olfactory signs of any significant soil contamination.

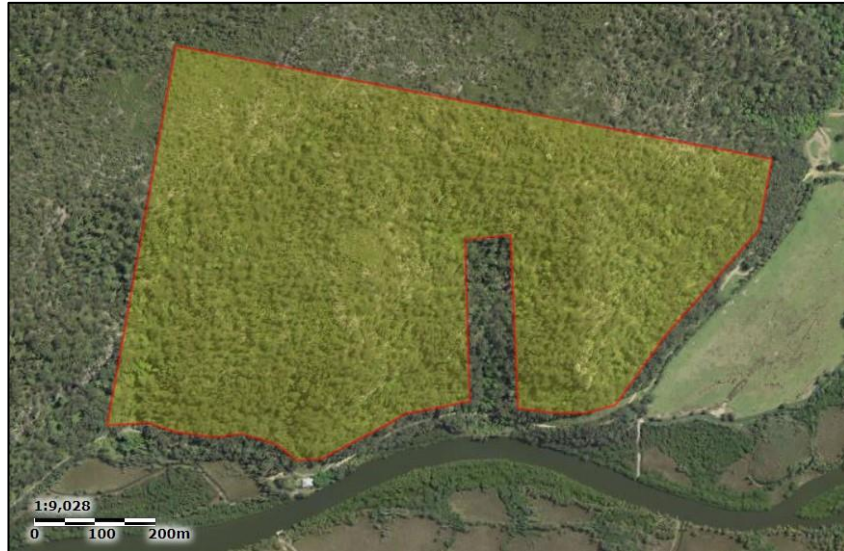
Lot 1 in DP617088

- No infrastructure
- Tall open eucalypt forest
- No significant contamination observed
- No potential sources of contamination observed

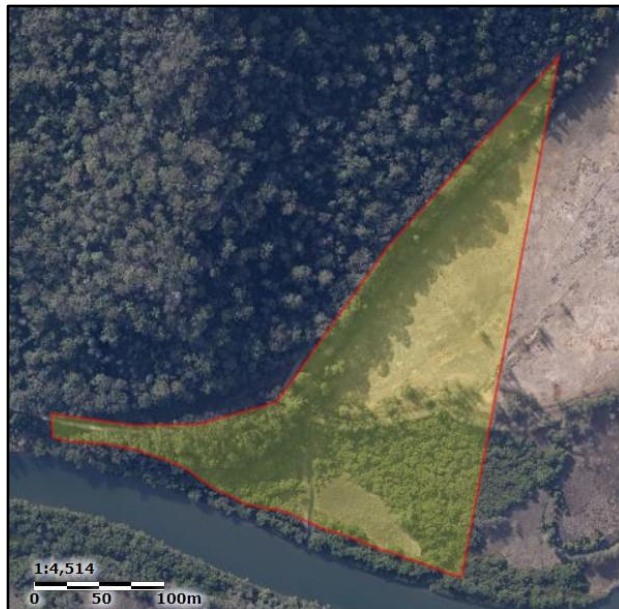
Lot 3 in DP617088

- No infrastructure
- Dominantly river flat with mangroves in southern part and tall open eucalypt forest long western boundary
- No significant contamination observed
- No potential sources of contamination observed

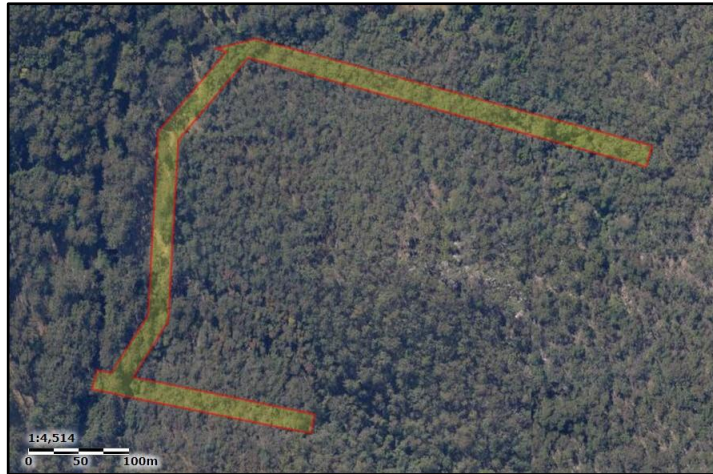
Lot 1 in DP1222754

- No infrastructure
- Tall open eucalypt forest
- No significant contamination observed
- No potential sources of contamination observed

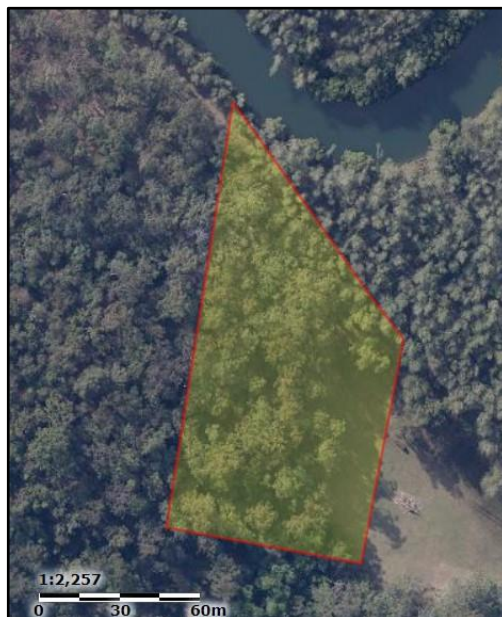
Lot 7 in DP1230083

- No infrastructure
- Dominantly tall open eucalypt forest with possible minor development of mangrove in the northern part adjacent to the waterway.
- No significant contamination observed
- No potential sources of contamination observed

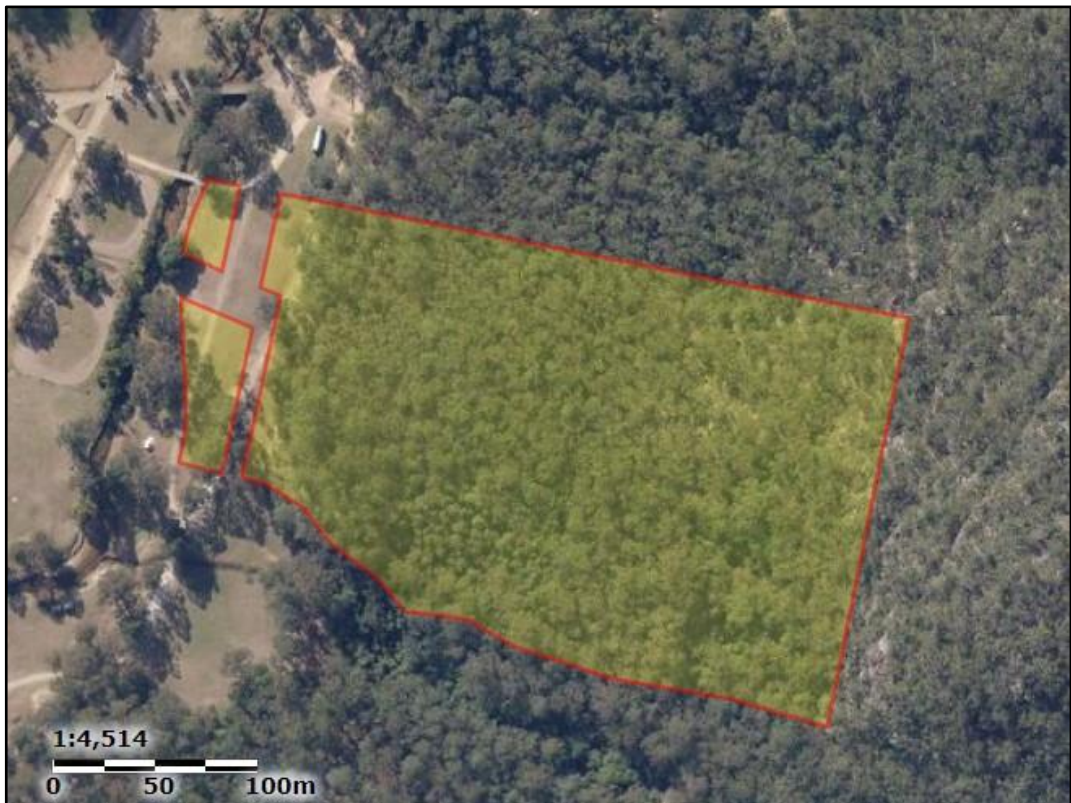
Lot 245 in DP48817

- No significant infrastructure. Small portable amenities in the north-western part
- Dominantly tall open eucalypt forest with minor river flat on the western end.
- Network access tracks in the westernmost part.
- No significant contamination observed
- No potential sources of contamination observe

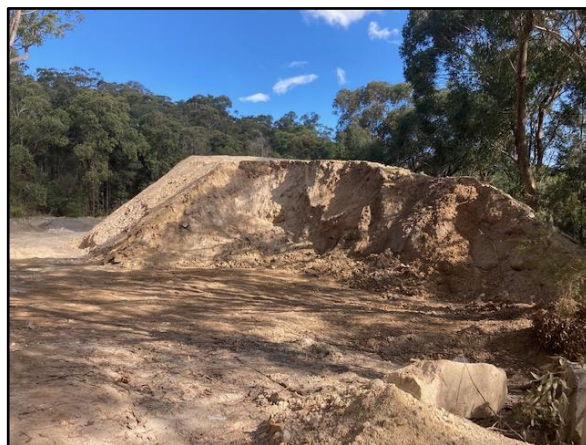
Plate 33 Sand Stockpile

- Dominantly tall open eucalypt forest with relative steep slopes.
- Main sinuous access road into Glenworth Valley.
- No significant contamination observed
- No potential sources of contamination observed
- Sand/rock stockpile (**Plate 34**)

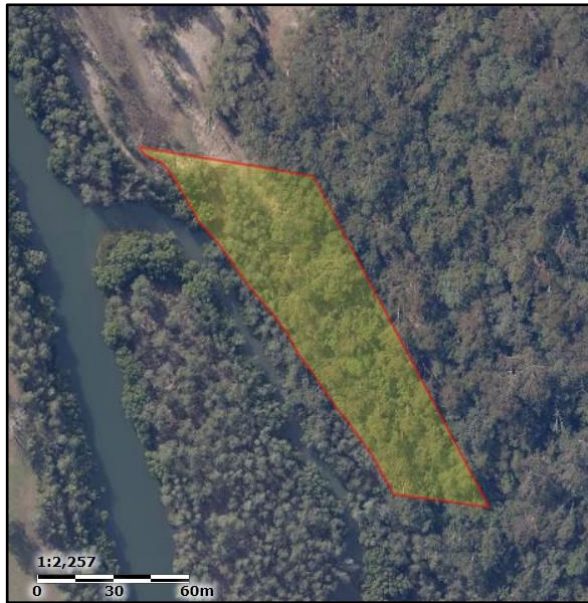
Lot 7029 in DP93603

- No infrastructure
- Dominantly tall open eucalypt forest with possible minor development of mangrove along western and northern parts adjacent to the waterway.
- No significant contamination observed
- No potential sources of contamination observed

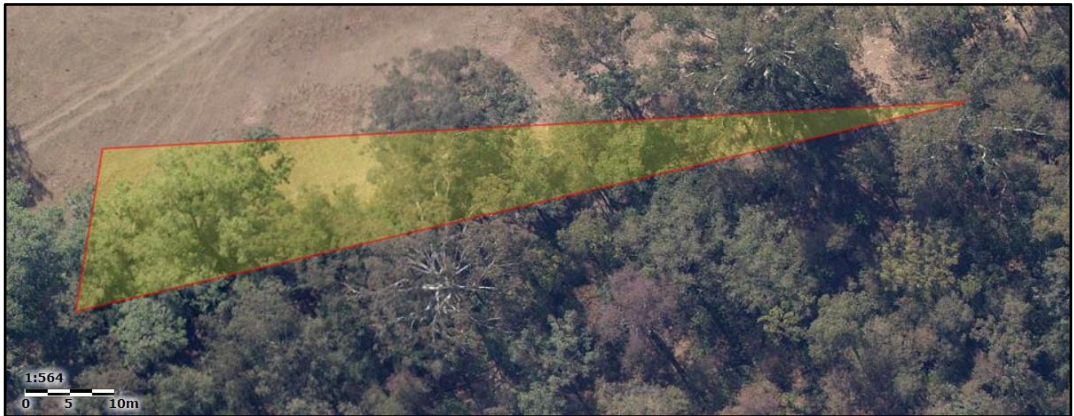
Lot 7036 in DP1059768

- Tall open eucalypt forest and river flat.
- Network access tracks in the westernmost part.
- No significant contamination observed
- No potential sources of contamination observed
