PHASE I ENVIRONMENTAL SITE ASSESSMENT WITH TARGETED SOIL SAMPLING AND TESTING

Cooks Road Glenworth Valley
NSW 2250

**PREPARED FOR: GLENWORTH VALLEY OUTDOOR
ADVENTURES**

PROJECT NUMBER: 21097

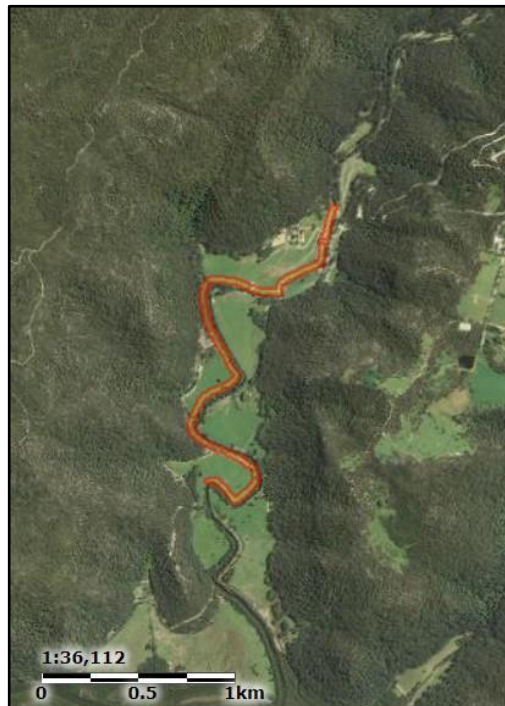
Lot 7303 in DP1154929

- Sinuous tree-lined Popran Creek.
- No significant contamination observed
- No potential sources of contamination observed

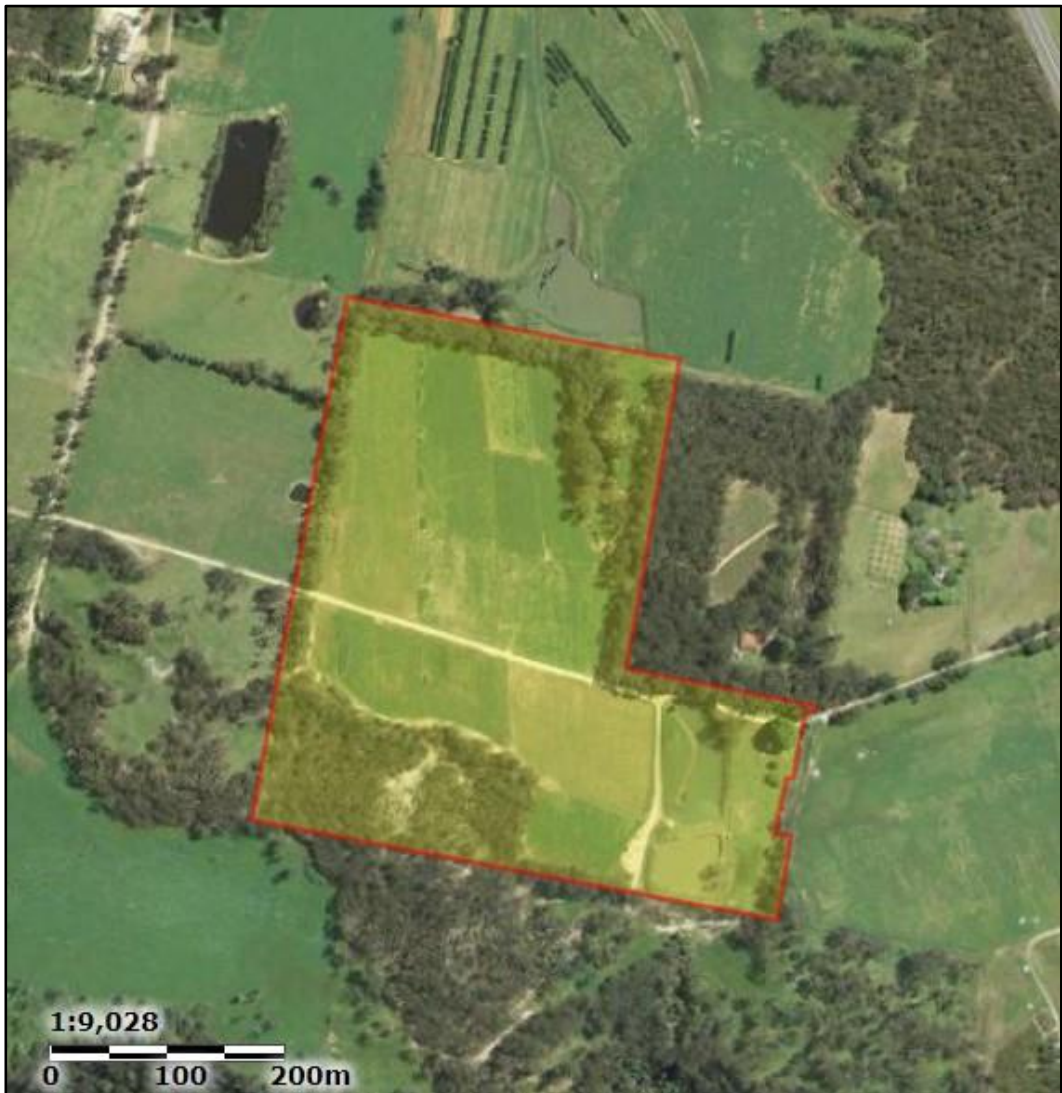
Lot 2 in DP1139242

- Dominantly cleared land with tall open eucalypt forest in south-western part.
- Access tracks dissect the land.
- Cottage in north-eastern corner (constructed in 1950s and observed in 1961 aerial coverage)
- No significant contamination observed
- Council-approved On-Site Sewage Management system (OSSM) treats all wastewater from the cottage with disposal via absorption trench
- No potential sources of contamination observed

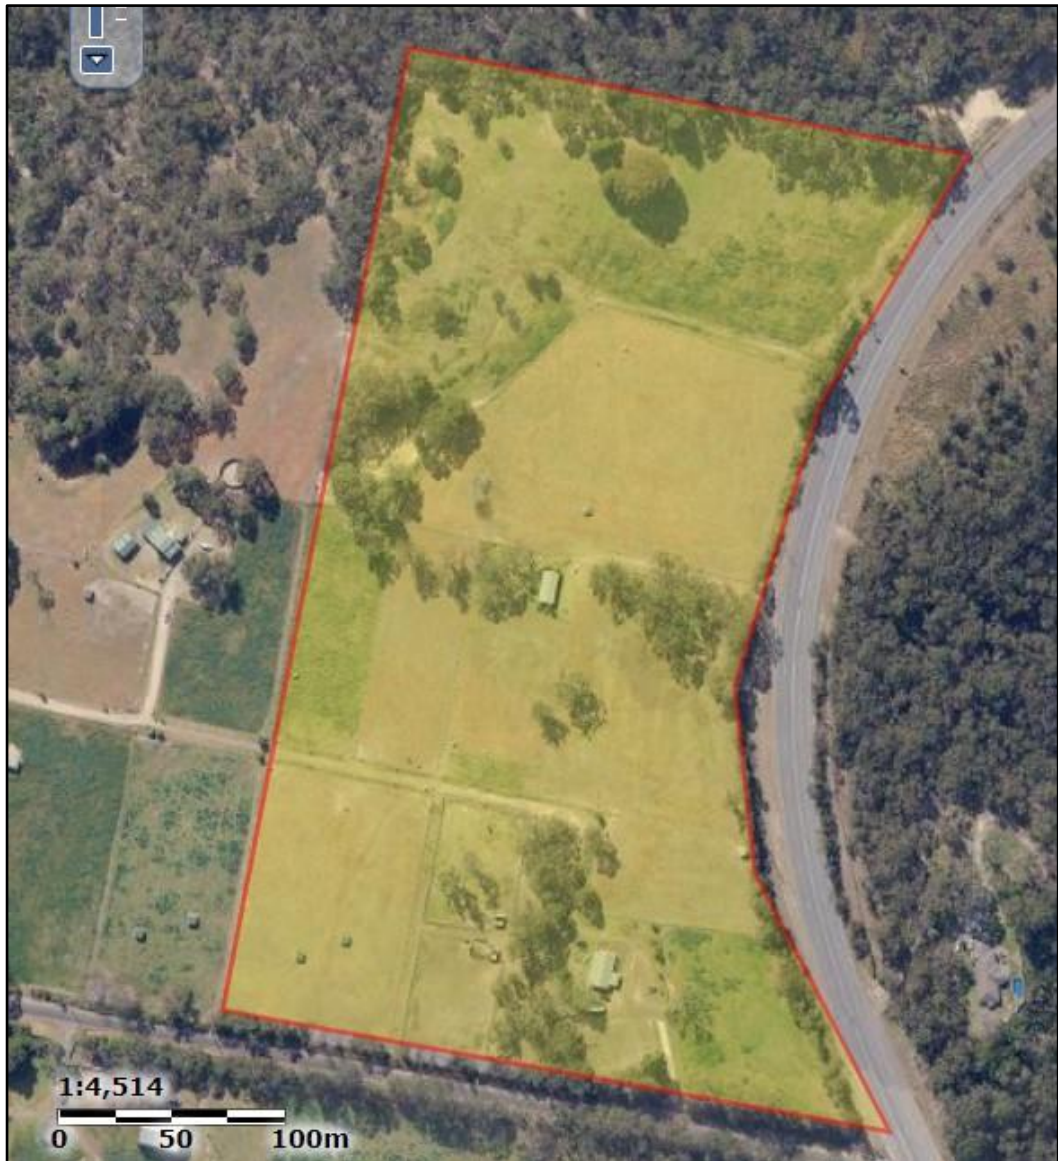
Lot 882 is located immediately north of the Cooks Road - Peats Ridge Road intersection.

Built improvements on the property include a rural/machinery shed in the central part (1970s) and a dwelling in the south-eastern part that is observed in the 1991 aerial photography (built in 1980s).

- No significant contamination observed
- Potential for very local sources of contamination possibly associated with the machinery shed and rural use of the land.

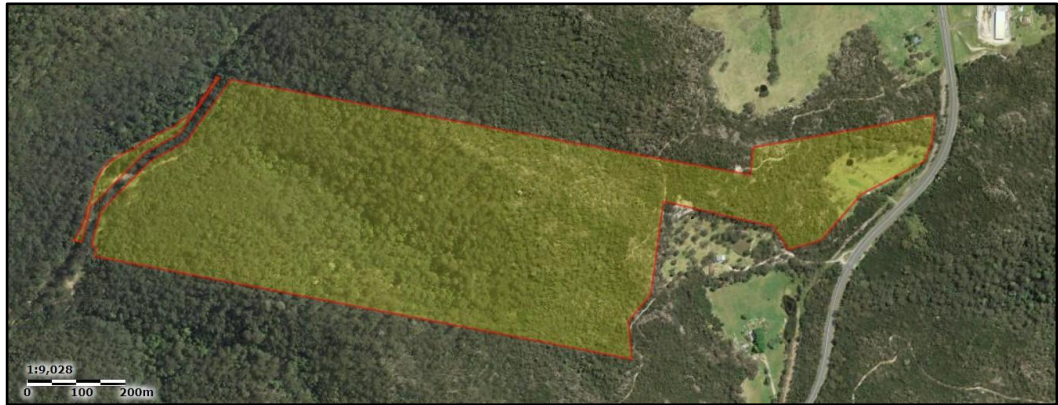
- No infrastructure
- Tall open eucalypt forest with clearing in north-eastern part
- No significant contamination observed
- Potential source of localised contamination associated with a temporary cluster of poly water tanks and machinery and metal framework deposited in the cleared area in the north-eastern part close to Peats Ridge Road.

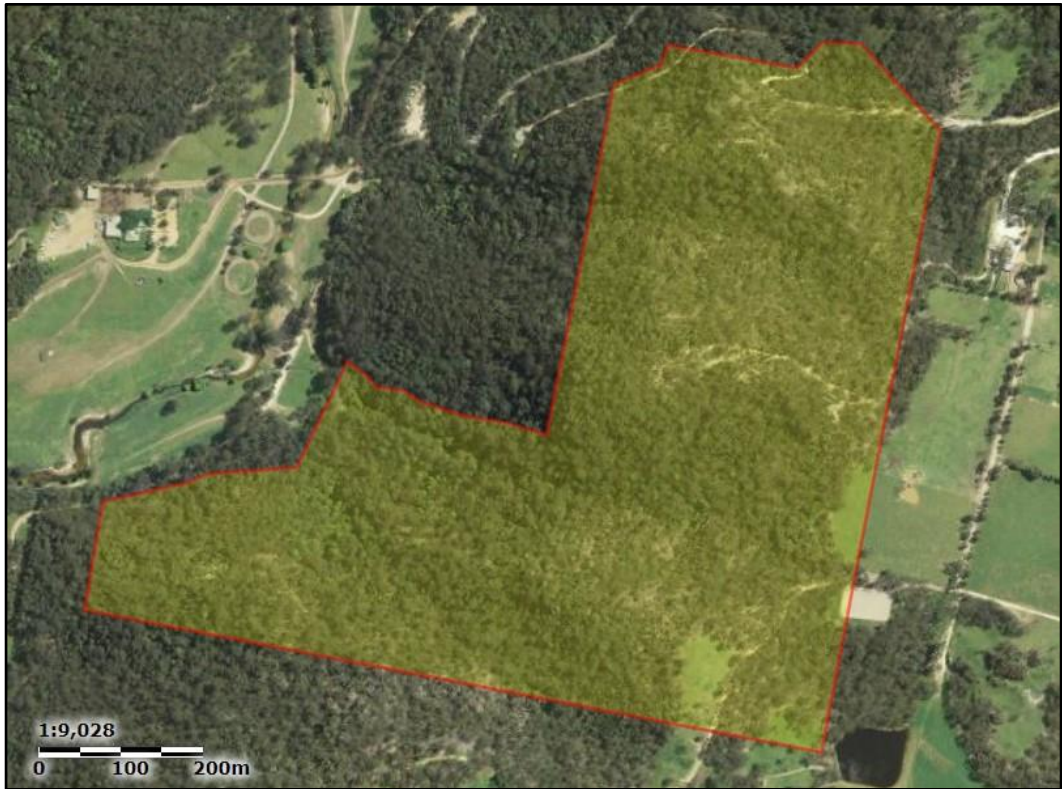
Lot 7039 in DP1059766

- No infrastructure
- Dominantly tall open eucalypt forest with small clearings in central eastern and south-eastern parts
- Access tracks observed in the south-eastern corner, central eastern part, and the main access road down into Glenworth Valley
- No significant contamination observed
- No potential sources of contamination observed

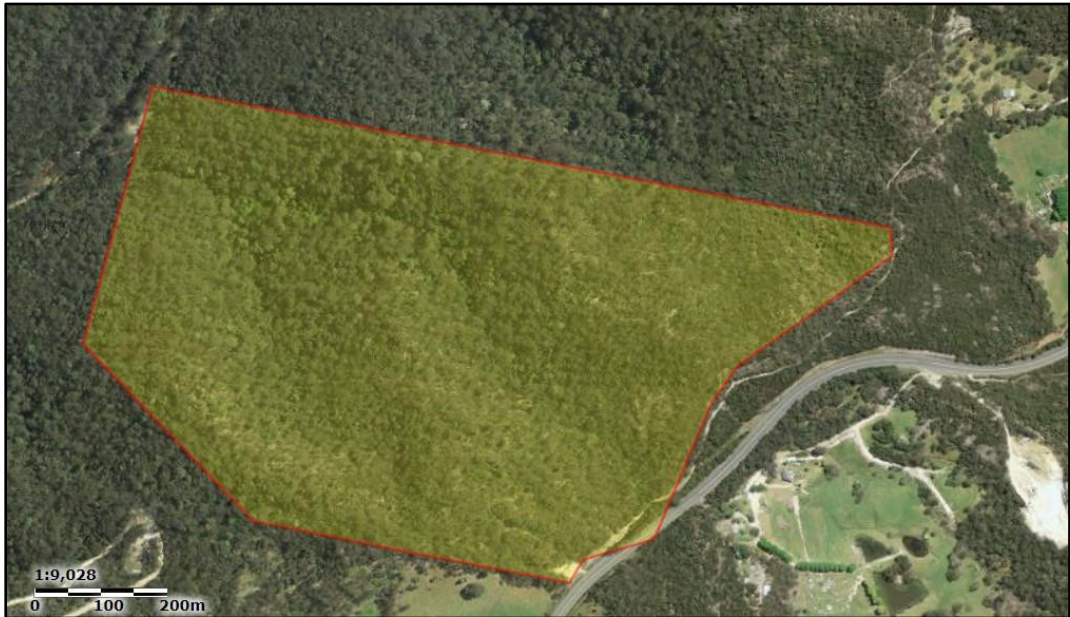
Lot 7303 in DP1161109

- No infrastructure
- Dominantly tall open eucalypt forest
- Access track observed along the eastern Peats Ridge Road boundary
- No significant contamination observed
- No potential sources of contamination observed

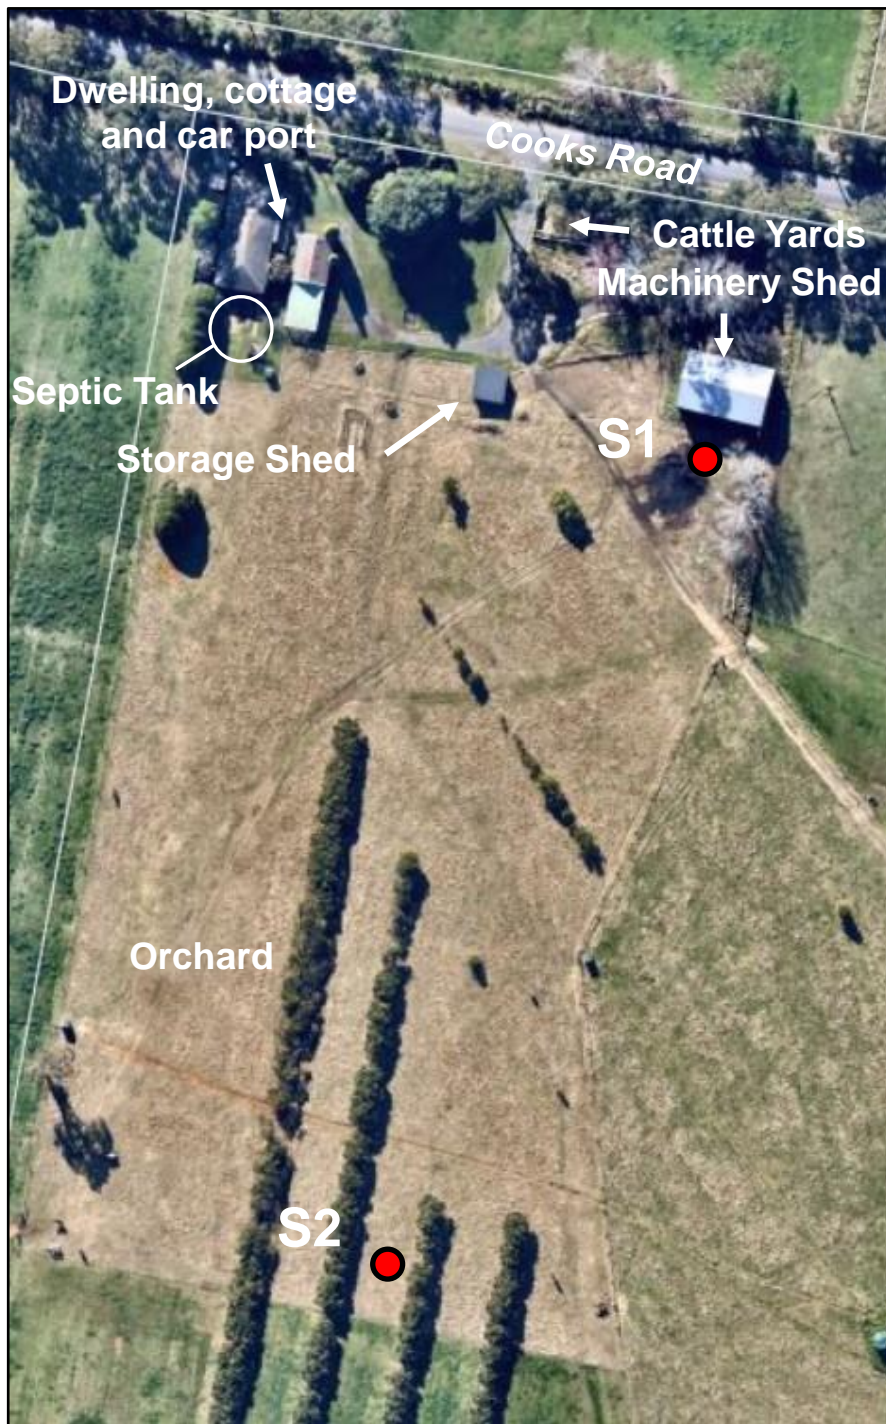
FIGURE 4

S1 ● Soil Sample

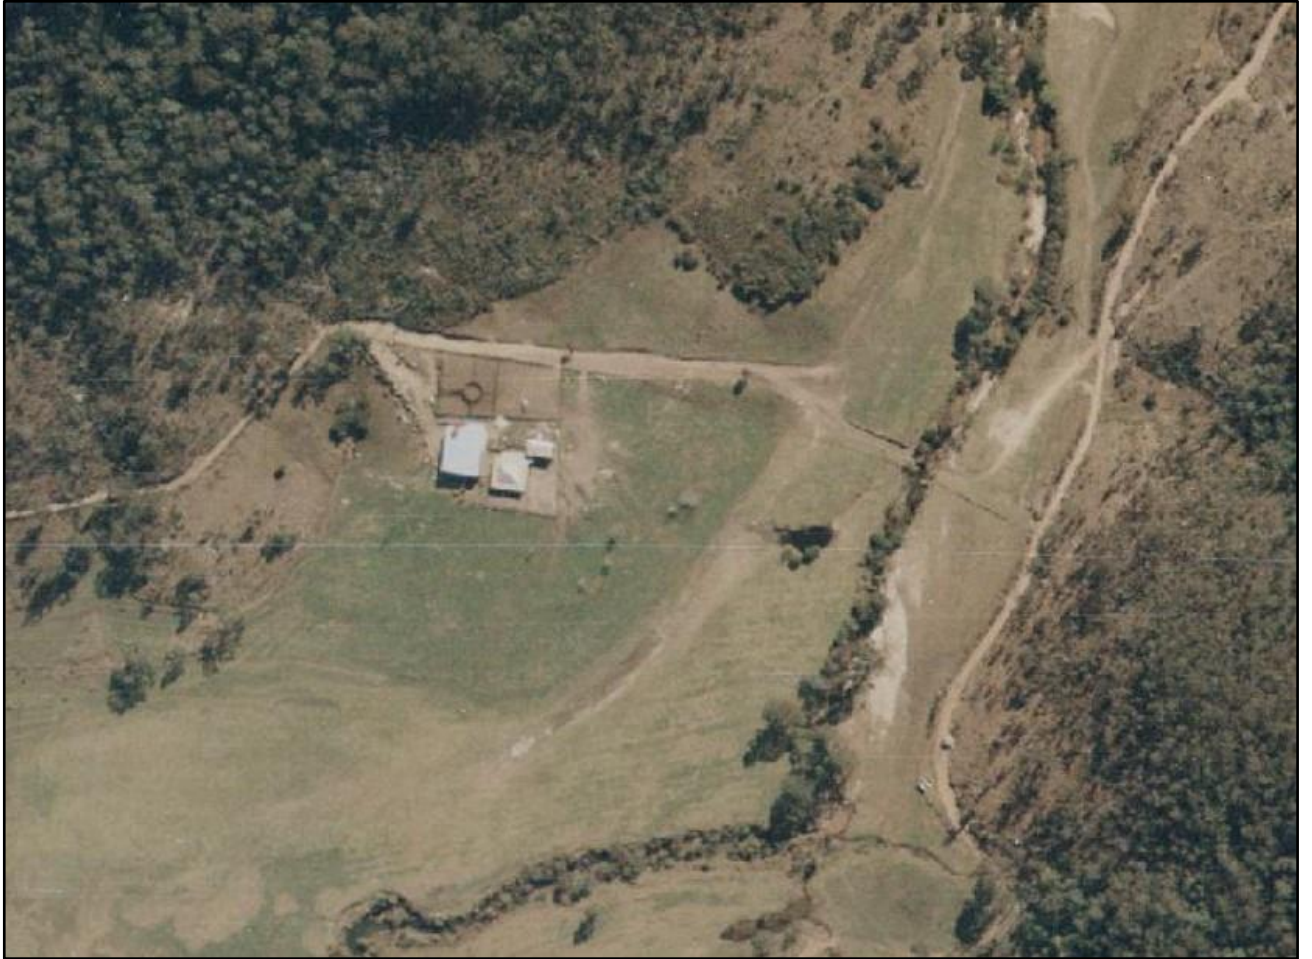
FIGURE B2

Phase I Environmental Site Assessment
North-Eastern Part of Lot 89 in DP755221
Glenworth Valley
Aerial Photo - 1976

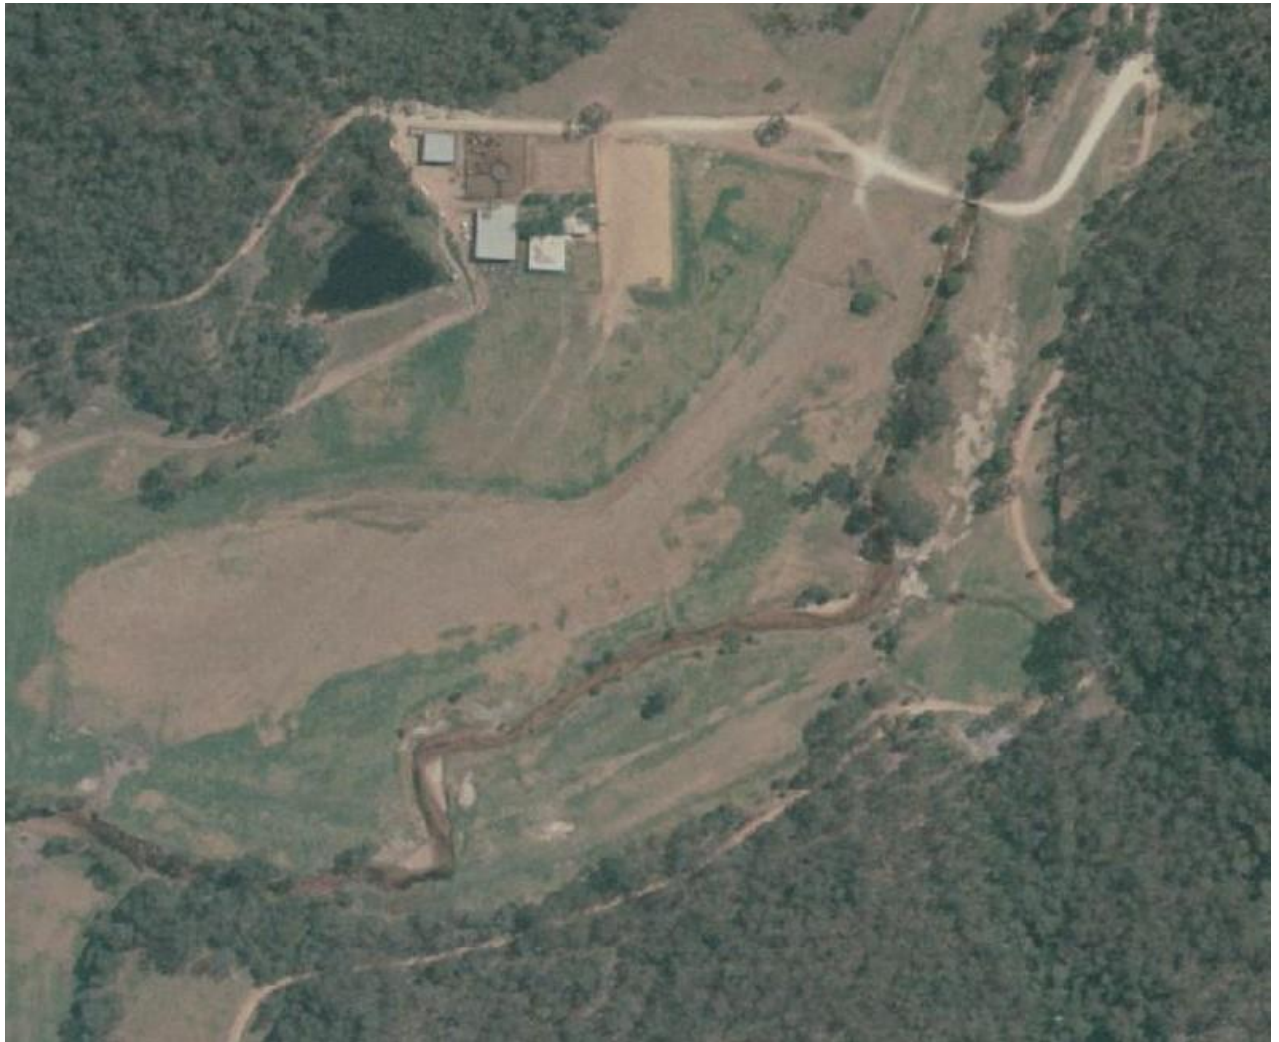
FIGURE B3

North-Eastern Part of Lot 89 in DP755221
Glenworth Valley
Aerial Photo - 1991

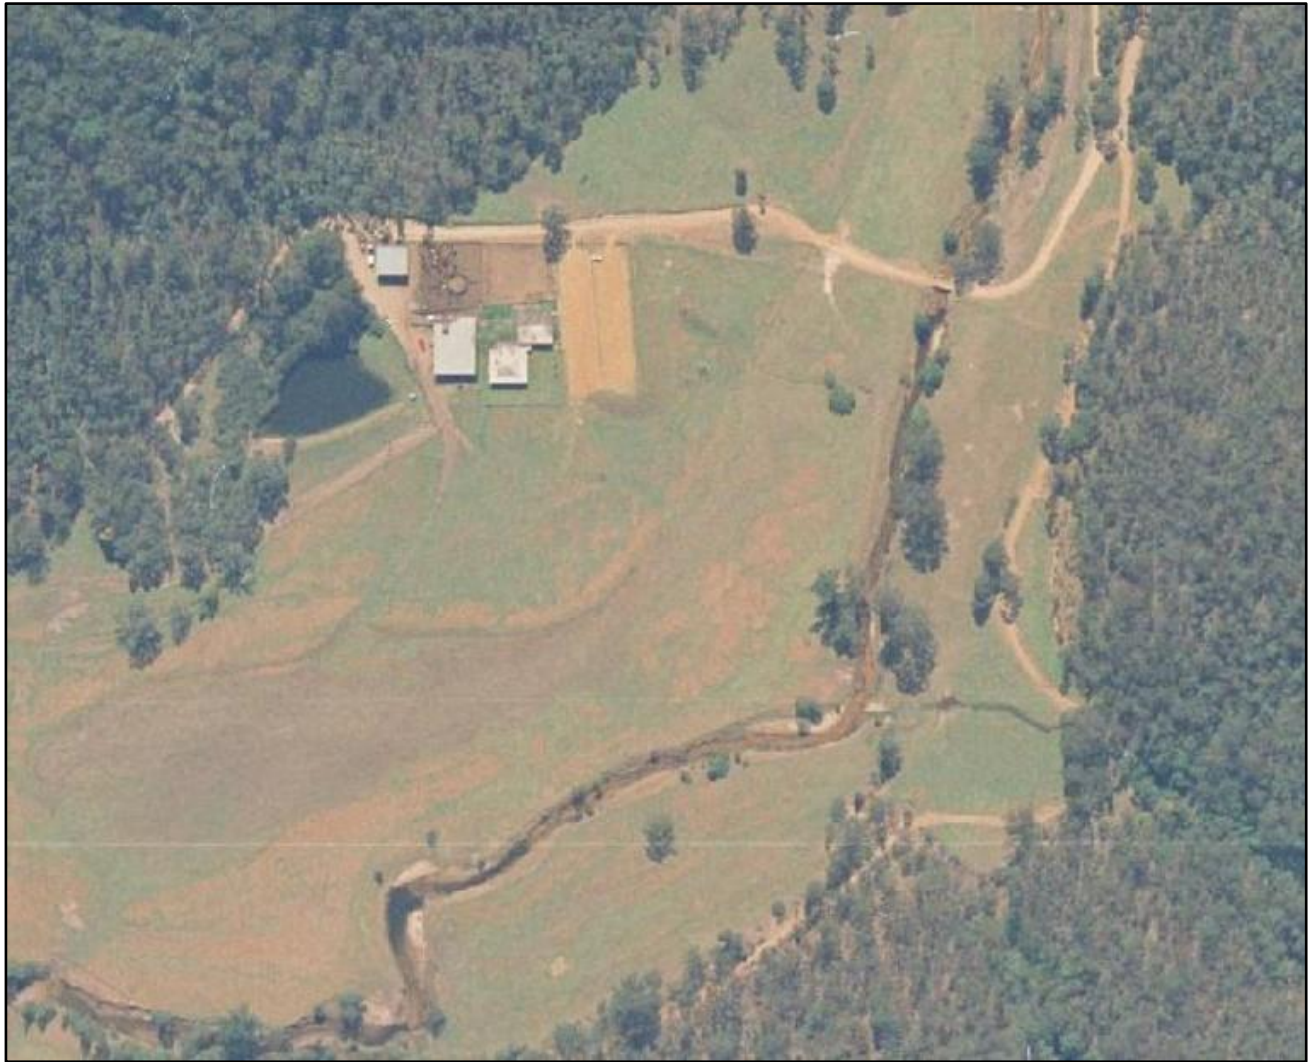
FIGURE B4

Phase I Environmental Site Assessment
North-Eastern Part of Lot 89 in DP755221
Glenworth Valley
Aerial Photo - 1994

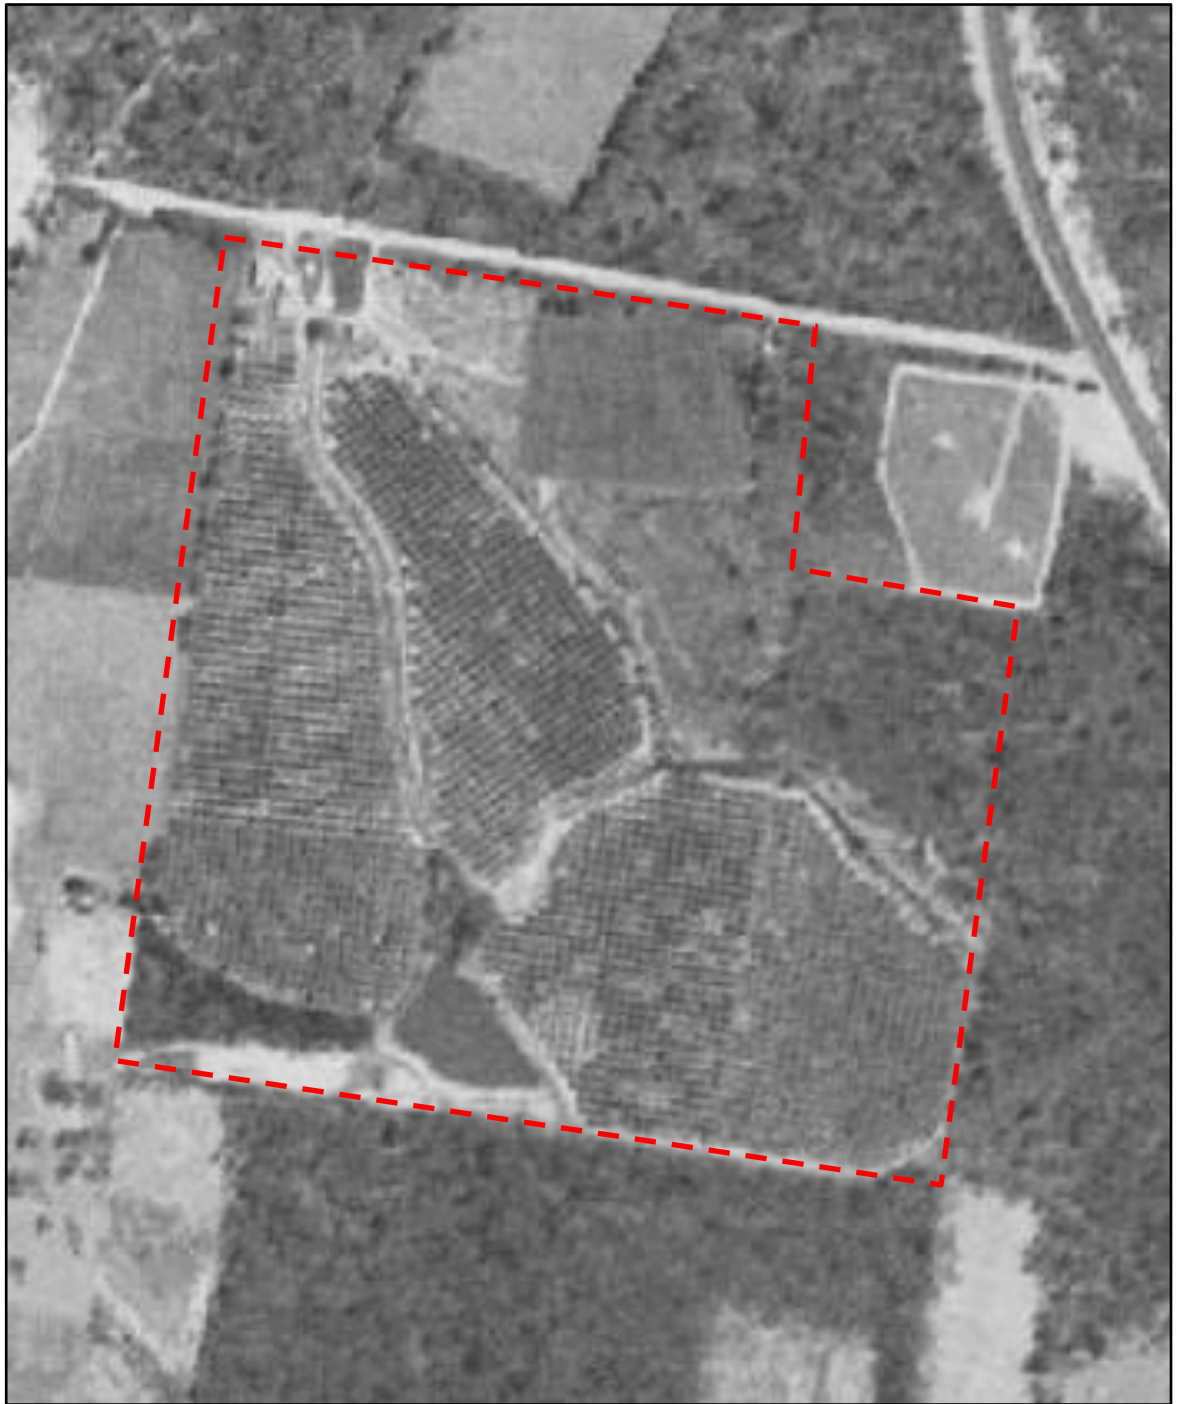
FIGURE B7

Lot A in DP365595
Aerial Photo - 1976

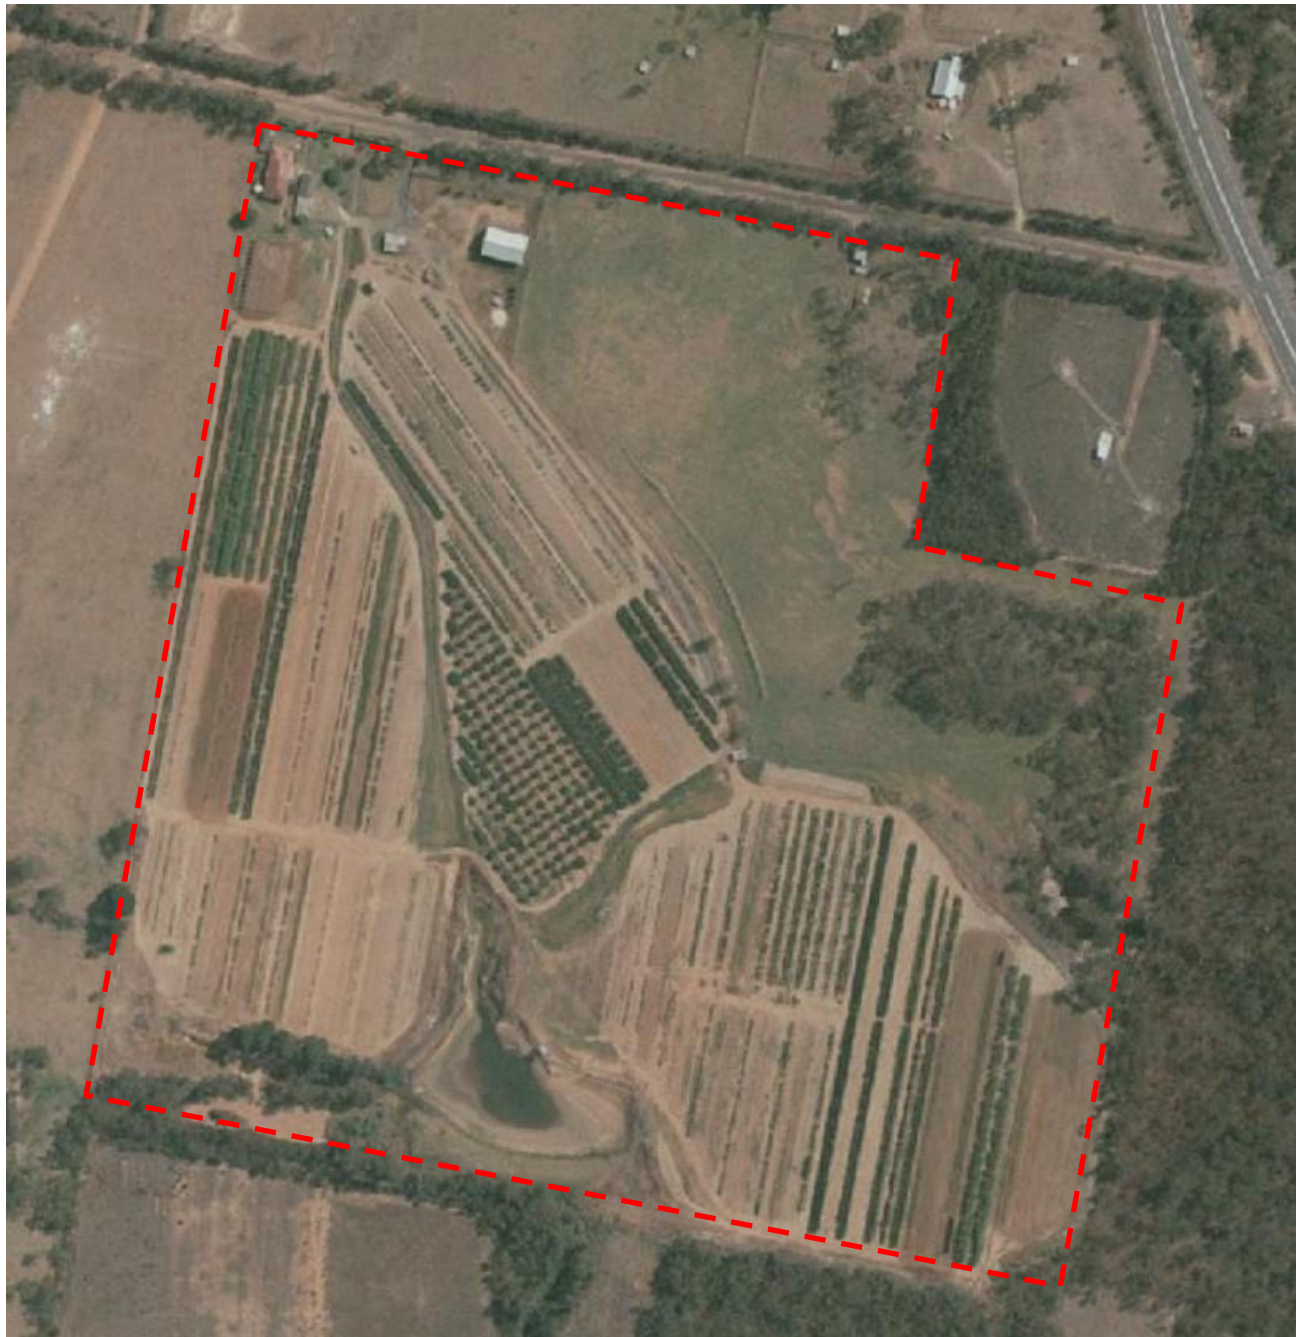
FIGURE B8

Lot A in DP365595
Aerial Photo - 1991

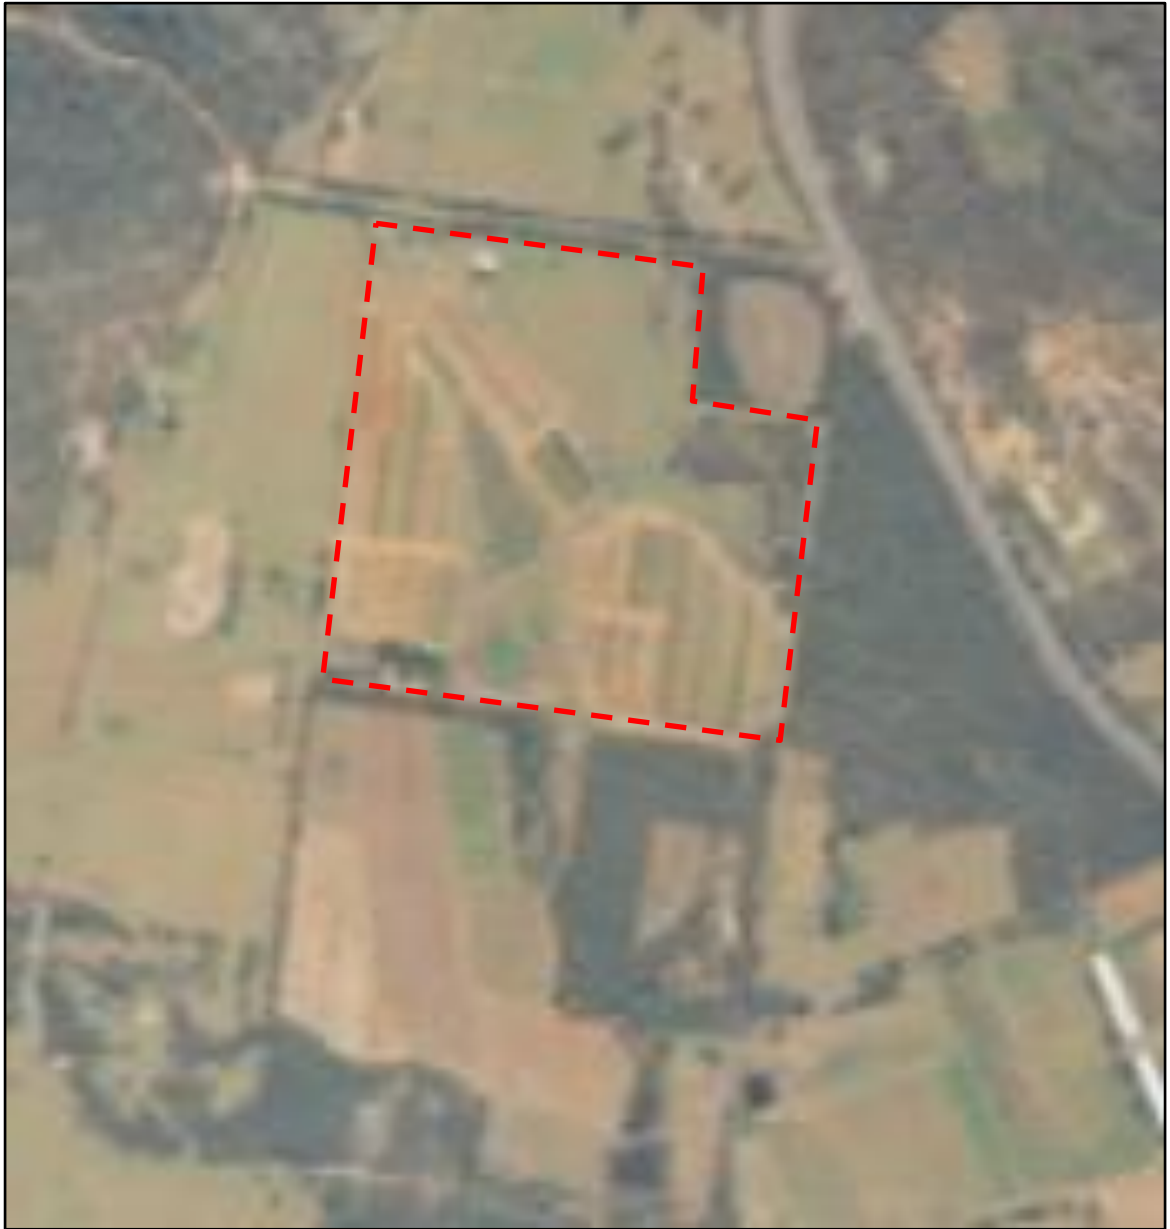
FIGURE B9

Lot A in DP365595
Aerial Photo - 1994
