Report on  
Preliminary Site Investigation  
for Contamination

Proposed Site Rehabilitation of Old Quarry  
Part of 39 Dell Road, West Gosford

Prepared for  
Valencia Homes Pty Ltd

Project 75853.00  
September 2014

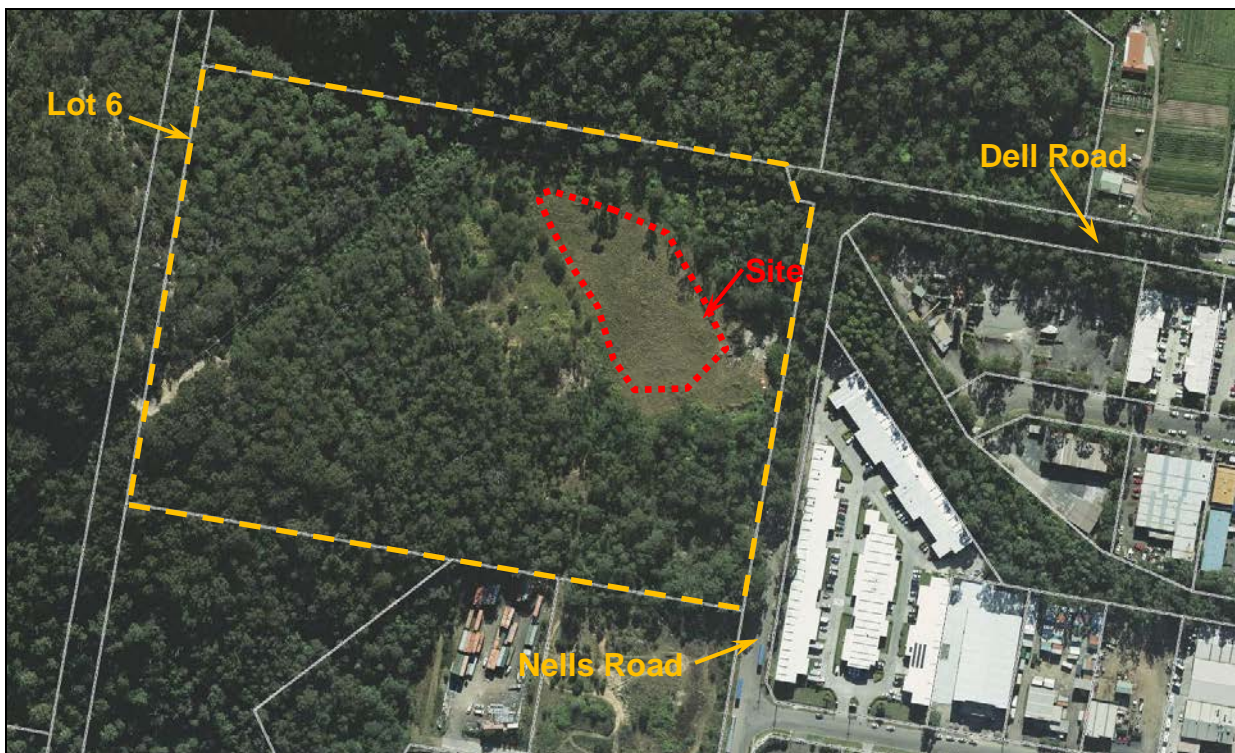
Figure 2: Location of Site (image sourced from Land and Property Information)

The site is defined as part of Lot 6 in Deposited Plan 3944, as indicated on Figure 2 (Section 1.2) and extends depths of approximately 2 m into the natural soil profile. The assessment results and conclusions are to apply to the whole of the site.

DP has undertaken a PSI at part of an old quarry, located at 39 Dell Road West Gosford, NSW. The extent of the site (assessment area) is identified in Figure 2 (Section 1.2) This PSI is to support an application for site rehabilitation of the old quarry to Gosford City Council (GCC) and also provides information on the likely contamination constraints associated with the proposed redevelopment of the site for a commercial/industrial land use.

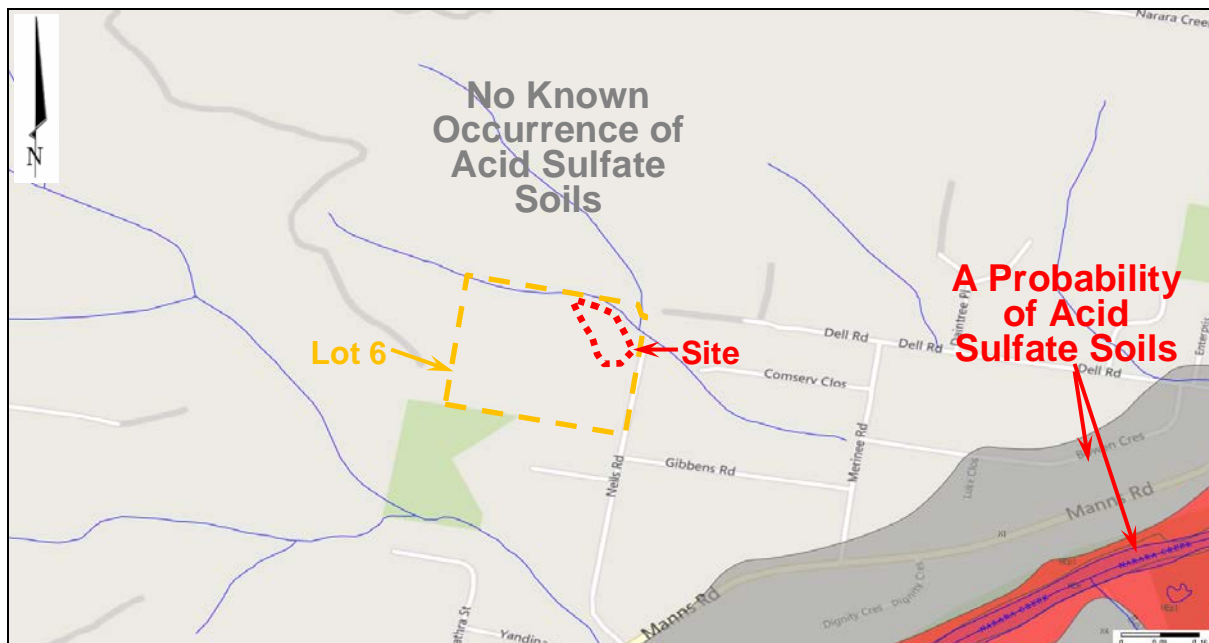
**Figure 6: Local Acid Sulfate Soil Risk Mapping**

The local acid sulfate risk mapping indicates that the site and surrounding areas are mapped as having no known occurrence of acid sulfate soils. An extract of the acid sulfate soil risk mapping is presented as Figure 6, which shows the acid sulfate soils conditions in the vicinity of the site.

(Image sourced from Microsoft Virtual Earth with Gosford-Lake Macquarie 1:100,000 Soil Landscape Sheet overlays)

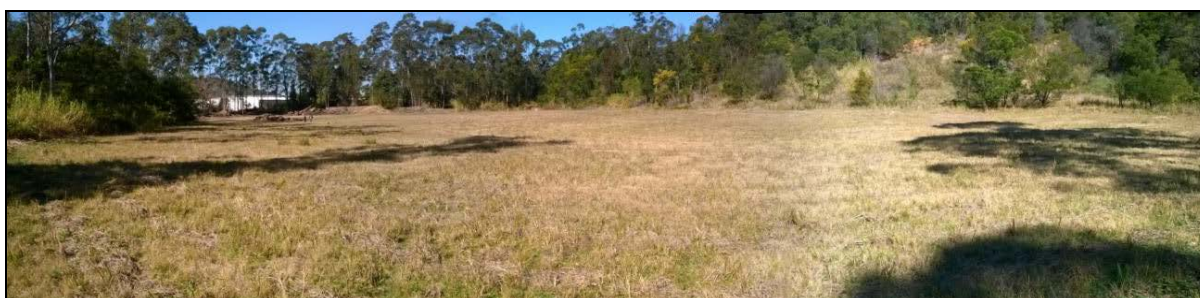
**Figure 8: Photograph of site taken from the northern site boundary.**

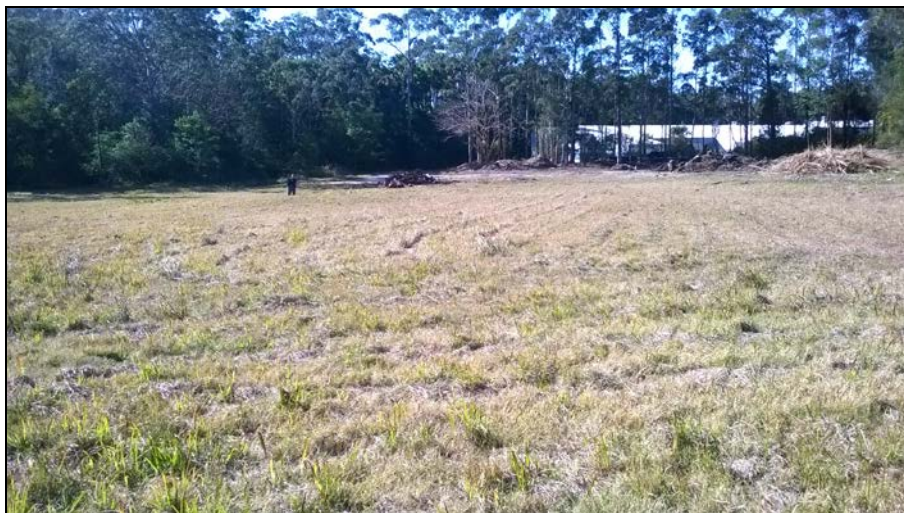
**Figure 9: Photograph of the southern portion of the site. Mounds of green waste (cleared weed regrowth and trees/stumps) were identified beyond the south-east site boundary.**

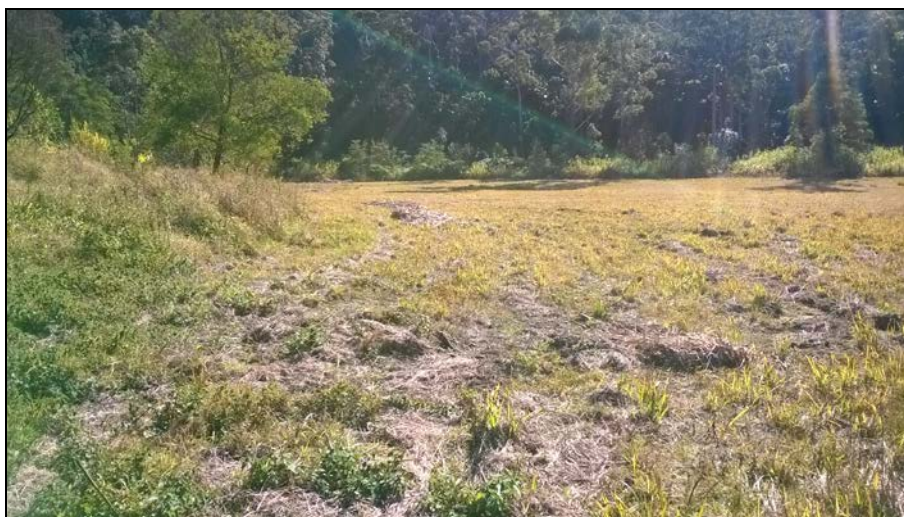
**Figure 10: Photograph along the western site boundary (facing north). The adjacent mound of filling (beyond site boundary) formed a catch drain to redirect surface water run-on from areas to the west.**

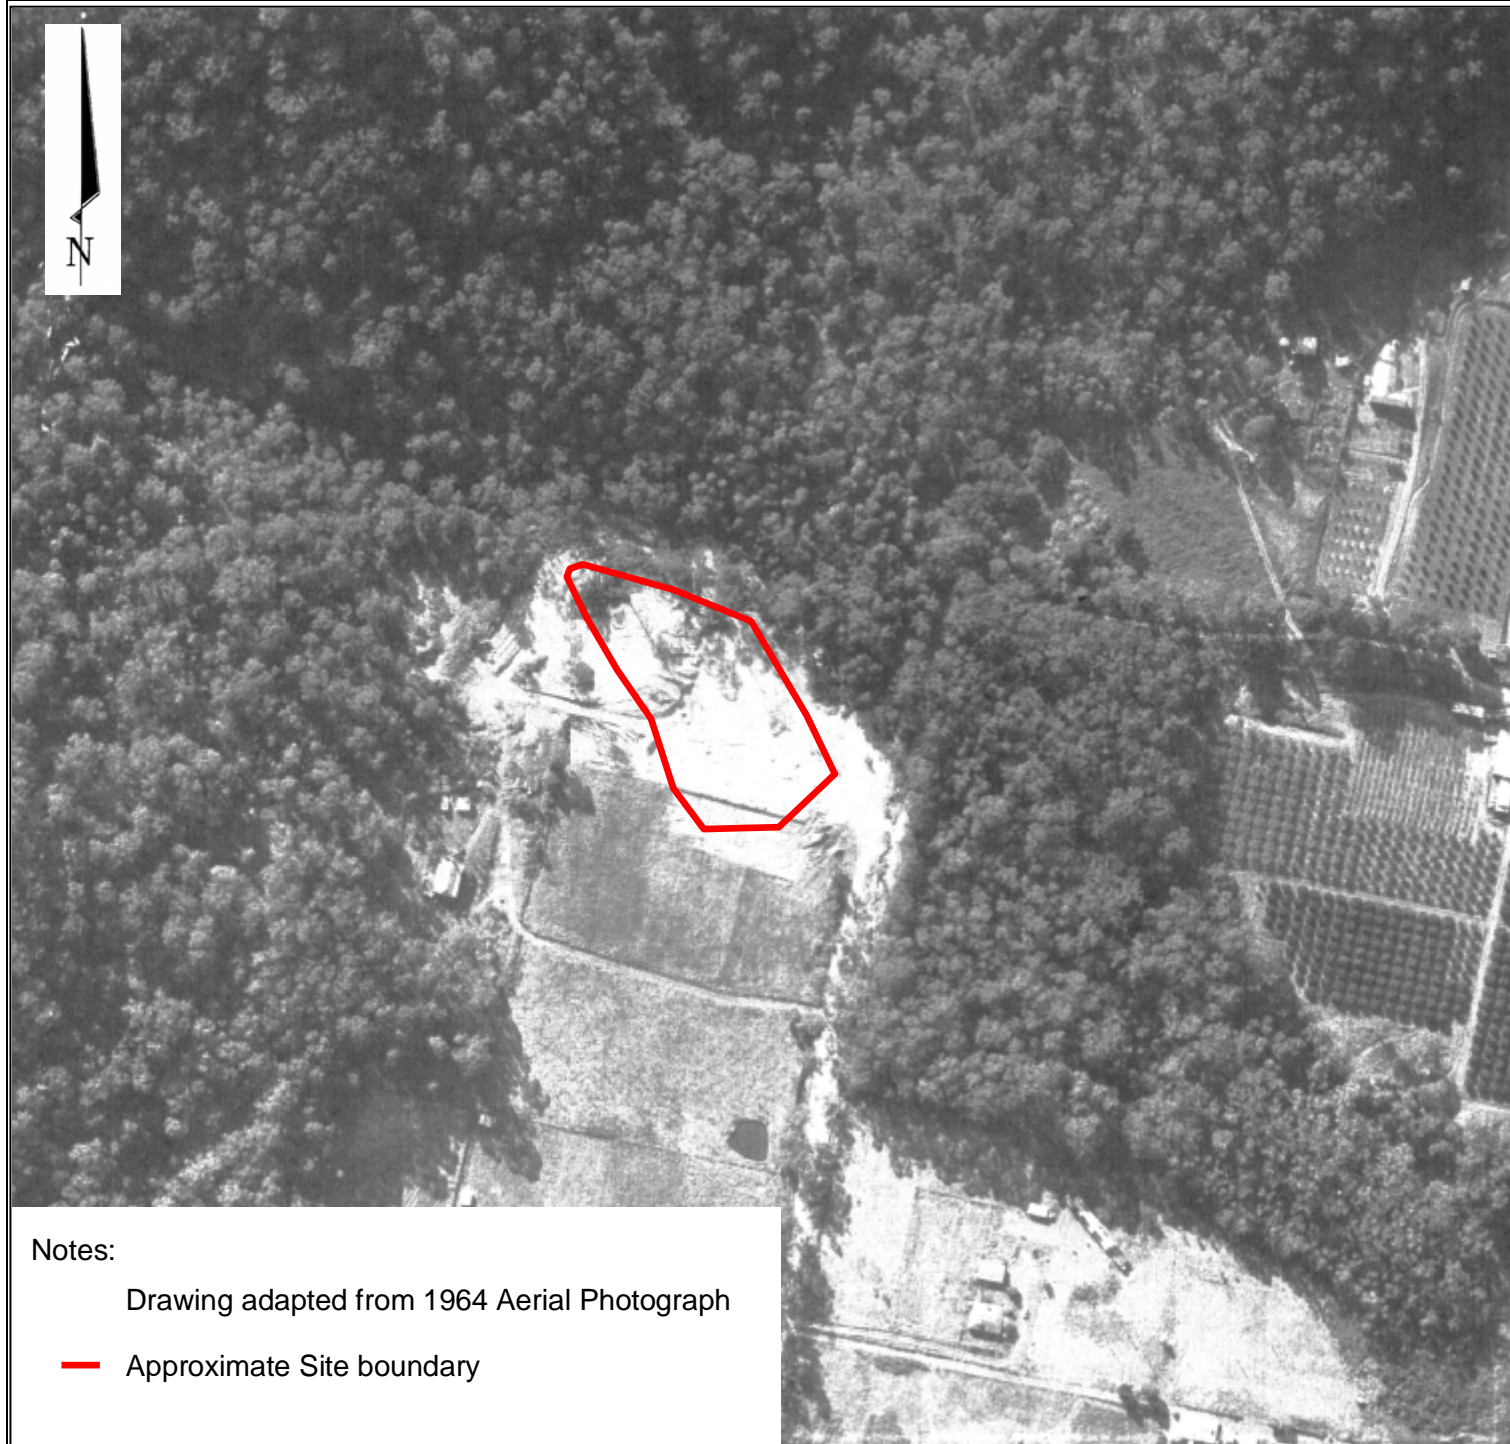
Notes:  
 Drawing adapted from 1964 Aerial Photograph  
 — Approximate Site boundary
