**EDH Group**  
Pacific Highway, Lake Munmorah NSW  
Phase 1 Contaminated Site Investigation

February 2019

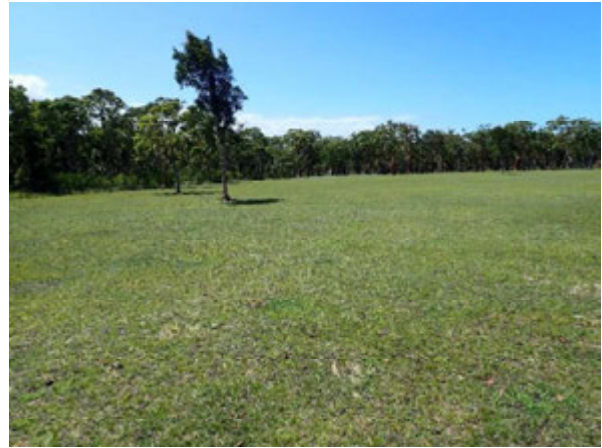
Photograph 4. Block 285 looking north along paddock towards open eucalypt with an area of possible fill in background

Based on the findings of this PSI, a detailed investigation is recommended to further investigate these potential contaminant sources and refine the CSM.

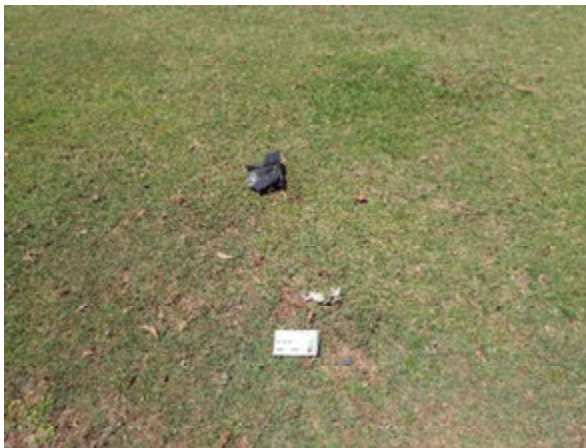
Photograph 5. Block 285 showing minor black plastic and cloth in area of potential fill.

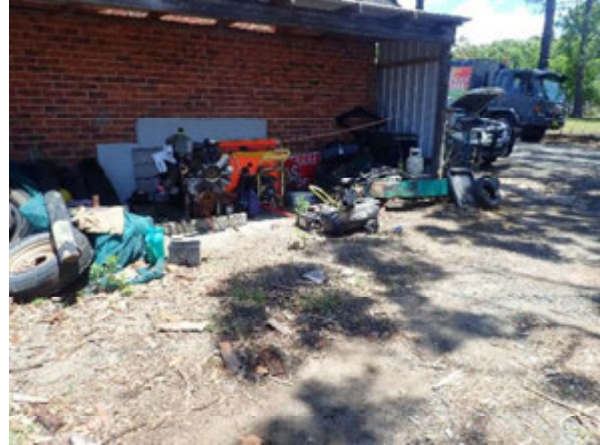
Photograph 8. Block 295 north wall of chainsaw and mower repair workshop showing batteries etc on the ground

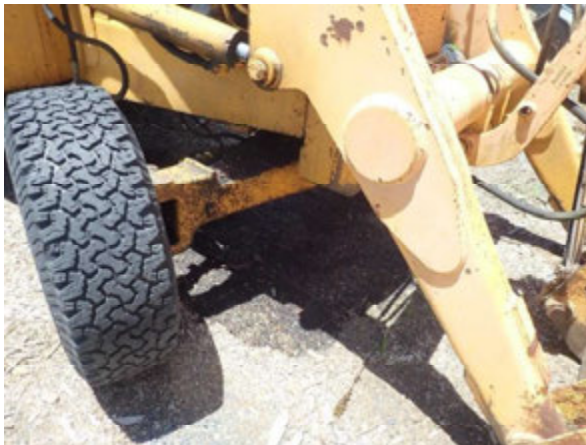
- Minor oil spills, identified from staining observed under machinery and around poorly kept empty oil containers on block 295.
- Fill material potentially comprising waste building material on all blocks but predominantly blocks 285 and 295.
- Rubbish around the dwelling and workshop buildings on block 295.
- Chemicals and empty chemical containers stored onsite.
- Leaks from the septic tanks identified on block 285 and 305.
- Residual chemicals from historical use of the site as an orchard or plantation.
- Potential hydrocarbon contamination from sources on adjacent properties (service stations) as indicated by odour and sheen observed on surface water at the rear of block 305.

Photograph 9. Block 295 leak beneath back hoe located next to the workshop

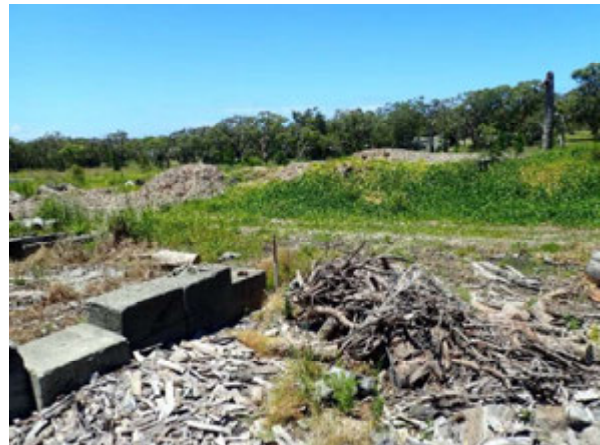
Photograph 10. Block 295 looking south from the workshop of the mulch piles

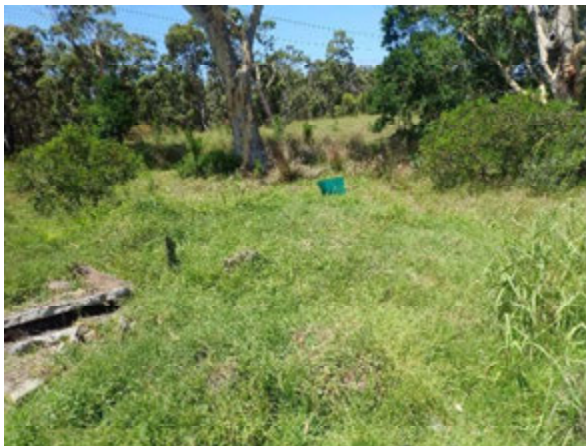
Photograph 11. Block 295 looking north east at building waste fill piles located in the north west corner of the block. Note concrete and plastic roof sheeting.

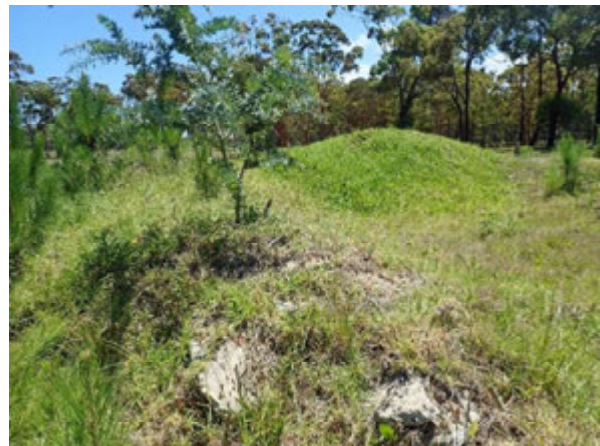
Photograph 12. Block 295 looking south at the building waste fill piles located in the north west corner of the block. Note concrete in foreground.

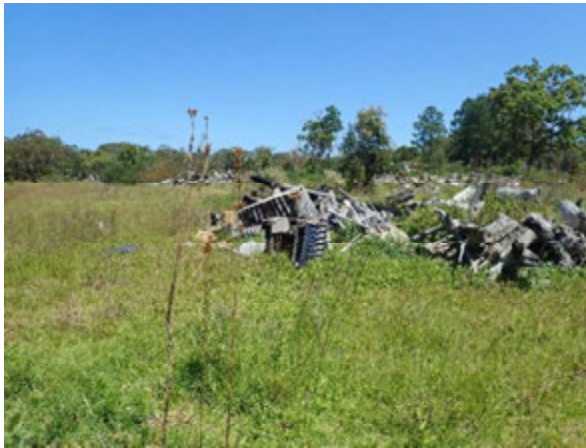
Photograph 13. Block 295 looking south from the north east of the block at various fill piles consisting of scrap timber / furniture / logs.

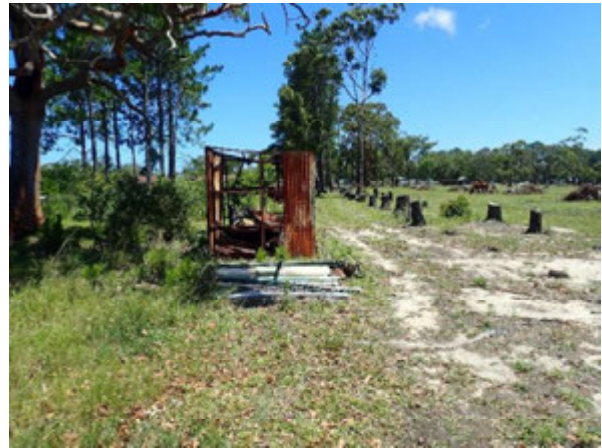
Photograph 14. Block 295 looking south at the central west of the block looking at scrap steel

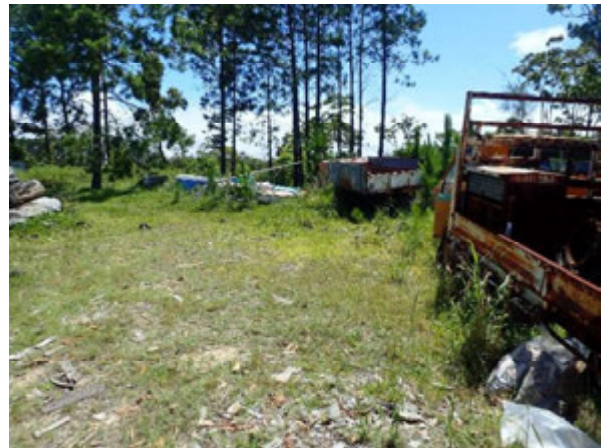
Photograph 16. Block 295 looking west from north of the main residence scrap vehicle and old boat.

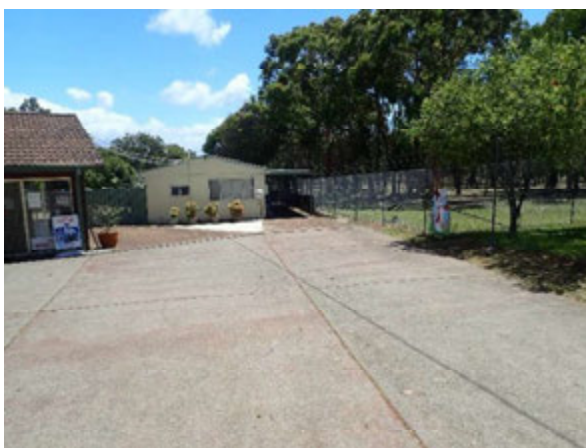
Photograph 17. Block 305 looking north along eastern boundary toward original dwelling on site. Note recent concrete pour for drainage works.

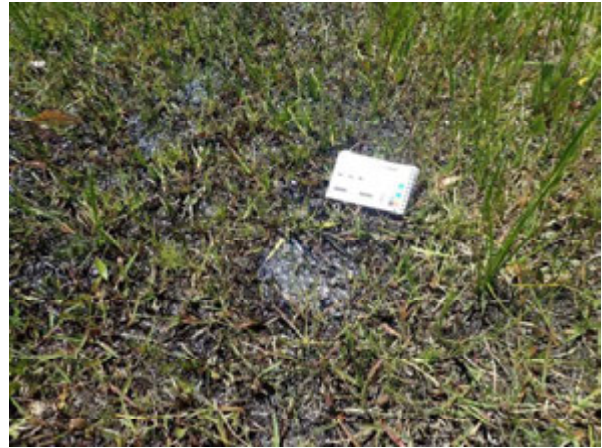
- At the location of oil stained soil around machinery and oil containers.
- Where potential hydrocarbon odour and sheen noted in surface water on block 305.
- From stored chemicals and residual chemicals from historical use of the site as an orchard or plantation.
- From fill and stockpiles of unknown sources.

Photograph 22. Block 305 showing possible oil on water surface in swamp area in the north east corner.
