Report on
Detailed Site Investigation (Contamination)

Proposed Tourist and Visitor Development
231 Pacific Highway, Mount White

Prepared for
The Trustee for Mount White Trust

Project 202936.01
December 2021

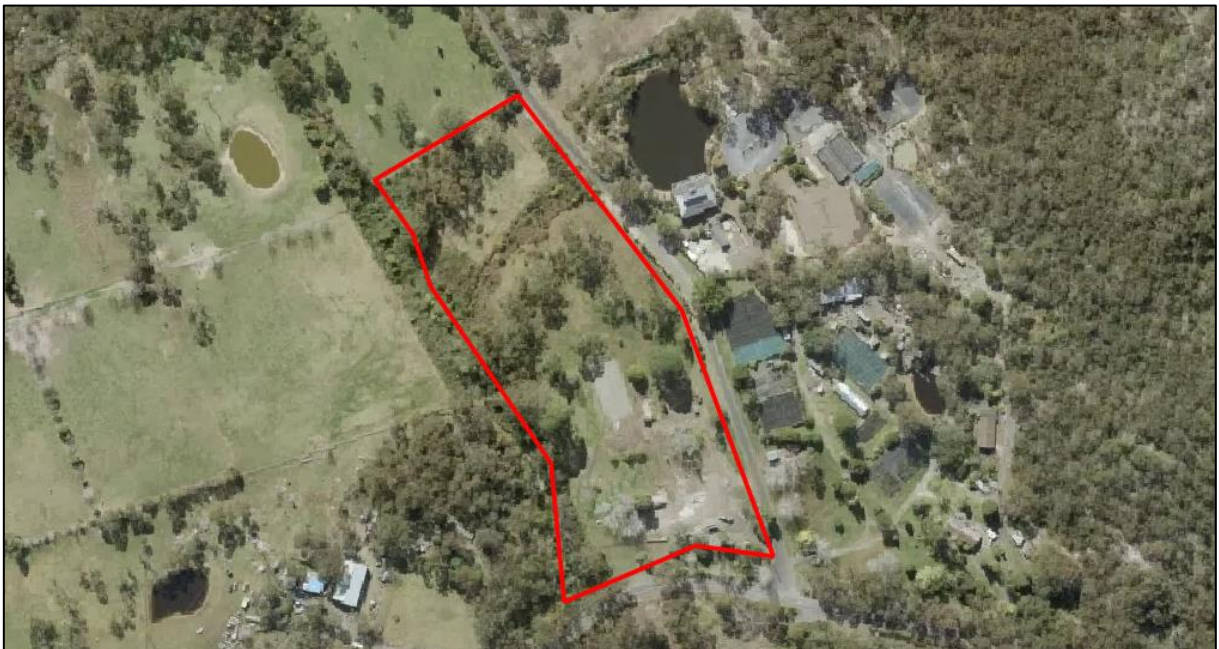
Figure 1: Site Location

The key site information is presented below, and the site boundary is shown in Figure 1.

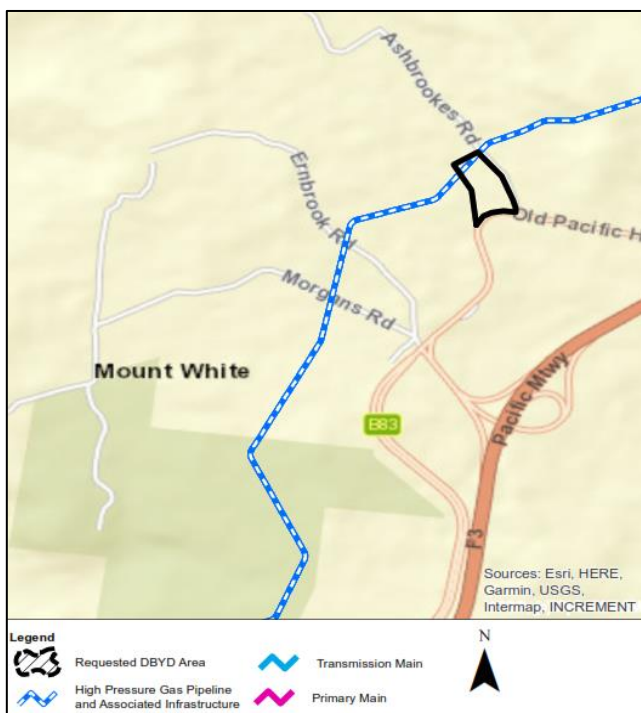
Figure 2: Alignment of high pressure gas (and fuel) pipeline intercepting the northern portion of the site (outlined in black). Figure extracted from Jemena Gas Networks DBYD search.

It is known a fuel pipeline traverses the northern portion of the site, however based on correspondence with an Ampol representative, DP was informed that there has been no evidence of leaks in the fuel pipeline in the locality of the site.

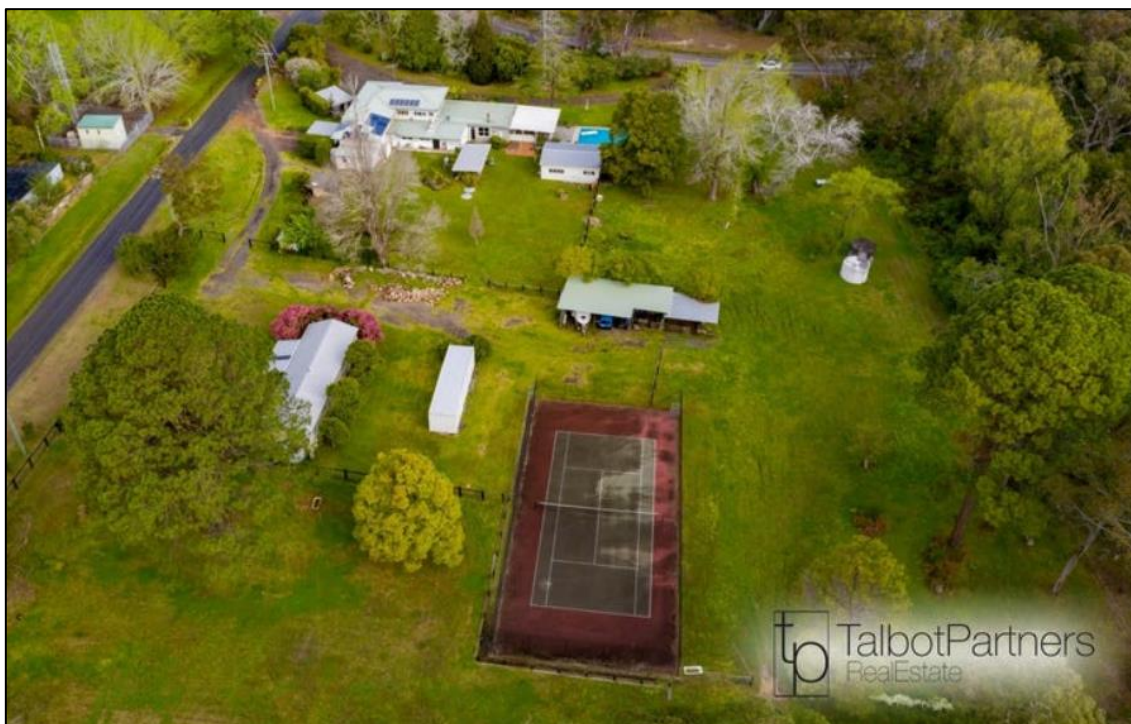
Figure 3 below shows the site layout of the southern half of the site, prior to the demolition of site structures, obtained from a real estate advertisement

Figure 3: Site layout prior to demolition of structures (source: TalbotPartners RealEstate).

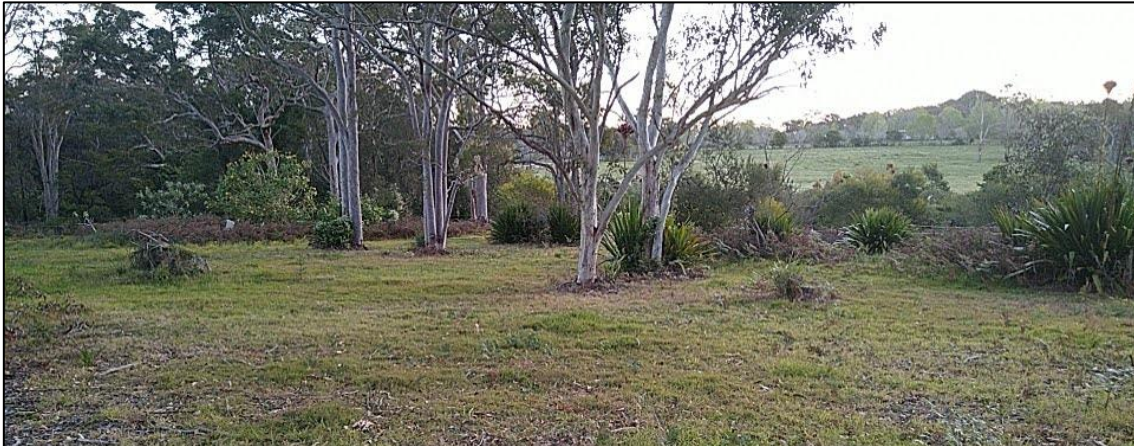
The northern half of the site was generally grass covered with scattered trees (Figure 4). A tributary of Calverts Creek intercepted the northern third of the site and was observed to be dry at the time of the walkover (Figure 5).

Figure 4: General site photograph of the northern portion of the site.

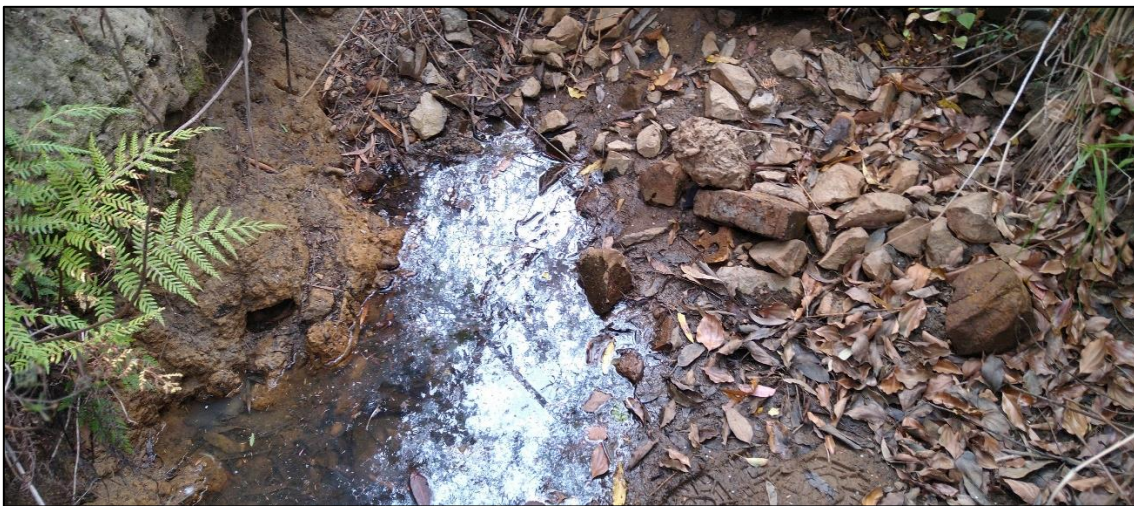
Figure 5: Intermittent tributary / creek line within the northern third of the site.

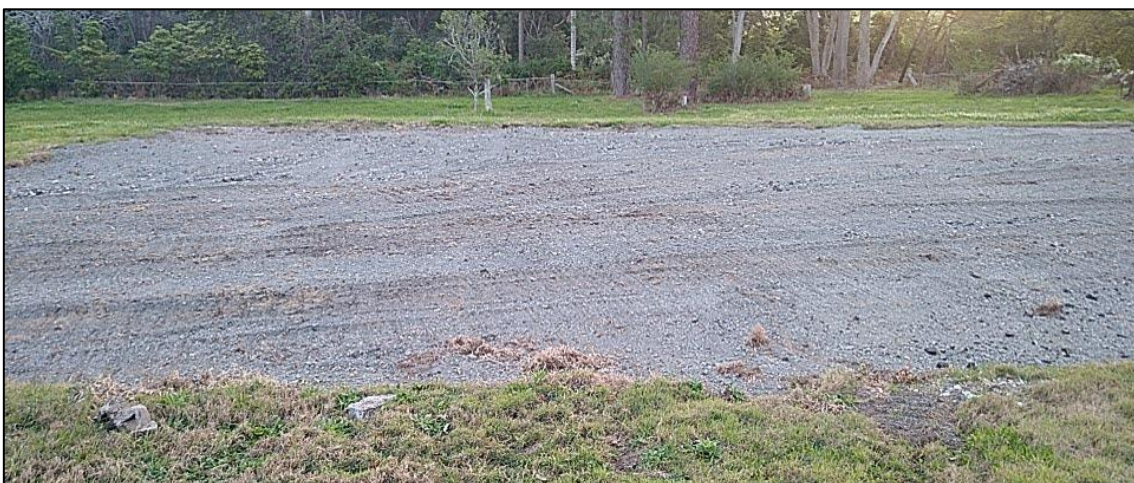
The southern half of the site comprised areas of suspected fill (or ground disturbance) and some grass cover. The surface of the former tennis court had been filled with a sandy gravel comprising asphalt and basalt (Figure 6), and fill was observed in the locality of the former structures (Figure 7). Fragments of potential asbestos containing material (ACM) were observed on the ground surface in the locality of the former structures (Figure 8), and oyster shells were observed in the fill and at the ground surface (Figure 9) in several isolated areas in the central portion of the southern half of the site (refer to approximate area outlined in a purple dotted line on Drawing 1, Appendix A).

Figure 6: Former tennis court filled with a sandy gravel.

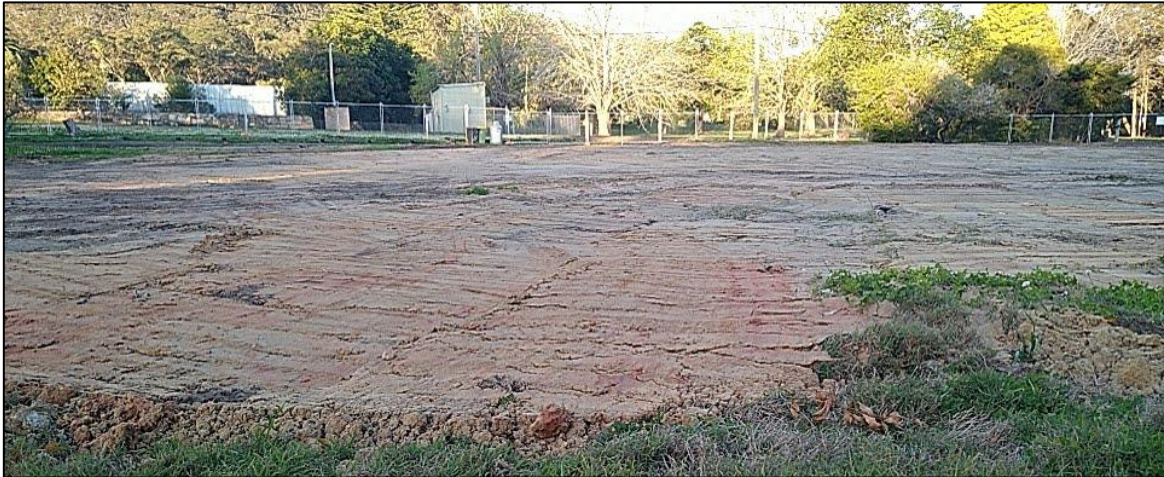
Figure 7: Fill observed in the locality of the former structures. Photo taken 6 September 2021.

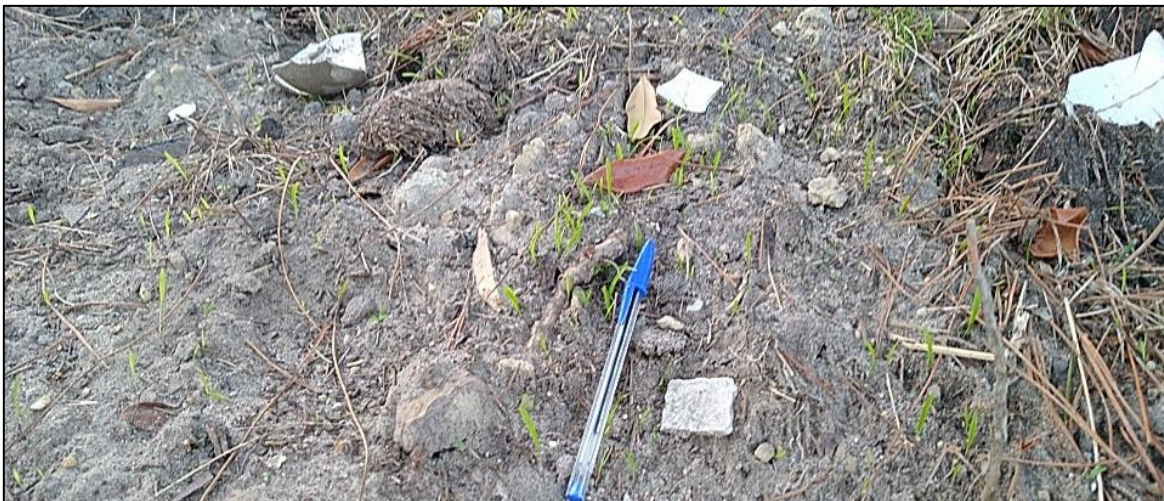
Figure 8: Fragments of potential asbestos containing material observed on the ground surface.

- The following results were obtained for asbestos:
 - o Chrysotile asbestos was detected in fibre cement material > 7mm in sample 131/0.1, but the concentrations of FA and AF were below the PQL. DP notes that the SAC states that there should be no visible asbestos in surface soils. Given that asbestos was detected in fibre cement material > 7mm at location 131/0.1, the result is considered to be an exceedance of the health-based SAC.
 - o No asbestos was detected in all other soil samples tested for asbestos, and the concentrations of FA and AF were below the PQL and SAC.

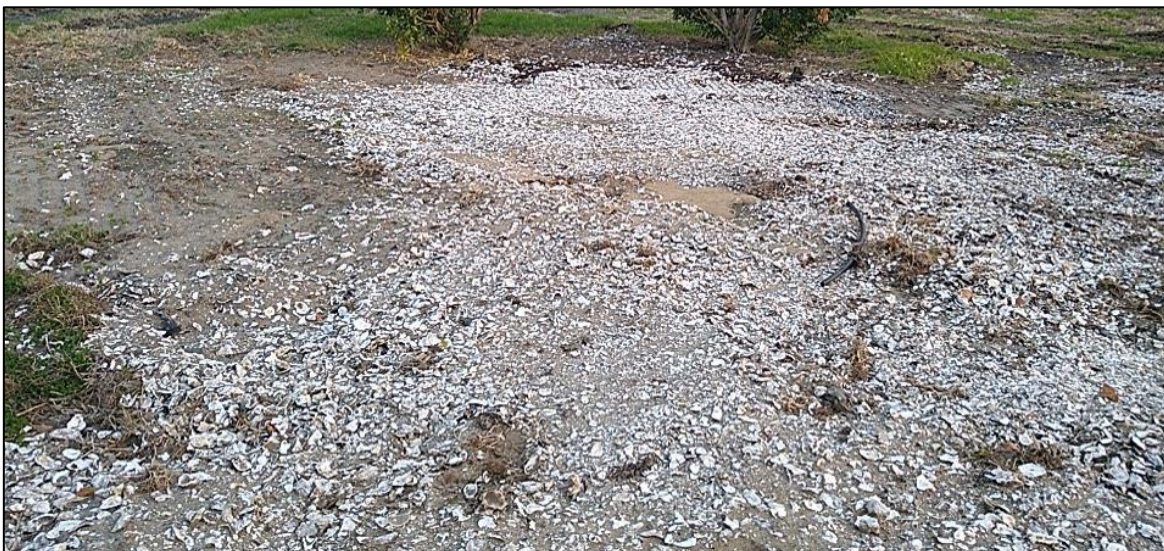
Figure 9: Oyster shells observed on the ground surface.

DP notes that asphalt and oyster shell fragments were observed in the fill at Bores 128 and 129. However, based on the results of sub-sampling/re-testing of observed inclusions and correspondence with a laboratory analyst from the primary laboratory, Envirolab Services, the likely source of PAH in samples 128/0.1 and 129/0.65 was considered to be carbonaceous material (i.e. ash, charcoal or residual material from fires) observed in the fill (see Figure 10 below). Furthermore, the laboratory analyst suggested that the PAH from this source may be relatively immobile (i.e. low leaching potential and low bioavailability) through the sub-surface, which could be confirmed with further investigation and laboratory testing. DP considers the concentration of TRH F3 fraction at location 128/0.1 may also be associated with the carbonaceous material.

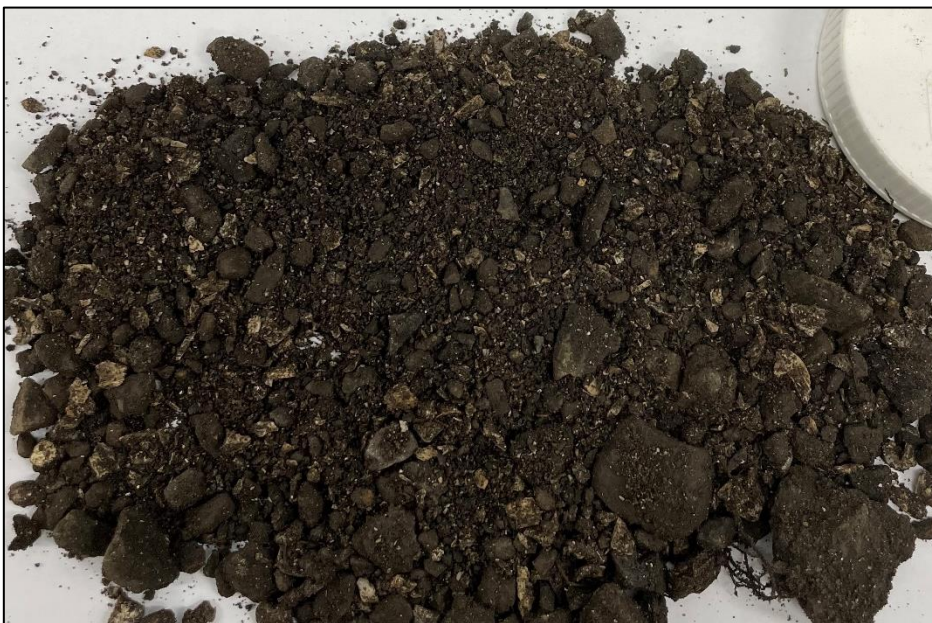
Figure 10: Carbonaceous (i.e. ash, charcoal or residual material from fires) material observed in Sample 128/0.1

DP notes the exceedances of the health-based SAC were in the general locality of the ground disturbance / possible filling activities observed in the 1991 historical aerial (refer to Drawing 1, Appendix A). Based on correspondence with the laboratory, the likely source of PAH (and TRH) in samples 128/0.1 and 129/0.65 was considered to be carbonaceous (i.e. ash, charcoal or residual material from fires) material observed in the fill.

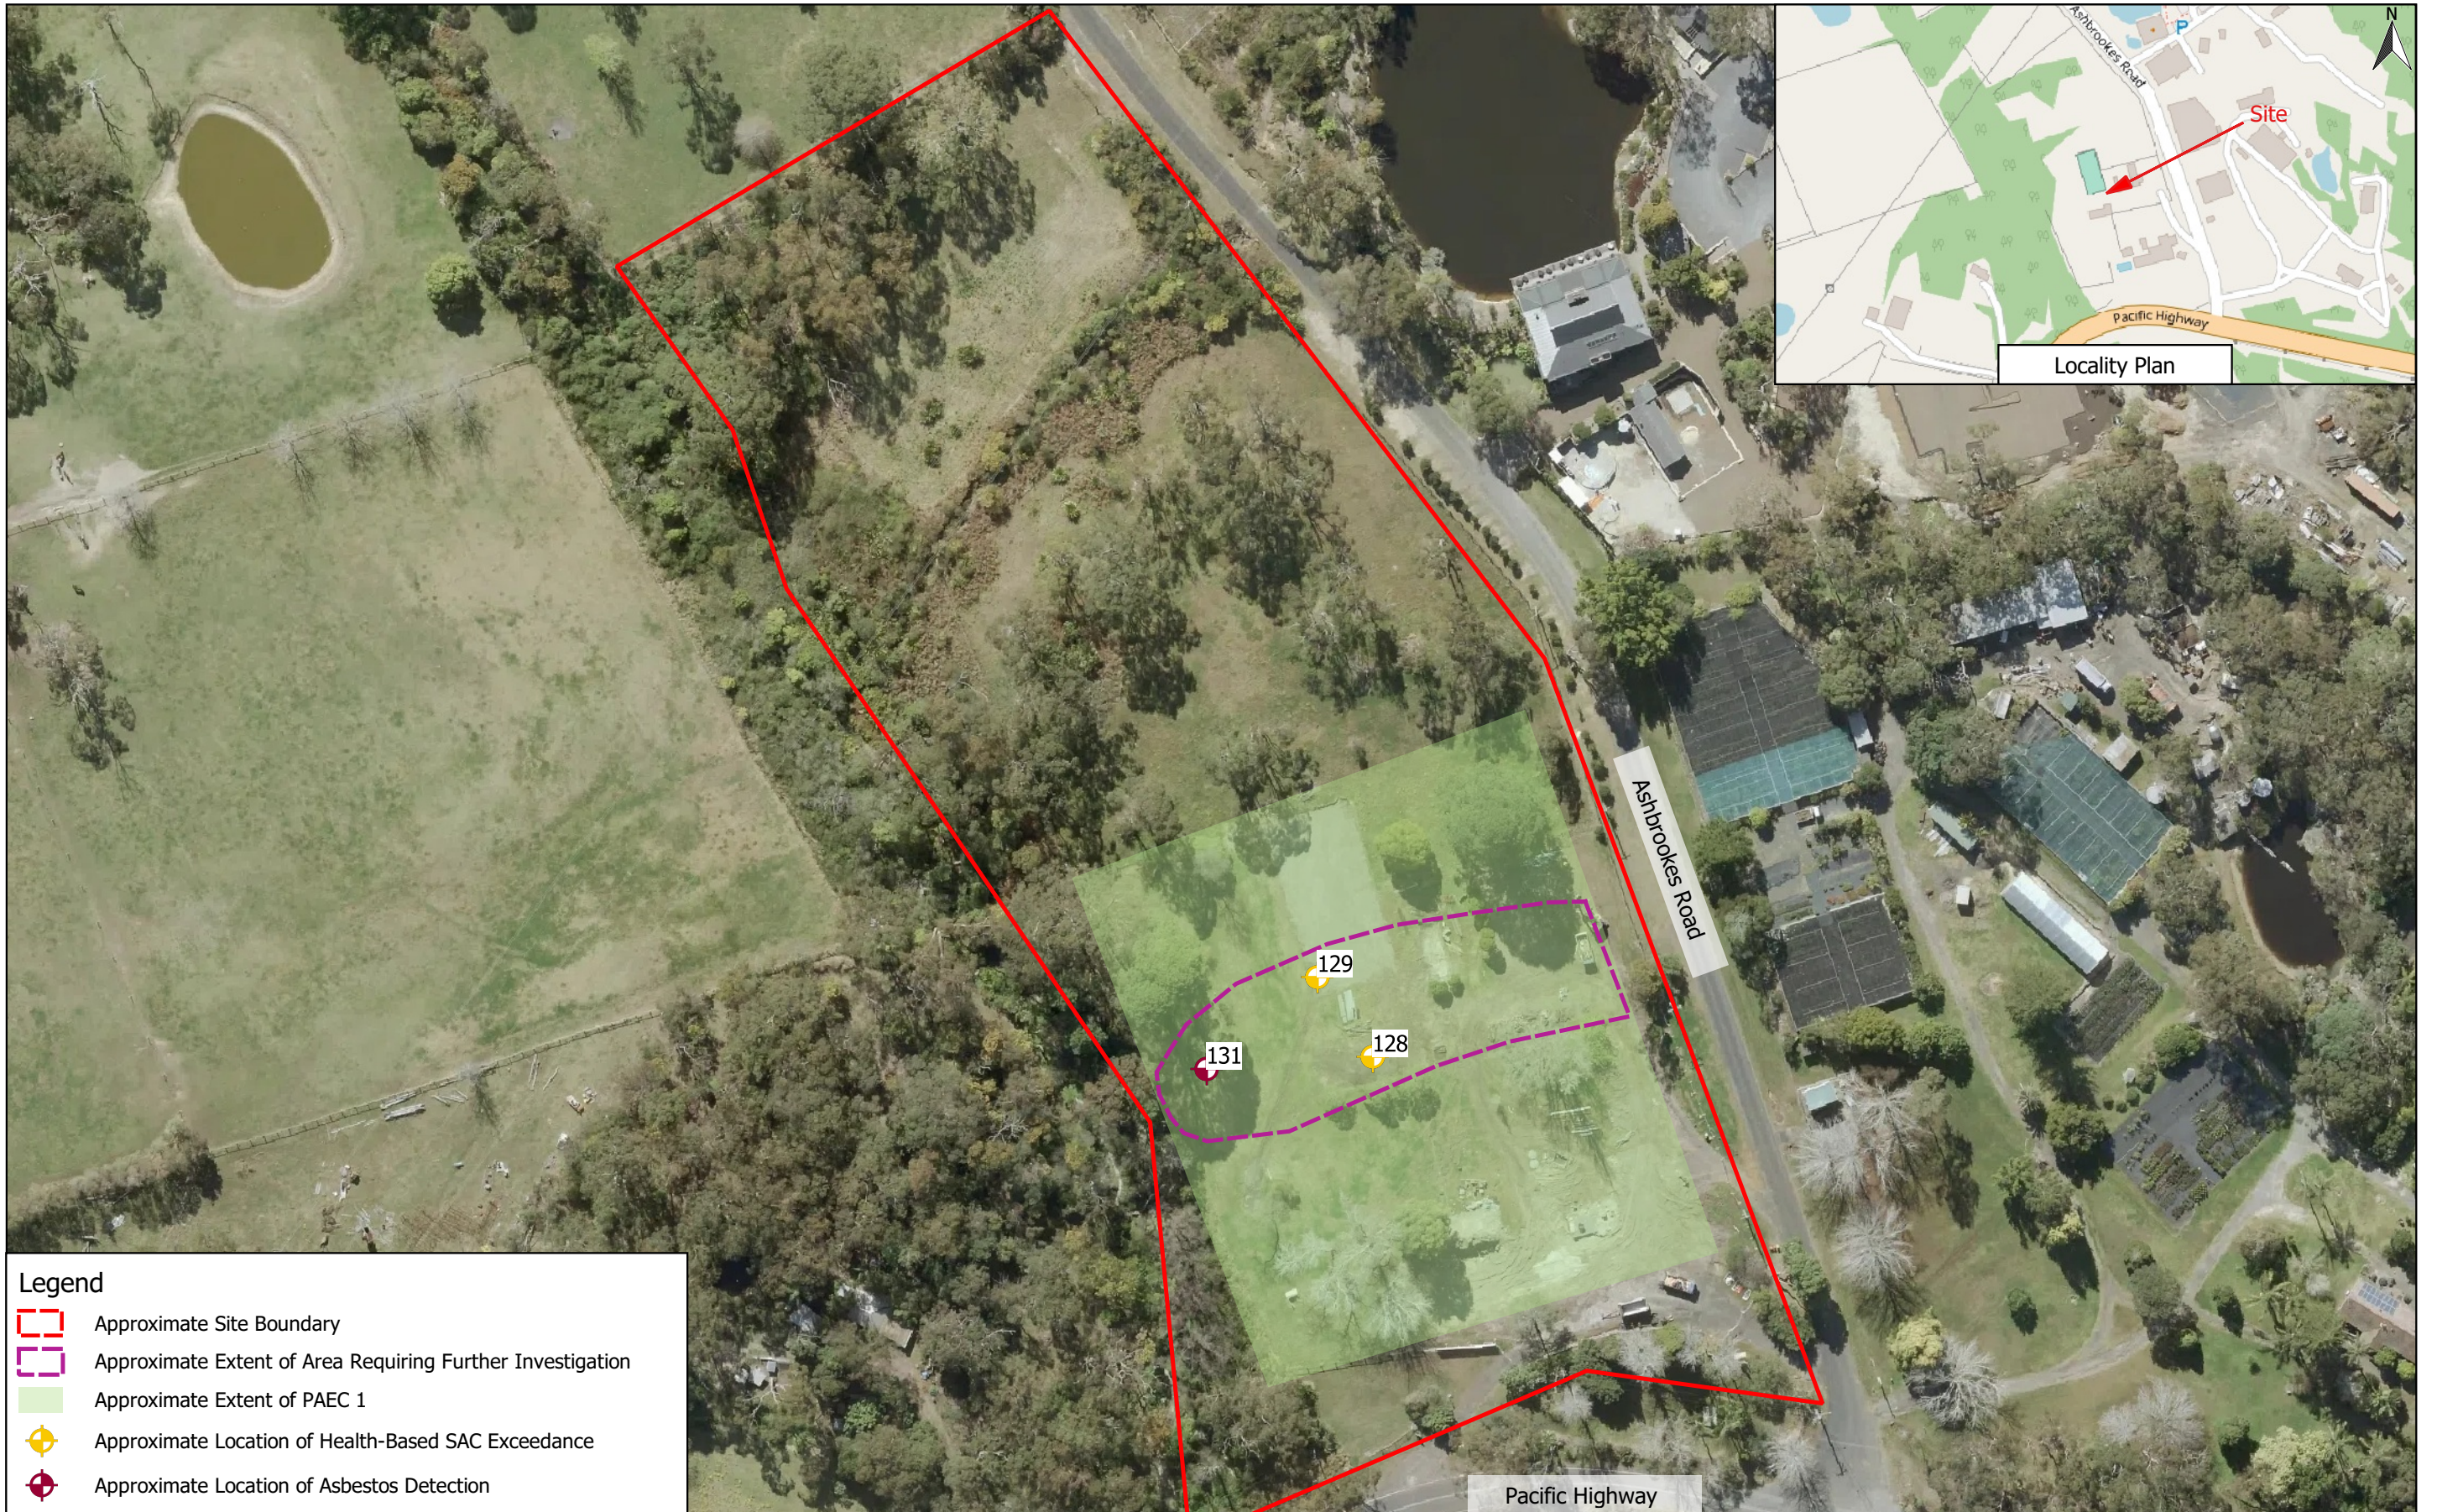
- Approximate Site Boundary
- Approximate Extent of Area Requiring Further Investigation
- Approximate Extent of PAEC 1
- ◆ Approximate Location of Health-Based SAC Exceedance
- ◆ Approximate Location of Asbestos Detection

- **PAEC 1:** Supplementary investigations to further characterise and delineation of the extent of contamination at the locations identified on Drawing 2, Appendix A. Based on current concept plans (see Appendix A), it appears that the area requiring further investigation is located in an area proposed for open space (i.e. exposed ground surface). The results could then be used to develop a remediation action plan (RAP) or environmental management plan (EMP) for the site. On this basis, as part of the future delineation scope of works, DP recommends undertaking the following additional field / laboratory testing, with a view of retaining contaminated material on site:

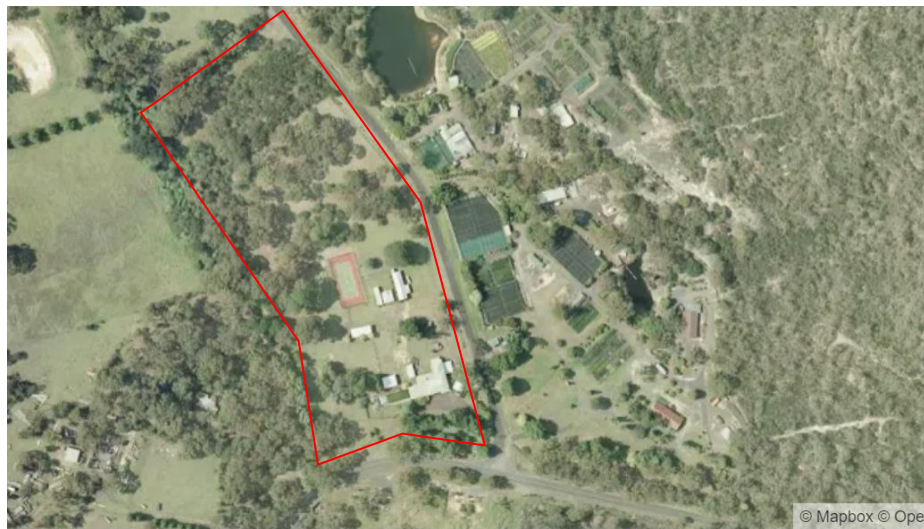
Photo 8 – Historical aerial photograph - 2007

2007	<p><u>Northern half</u></p> <ul style="list-style-type: none"> Appears much the same as in 2002. <p><u>Southern half</u></p> <ul style="list-style-type: none"> The large rectangular ground disturbance noted in the 2002 aerial image is observed to be a tennis court; The remainder of the area appears much the same as in 2002. 	<ul style="list-style-type: none"> The surrounding land use appears much the same as in 2002.
2014	<ul style="list-style-type: none"> The site layout is generally consistent with the layout shown in the survey plan (see Appendix A) and in Figure 3 below. <p><u>Northern half</u></p> <ul style="list-style-type: none"> The area has been subject to some vegetation clearing. 	<ul style="list-style-type: none"> The surrounding land use appears much the same as in 2007.
