Report on
Preliminary Site Investigation for Contamination

Proposed Rezoning for Residential Development
15 Mulloway Road, Chain Valley Bay

Project 83024.00
August 2016

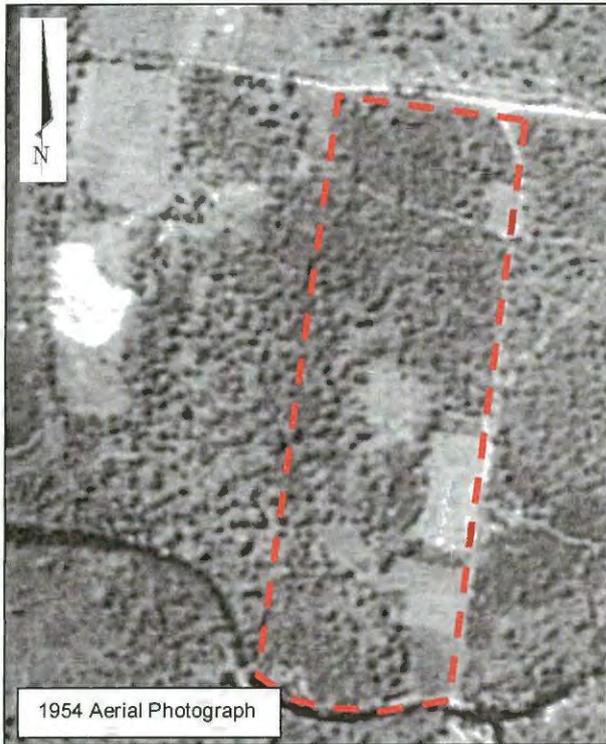
1954 Aerial Photograph

Year	Site	Surrounding Land Use
1954	The site appears to be generally vegetated with bushland, except for an access track extending from Mulloway Road south and linking four probably grass surfaced paddocks that match the approximate location of the existing open grassed surfaced areas at the site.	Surrounding areas appear to comprise mostly bushland with some areas cleared and appear to have a grass surface cover. No intensive rural activities (i.e. orchards, market gardens or poultry) were identified on the adjacent properties.
1975	The site generally appears to be in a similar condition to the 1954 photograph. Major changes appear to comprise construction of the existing residence, detached shed and access driveway in the northern portion of the site, and the existing dam located centrally along the western site boundary.	Surrounding areas appear generally partially cleared and in-part under development for probably residential uses. No specific rural uses were identified on nearby properties.
