FINAL REPORT:

The Hawkesbury-Nepean River System Estuary Bank Erosion
Assessment and Options Report

December 2022

Hawkesbury-Nepean River System (HNRS) Coastal Management
Program (CMP) – Stage 2

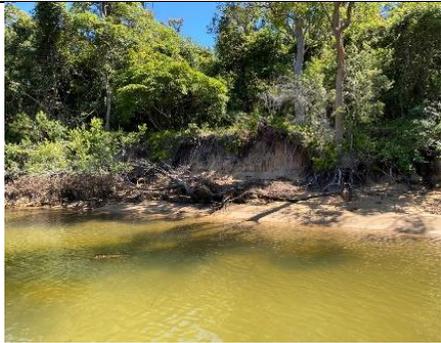
Site category	Key characteristics	Example	Priority sites	<i>Low/Very low risk sites with similar attribute</i>
1. Estuarine inlets - Natural	<ul style="list-style-type: none"> • Natural estuarine inlet • Native vegetation in good condition • Land use primarily conservation/recreation • Steep upper erosion scarp with intertidal beach

<ul style="list-style-type: none"> • CCC13g – ‘Patonga Creek’ <i>(example photo)</i> 	<ul style="list-style-type: none"> • CCC13f

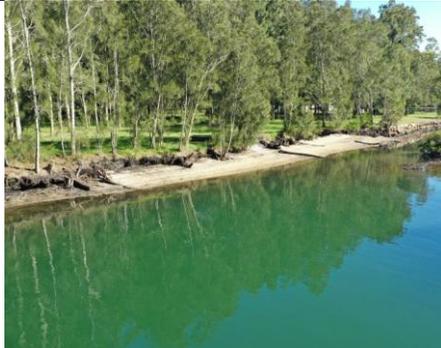
2. Estuarine inlets - Artificial	<ul style="list-style-type: none"> • Artificially created estuarine inlet • Land use – public recreation • Public access and safety/amenity impacts • Moderate to wide intertidal bench with mangroves present or nearby • Low bank height with some setback available

<ul style="list-style-type: none"> • NBC9 – ‘Cicada Glen Creek’ <i>(example photo)</i> • NBC10b – ‘McCarrs Creek’ 	<ul style="list-style-type: none"> • NBC10a • CCC13d*

2. Estuarine inlets – Artificial	NBC9 – ‘Cicada Glen Creek’ <i>(example photo)</i> NBC10b – ‘McCarrs Creek’	Armour banks – Install logs, geobags or rock in front of near vertical escarpment, maintain existing beach. Formalise access. <i>Concrete reef habitats can be incorporated</i>	Bench protection with rock fillets infill to height for mangrove establishment if required (incorporate a BESE-Elements grid (biodegradable 3-D grid structure) to encourage deposition of sediments and seeds and provide some protection to saplings). <i>Concrete reef habitats can be incorporated</i>	Large wood installation -toe protection and backfill material. Large log (or geobag) installations just above high tide level and then back fill to gentle slope install coir matting and revegetate. Formalise access. <i>Concrete reef habitats can be incorporated</i>	Coir logs and revegetation of overbank. Formalise access <i>Concrete reef habitats can be incorporated</i>	Do nothing/monitor

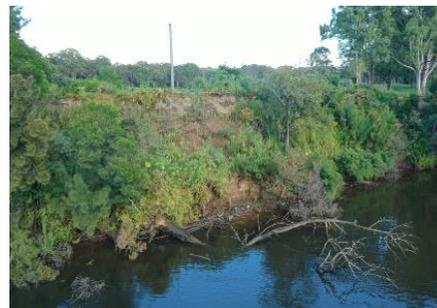
- Mid-upper estuary
- Impacted by estuarine and riverine processes
- Steep and high banks (>3m in height)
- Limited/no setback available
- Narrow or no intertidal bench
- Public access and safety/amenity impacts

- HCC24 – 'The Terrace, Windsor'
- HCC25b- 'Argyle Bailey Reserve' (*example photo*)
- HCC26- 'Churchills Wharf'
- HSC34

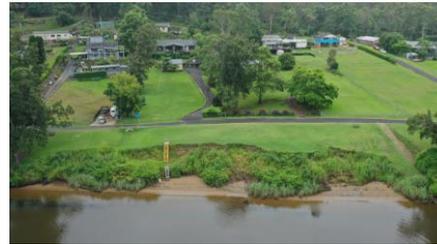
- Mid-upper estuary
- Impacted by estuarine and riverine processes
- Low to moderate bank height (<3m)
- Some setback available
- Public access and safety/amenity impacts
- Intertidal bench

- HCC27 a- 'Holmes Drive Reserve'
- HCC27b- 'Holmes Drive Reserve' (*example photo*)

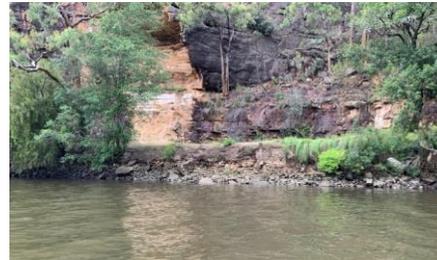
- Mid-upper estuary
- Impacted by estuarine and riverine processes
- Limited/no setback available
- Road/asset immediately adjacent
- Existing protection there in varying types and conditions

- HSC30
- CCC16d- 'Gunderman S'
- HSC38a
- HSC41- (*example photo*)
- HSC42
- HSC35
- HSC37
- HSC38b
- HSC38c
- HSC43
- HSC44

7. Mid/upper estuary - Existing protection	CCC16d- 'Gunderman S' HSC38a HSC41 HSC42	These sites contain a variable types, extents and conditions of existing protection. For example, there are sections of newly constructed rock or gabion basket protection that will require no additional work, Sections of old rock revetment in variable condition that may require structural assessment and redesigns or infill/top up of existing material. There is insufficient information to develop and assess discrete options that account for the variability in conditions across the sites. It is recommended more detailed investigations are undertaken including geotechnical design/condition assessment, and survey including bathymetry to develop and assess appropriate management options at each site. However, given the proximity to road infrastructure options are likely going to be limited to hard engineering approaches such as rock revetment.

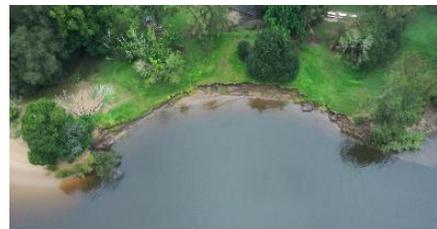
- Mid estuary
- Mangroves present
- Low bank height
- Some setback available
- Public access and safety/amenity impacts
- Intertidal bench

- HSC45b
- CCC16b
- HOR18c

8. Mid estuary - Low-moderate banks, setback available, mangroves nearby	HSC45b	Armour banks – Install logs, geobags or rock in front of near vertical escarpment, maintain existing beach. Formalize access. <i>Concrete reef habitats can be incorporated</i>	Bench protection with rock fillets infill to height for mangrove establishment if required (incorporate a BESE-Elements grid (biodegradable 3-D grid structure) to encourage deposition of sediments and seeds and provide some protection to saplings). <i>Concrete reef habitats can be incorporated</i>	Large wood installation -toe protection and backfill material. Large log (or geobag) installations just above high tide level and then back fill to gentle slope install coir matting and revegetate. Formalise access. <i>Concrete reef habitats can be incorporated</i>	Coir logs and revegetation of overbank. Formalise access. <i>Concrete reef habitats can be incorporated</i>	Do nothing/monitor (natural replenishment) <i>*Note imagery analysis suggests there may have been significant natural replenishment observed since the 2022 flood events. The site sits on inside bend and would typically be an area of deposition rather than erosion. An ongoing monitoring and a 'do nothing' approach could also be warranted.</i>

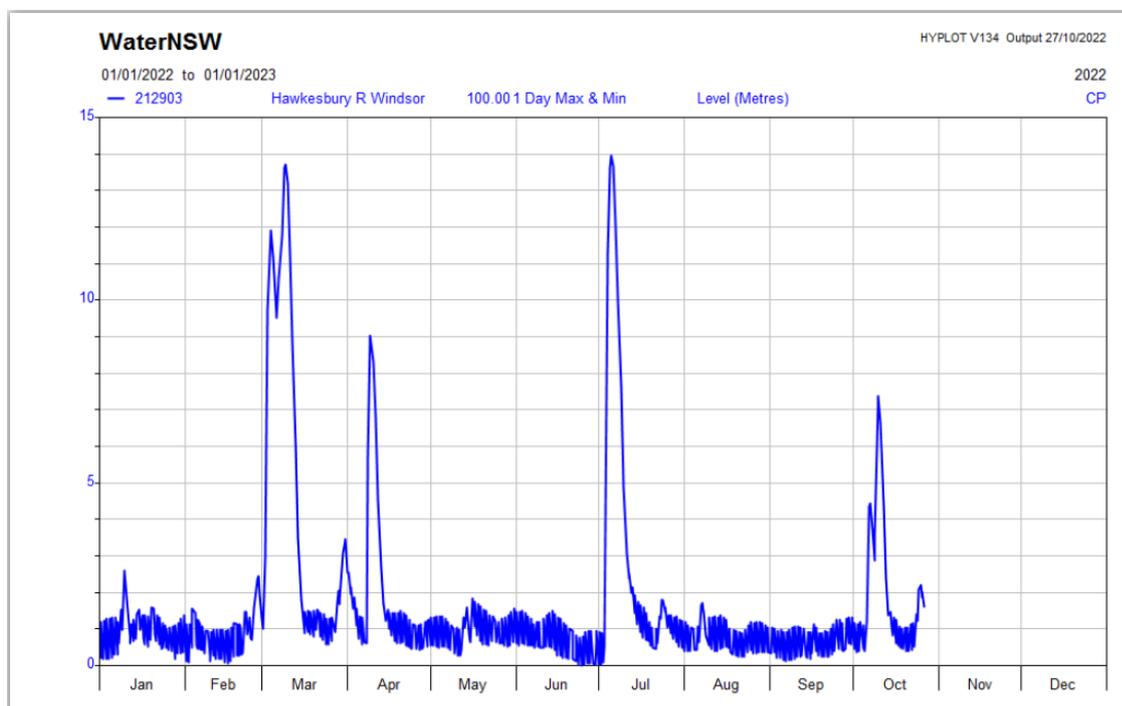
Figure 29. Hydrograph of the water levels at the WaterNSW Windsor gauge (ID 212903) for the calendar year 2022.

During the development of this study, and following the on-site data collection, the Hawkesbury Nepean River experienced two major floods (March 2022, July 2022) and a prolonged period of wet conditions in the catchment which dramatically impacted on local communities and considerably altered the extent, distribution, and severity of erosion along the Hawkesbury River. A hydrograph of the water levels at the WaterNSW Windsor gauge (ID 212903) for the calendar year 2022 is provided in Figure 29.

In response, on 8 September 2022, Alluvium undertook post-flood assessments of the identified priority sites in the Upper Hawkesbury LGAs (Hawkesbury City Council and The Hills Shire Council) totalling ten sites altogether. It was determined by the other Partner Councils that the priority sites in their LGAs did not warrant a full re-assessment due to the lessened impact of flood waters on erosion at these sites. The objective of the re-assessment was to determine the impact of the major floods on the sites and to determine if the assessments completed in this study were still appropriate. For these priority sites, the option summary in Attachment E describes the impact of the floods on the site and provides an updated assessment of recommended or required works. A flood impact summary has been developed and is provided in Attachment F. For some of these sites, an accelerated timeline of works is justified by the severity of the erosion and the immediate threat to assets and public safety, thus requiring council to seek alternative pathways for securing funding outside of the CMP framework. The information provided in the options summaries for these sites can support council's application and scoping of these works.
