Re: Habitat Corridor Functional Analysis at 15 Mulloway Road, Chain Valley Bay

Attachment 1 – Functional Corridor Analysis

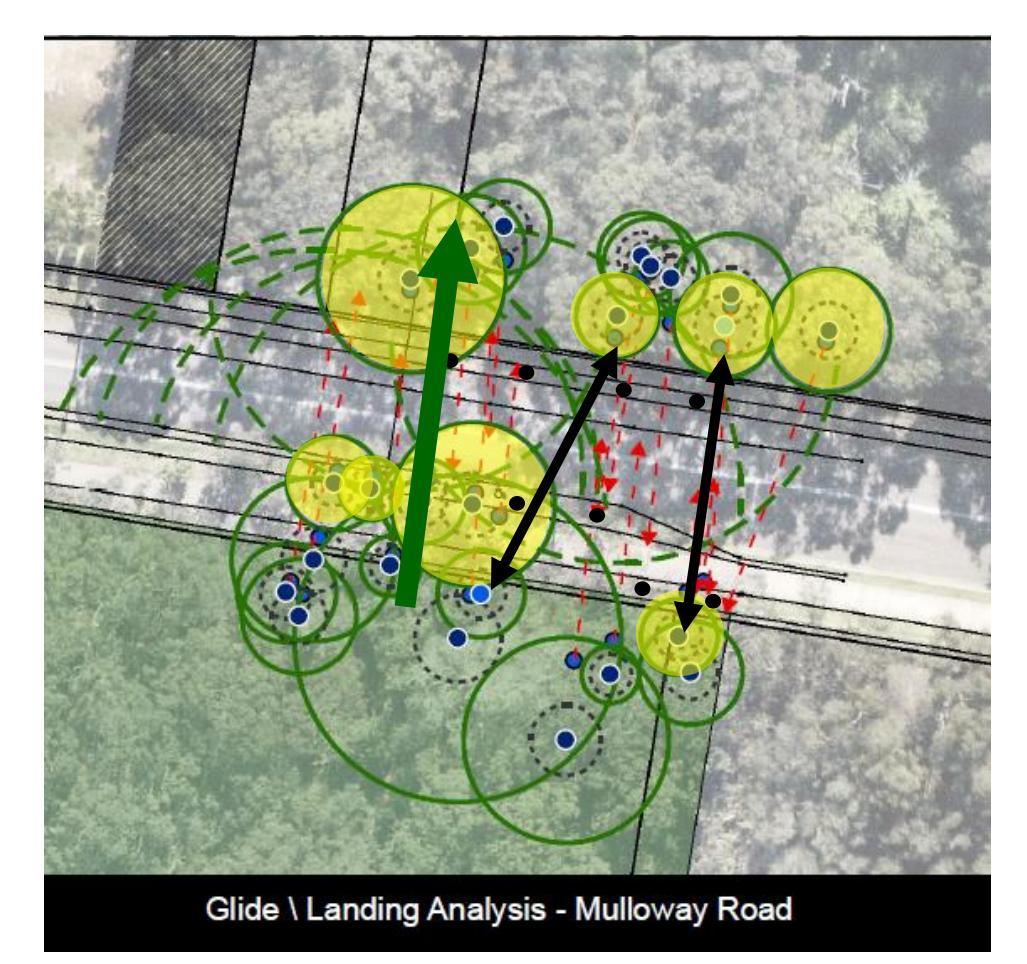
- In the Mulloway Road reserve *Travers bushfire & ecology* recommend:
 - a) The planting of tall fast-growing foraging tree species that would grow tall in the next 10-20 years.
 - b) In the short term a minimum of four glider poles (eight options provided), two on the southern side of Mulloway Road and two on the northern side of Mulloway Road be installed preferably to the east of the existing melaleuca trees.
 - c) That both sides of the road reserve are planted with Melaleucas such as the existing shrubbery for protection to potential gliders moving through the site.

This clearly indicates is that the connectivity across Mulloway Road is tenuous and marginal. To ensure that this connectivity maintains and retains the functionality it would be necessary to ensure that trees are present in either side of the pavement of Mulloway Road that allow gliders to climb to a suitable height and glide across the road corridor. Consequently, glider poles are recommended to be installed and planting of additional rapid growing tall trees on either side of Mulloway Road with the permission of the adjoining landholders which is believed to be National Parks and Wildlife Services. These measures will allow the effective width of the corridor connection across Mulloway Road to increase from 20 to 40m.

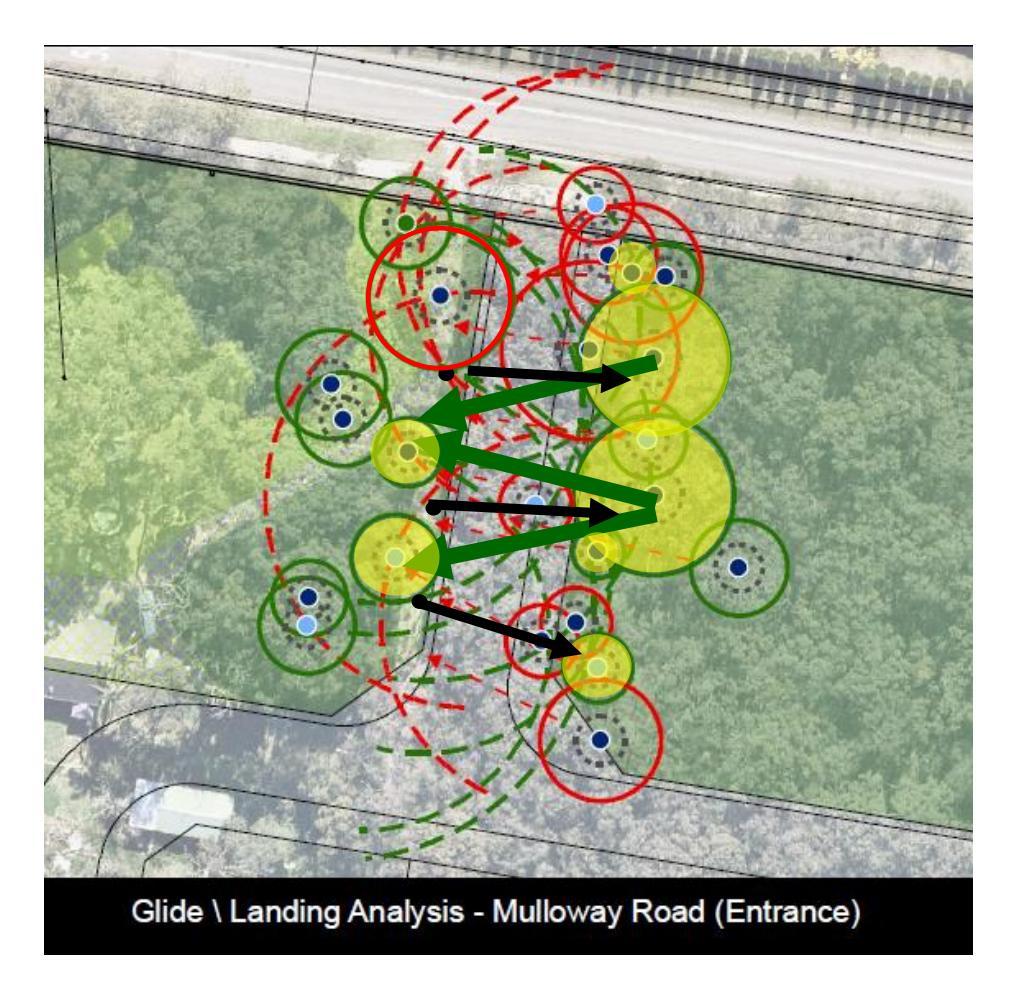
In regards, to the entrance to the site off Mulloway Road, *Travers bushfire & ecology* recommends terrestrial culverts be included beneath the road as part of the subdivision design works. We recommend 2-3 gilder poles are installed at the Mulloway entrance road on the western side to facilitate glider movement from west to east. Planting of Tall growing trees would assist connectivity in the long term. The road corridor, services and pathway may be able to be moved to the west or east to enhance tree retention. The main entrance may require more detailed investigation at subdivision stage.

The second point of glider connectivity analysis is the main entrance into the proposed residential subdivision. The glider connectivity analysis shows once the trees impacted as a result of the proposed future entry road, are considered, connectivity is disrupted from east to west. An option to shift the road corridor is shifted slightly to the west was considered, to conserve selected trees then connectivity is maintained in both direction without the need for Glider poles. However we have confirmed that this slight shift is not supportable to meet current road design requirements. Consequently we advise that the road entrance either remains with additional pole installation or the road is entrance is moved to the west or east to identify another location that results in better arboreal/glider connectivity.

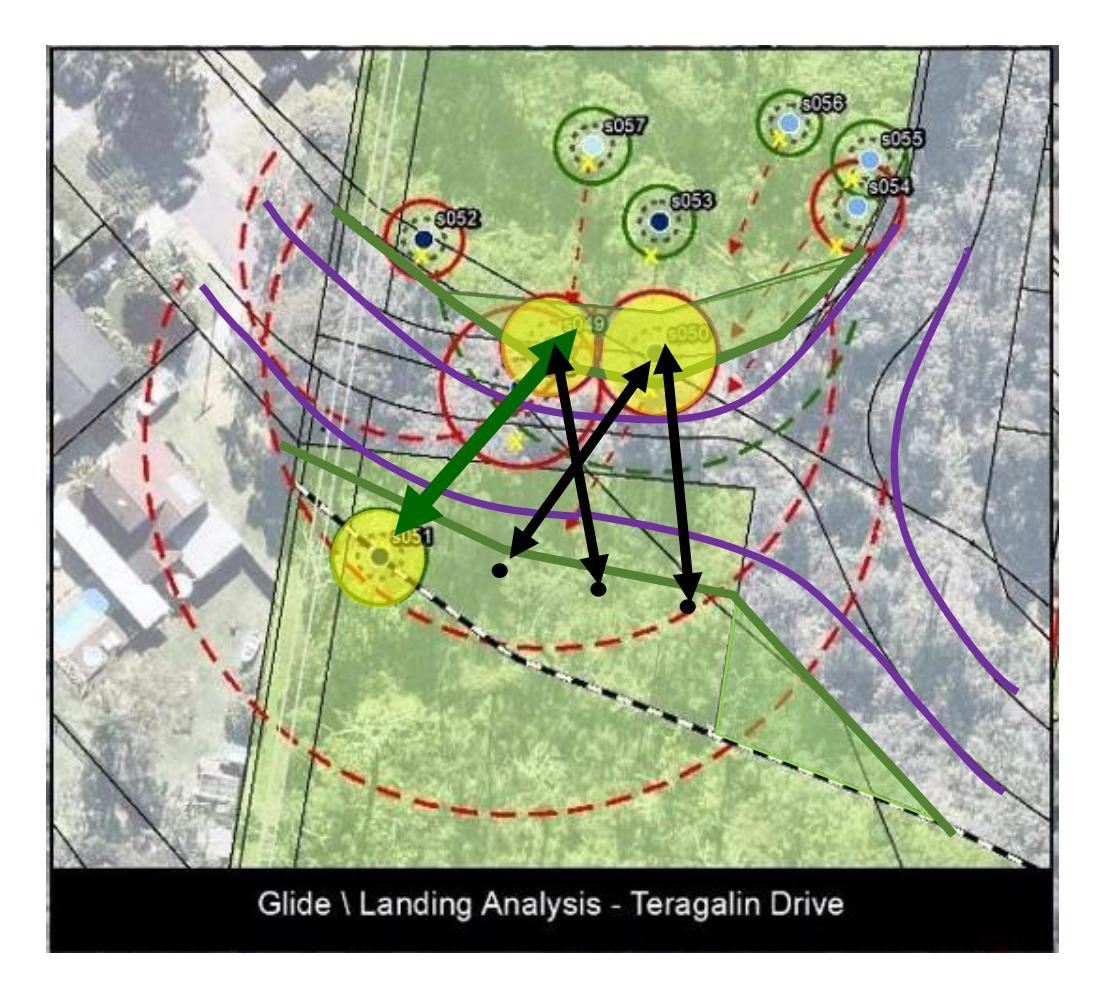
For the Teraglin Drive access road *Travers bushfire & ecology* recommend the installation of a minimum of 2 glider poles to the south of the pavement, together with the installation of culverts under the road to facilitate the movement of wildlife to the north and south without crossing the pavement. Additionally, enhancement of the corridor in this location by planting of fast-growing tall tree species and the road alignment adjusted to retain the identified trees.

The remaining aspect of the functional connectivity analysis is at the southern end of the proposed corridor in the vicinity of Teragalin Drive. The analysis shows that the glider connectivity to the south of the corridor is tenuous, because the existing water main and access roadworks have already cleared significant trees from this locality which would otherwise be present under natural circumstances. There are two or three pre-existing trees present in the proposed road that crosses the corridor to access the development that provide potential glider connectivity. As the proposed road will remove these trees and the road connection in this location is essential, measures to maintain a functional corridor will need to include modification of the road alignment and pavement position, the planting of additional tall growing trees and installation of telephone poles.

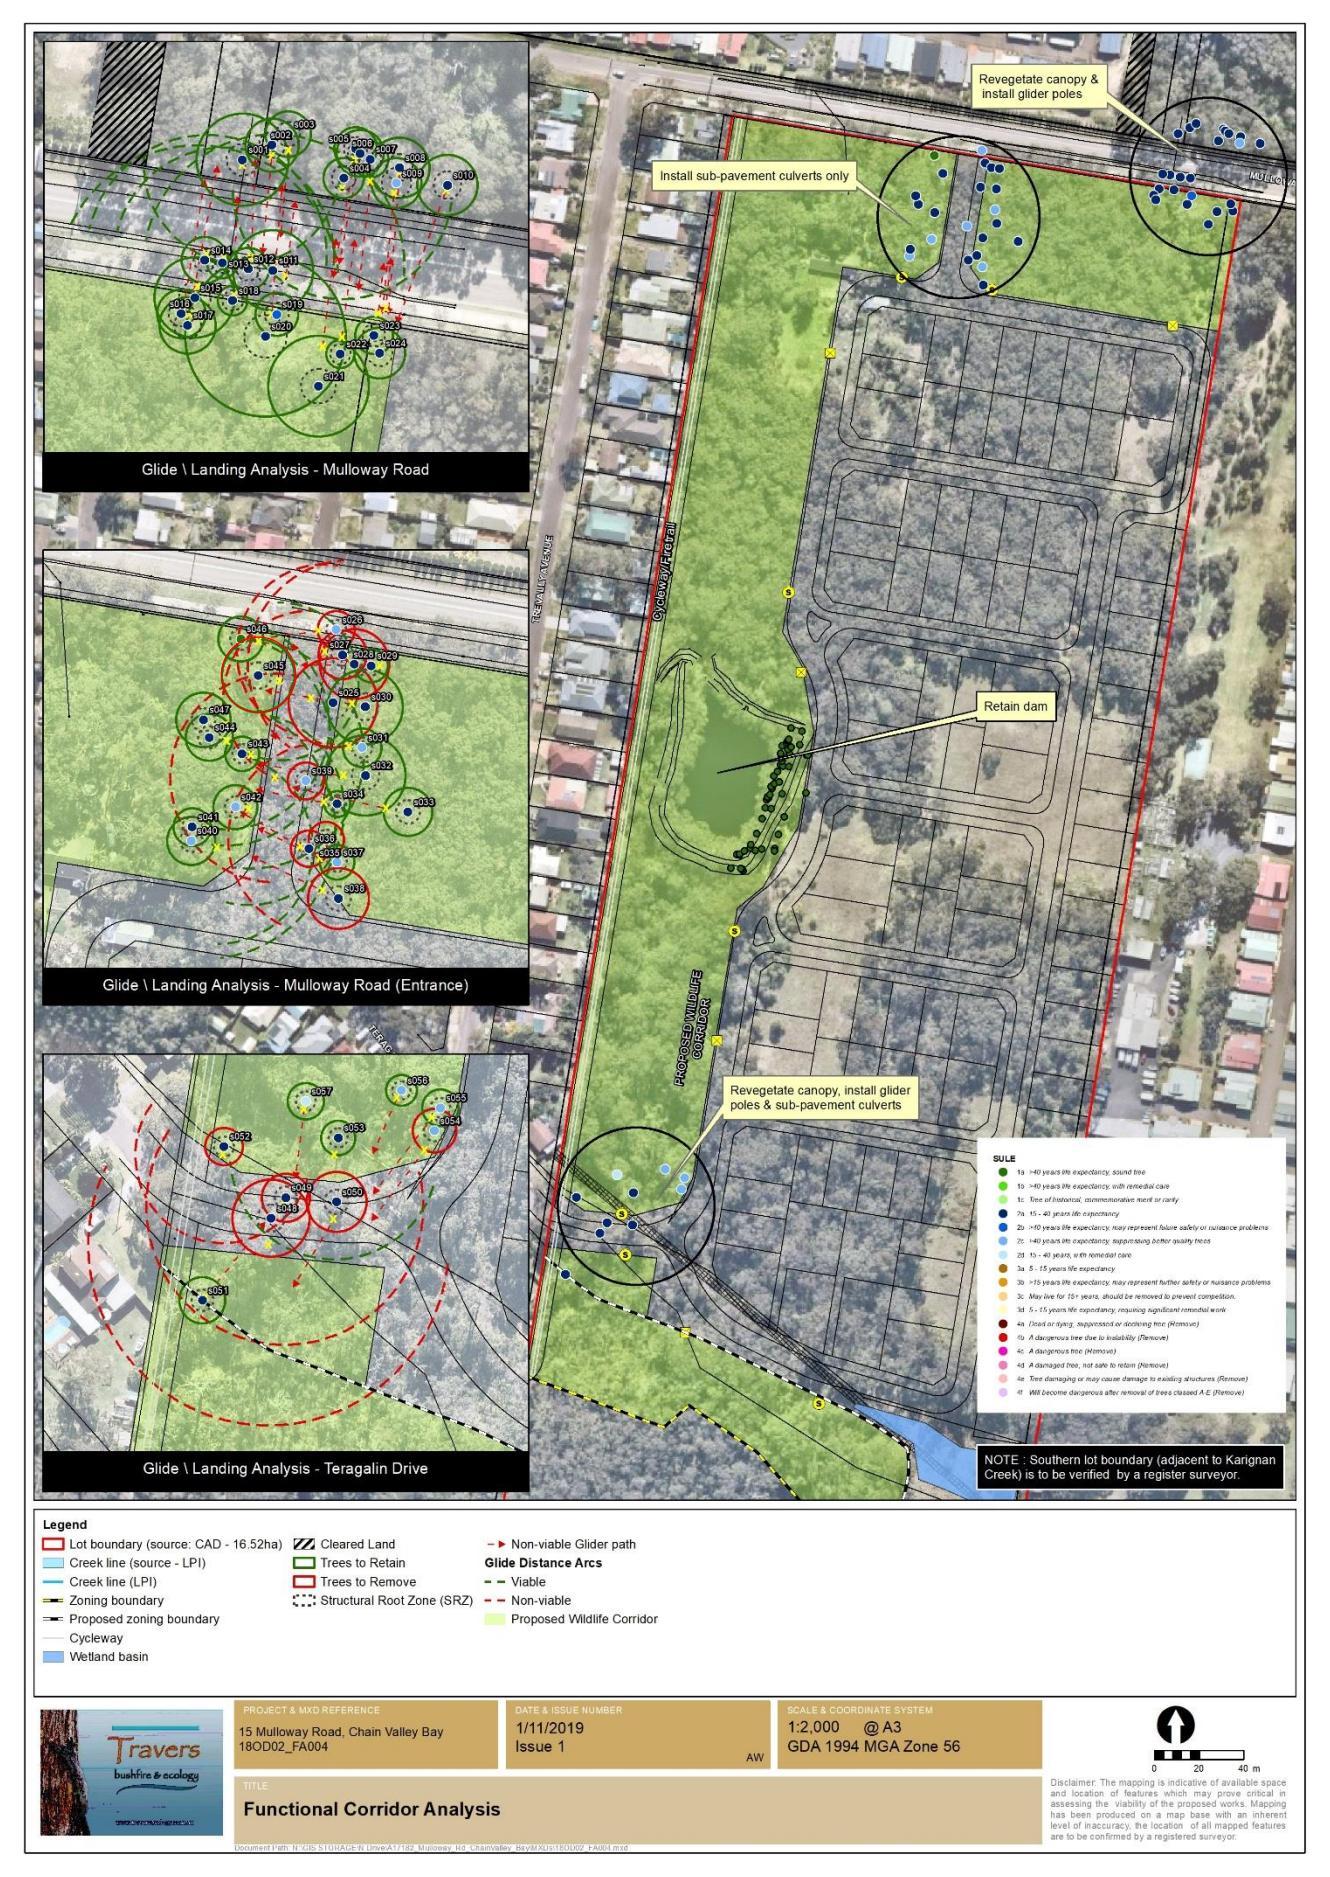
Attachment 1 – Functional Corridor Analysis

Fauna ecologist Mr Corey Mead has undertaken an assessment of the glide distances and angles from existing launch points, on trees immediately adjoining and within 15 to 20 metres of Mulloway Road, the proposed entrance to the site and to the proposed extension to Teraglin Drive on the southern end of the site. The results of this glider connectivity is shown on the attached figure (figure 1) and this identifies the following outcomes.

This is demonstrated by the green arcs and green dashed arcs (Figure 1). The green dashed arcs indicates where gliders can effectively reach based on the physical gliding capability known for squirrel gliders. I note that only trees of good condition have been considered and the assessment has excluded poor condition trees that may be removed or fall. The green and red arcs indicate to which side of the road corridor that gliding is currently feasible. The red arcs demonstrate the impact on glide distance as a result of the proposed roads based on the trees to be removed effectively resulting in the loss of gliding capability.

Mulloway Road is the existing main road providing access to the main urban zoned area of Chain Valley Bay at the northern boundary of the site and the analysis has identified that the glider connectivity across Mulloway Road whilst currently physically possible, is somewhat tenuous in mostly a northern direction. The connectivity at this location relies on the presence of four Melaleuca trees that have been retained along the pathway within the road reserve. Without these four Melaleuca trees arboreal connection across Mulloway Road will effectively be severed.
