KARIONG OVAL RECREATION AREA

DRAFT CONCEPT | DESIGN WORKSHOP
MAY 2021

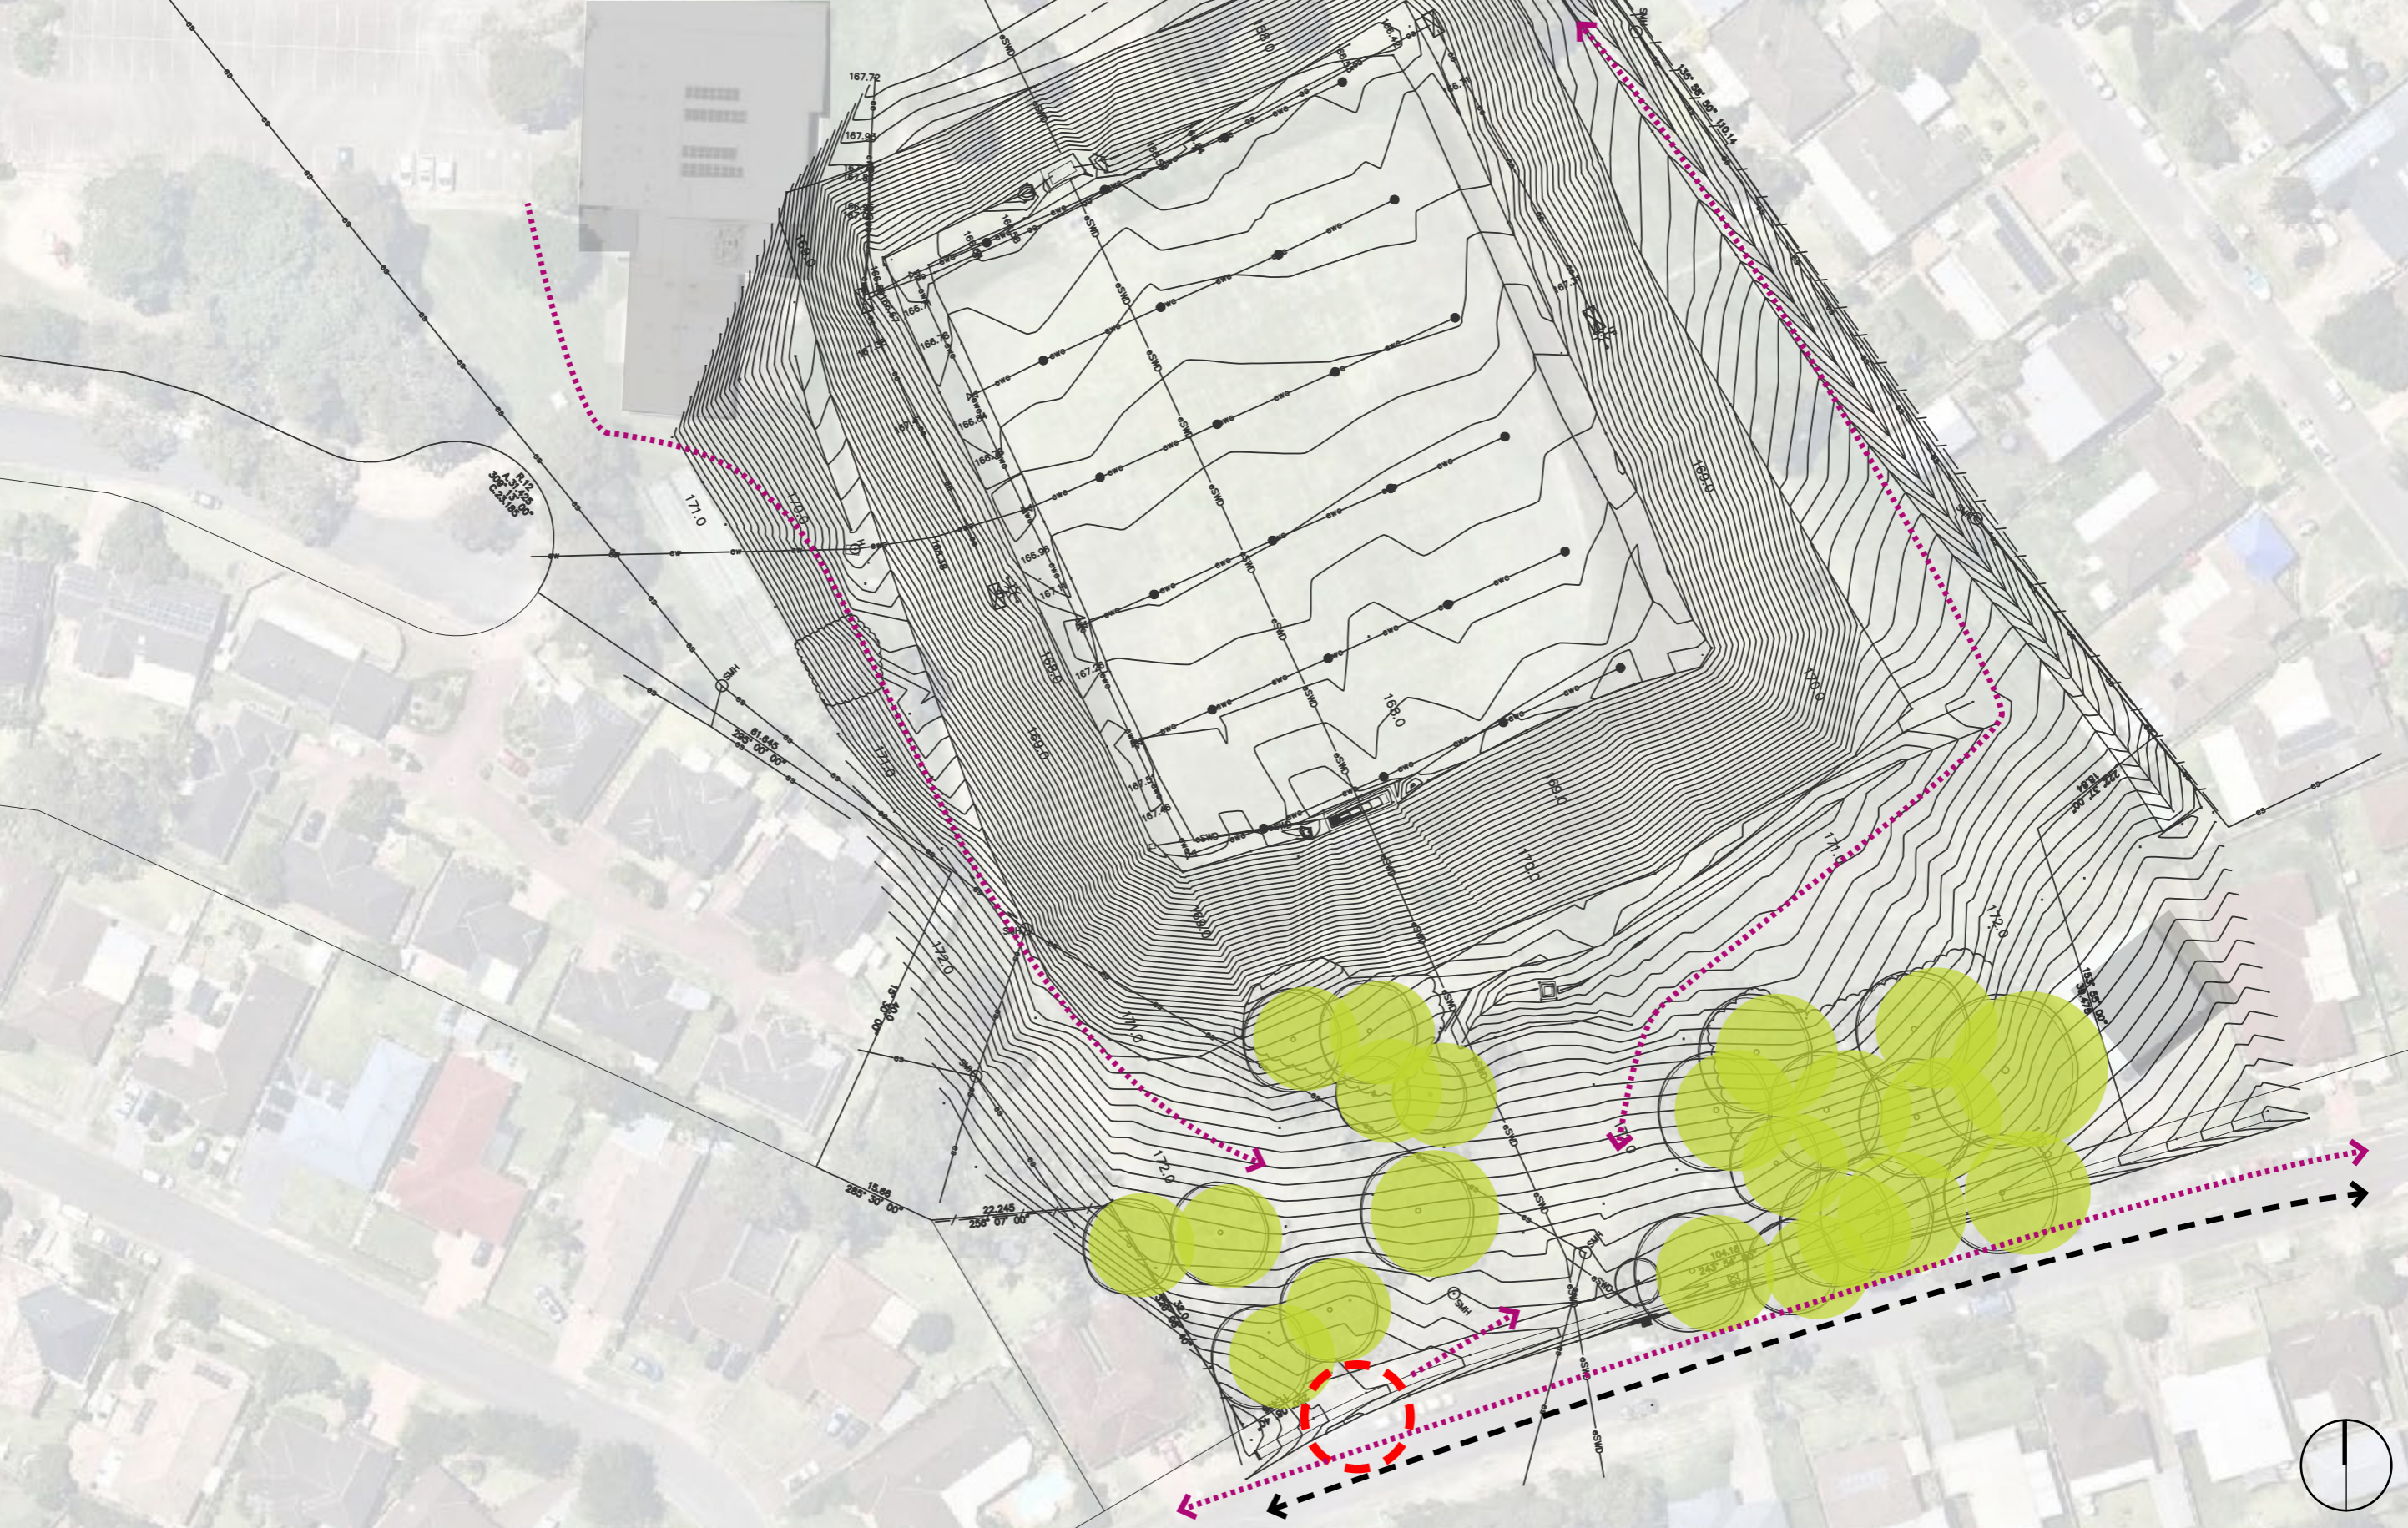
THE SITE - CIRCULATION + ACCESS

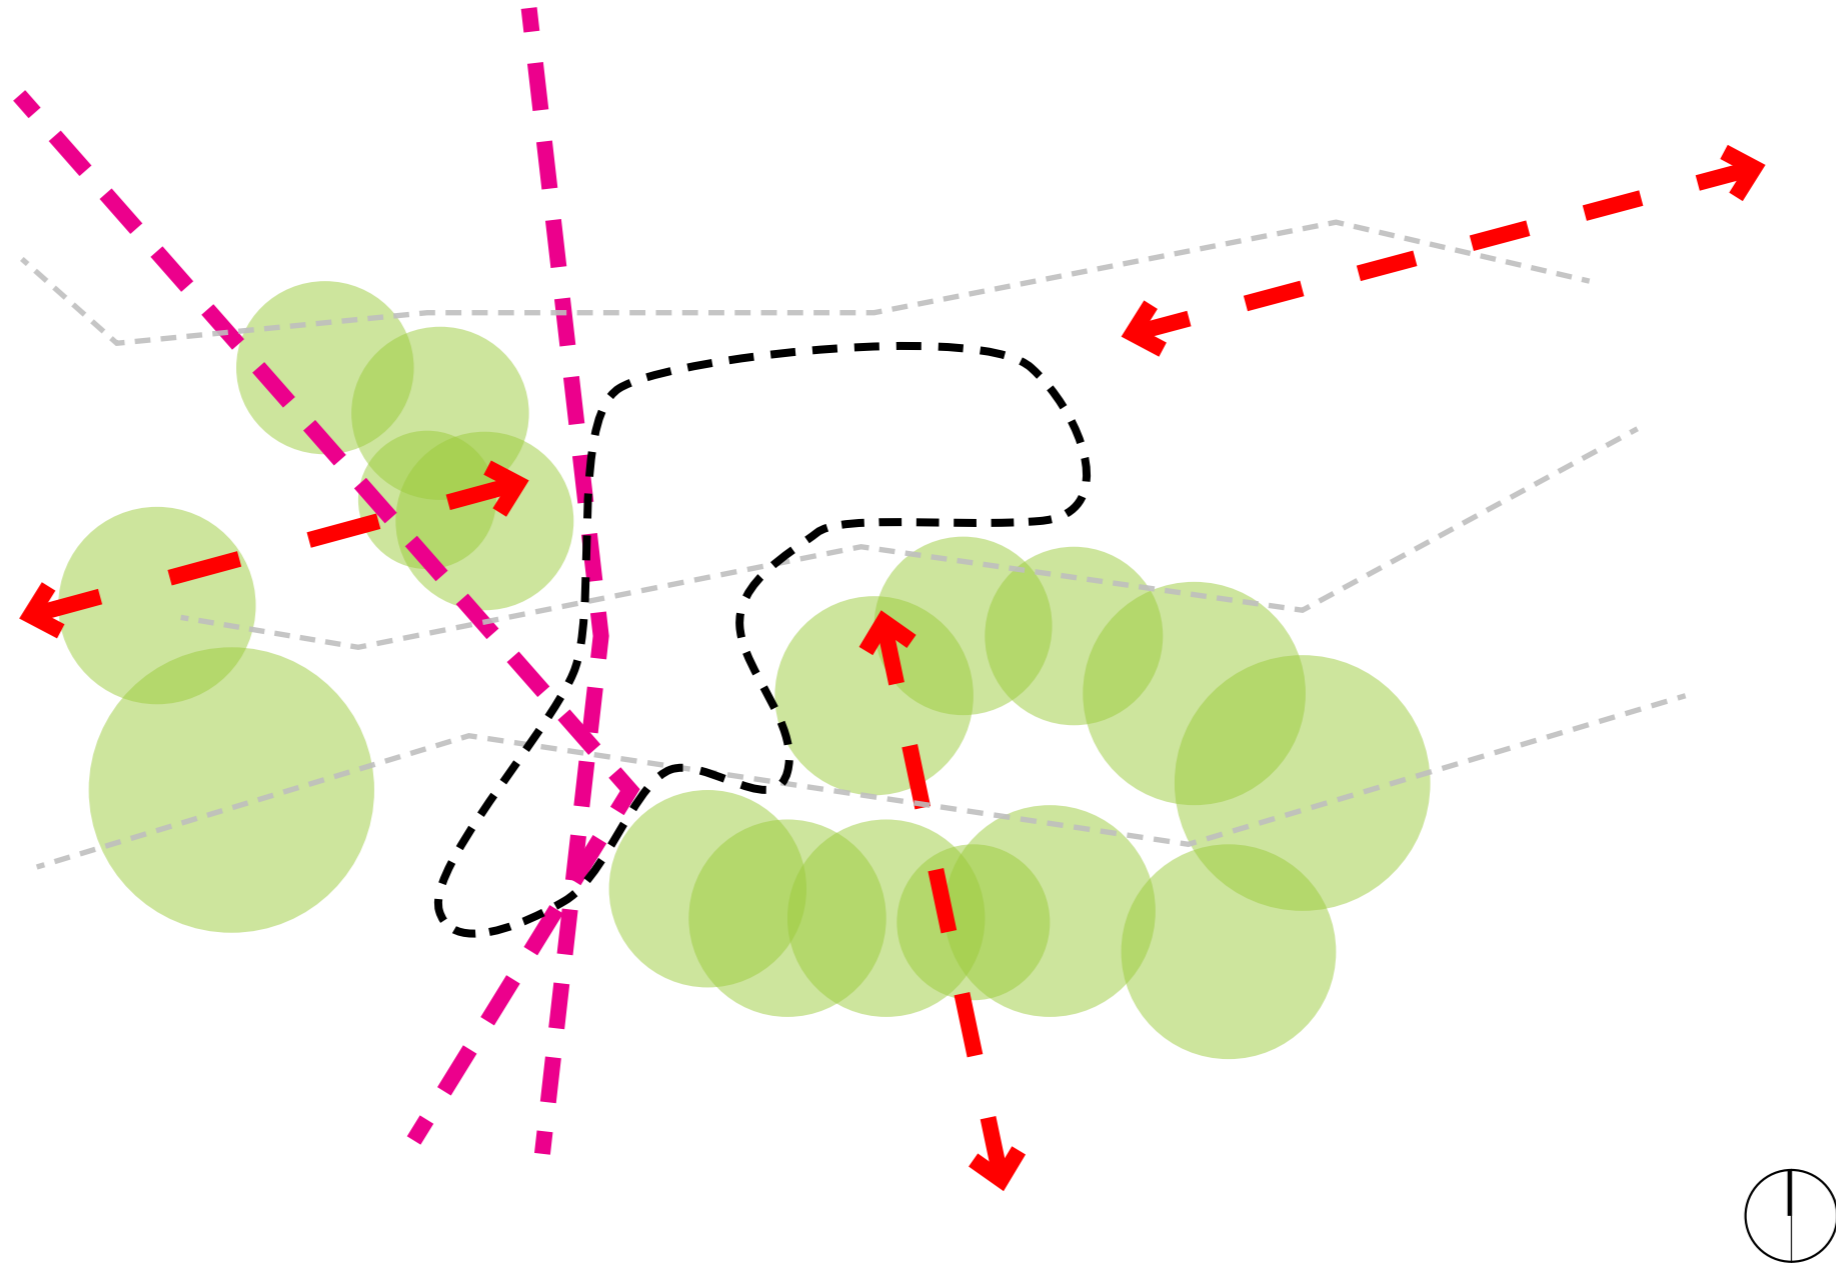
1. SITE CONSTRAINTS

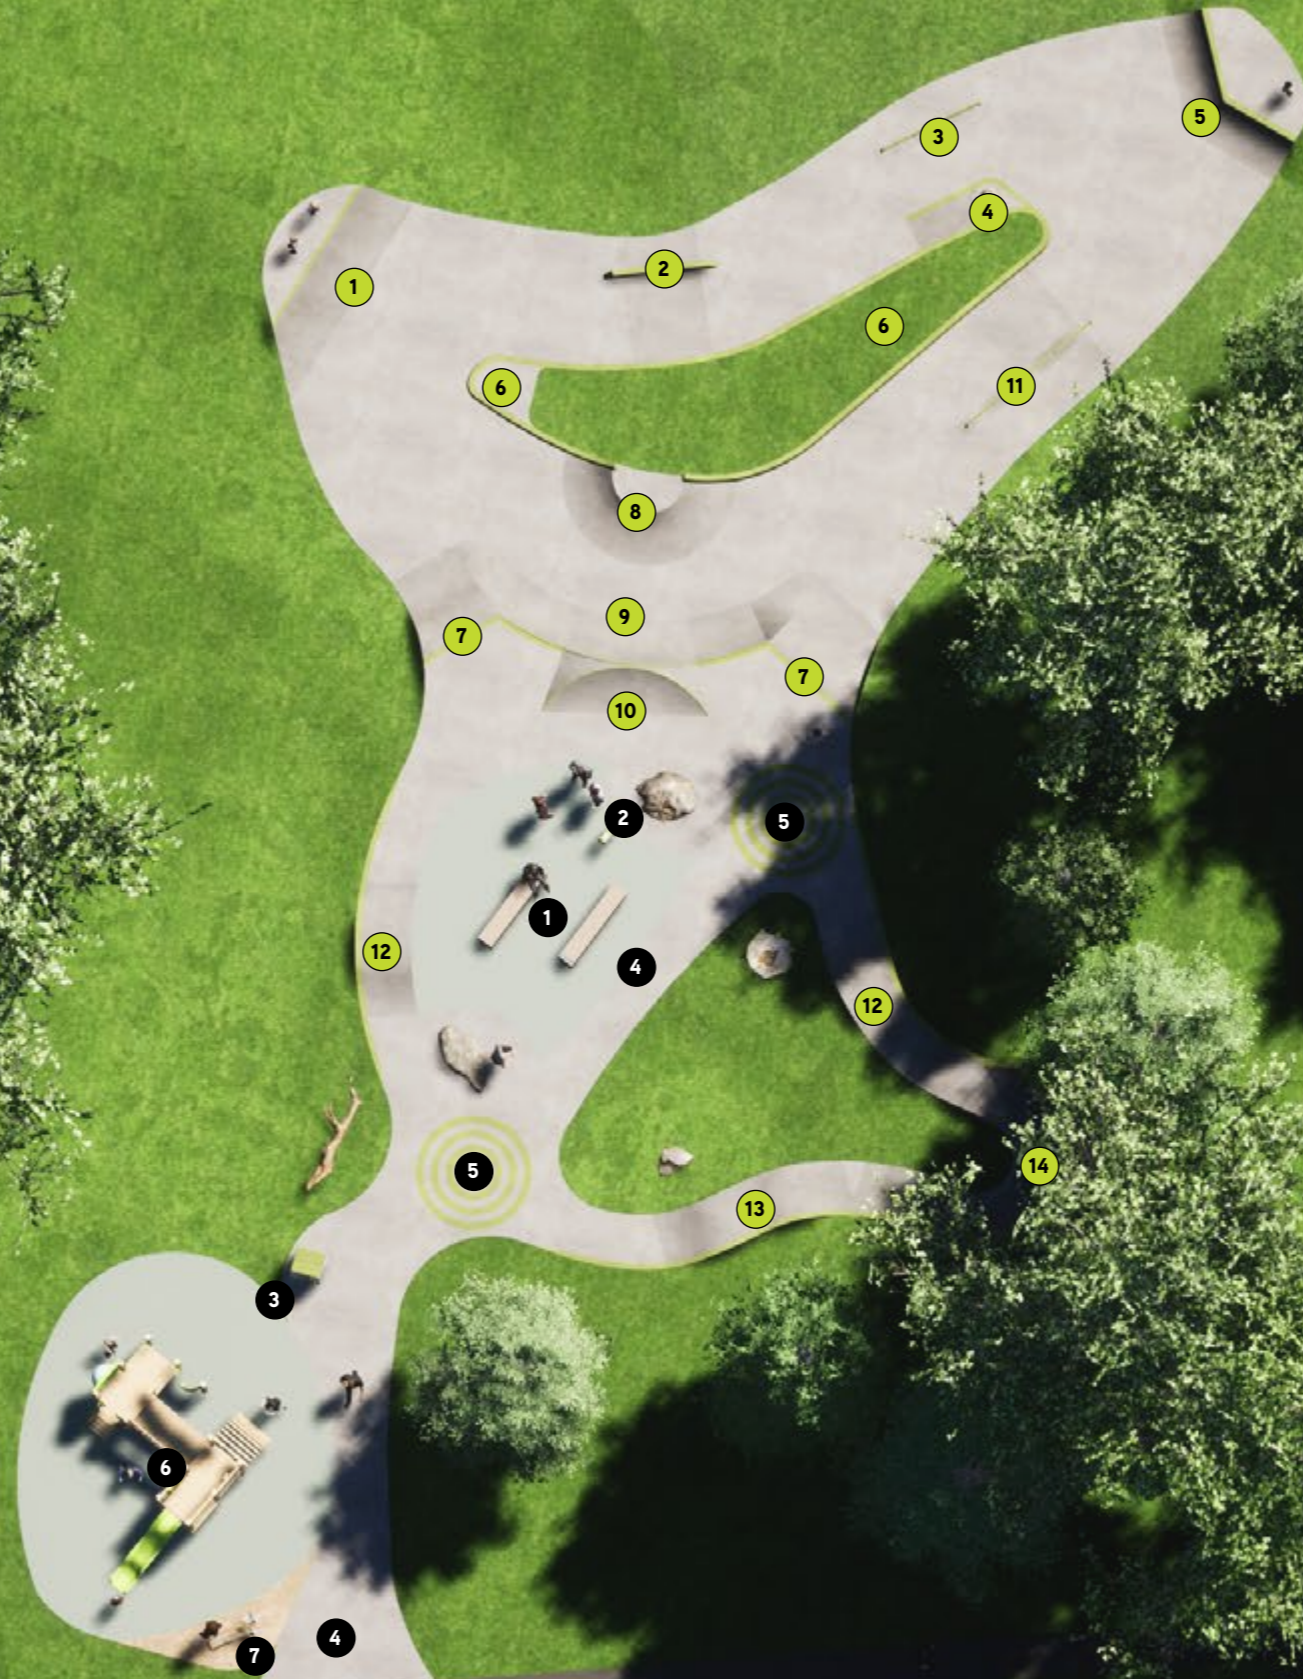
LEGEND

SKATE + PUMP WORKS

- 1 750H 'China' Bank
- 2 Hubba Slider
- 3 Flat Bar
- 4 Slappy Kerb Kicker
- 5 750H Transition Hip
- 6 Kerb Manny Pad
- 7 900H Roll in Hips
- 8 600H Volcano with Kerbs
- 9 900H Curved Quarter Pipe
- 10 Taco Extension
- 11 Down and Out Rail
- 12 Single Roller
- 13 Double Roller
- 14 900H Berm

LANDSCAPE WORKS

- 1 Central Seating area
- 2 Drinks fountain
- 3 Bins
- 4 Primary Footpath
- 5 Line Marking
- 6 Play Space with Soft Fall
- 7 Informal Seating Pod

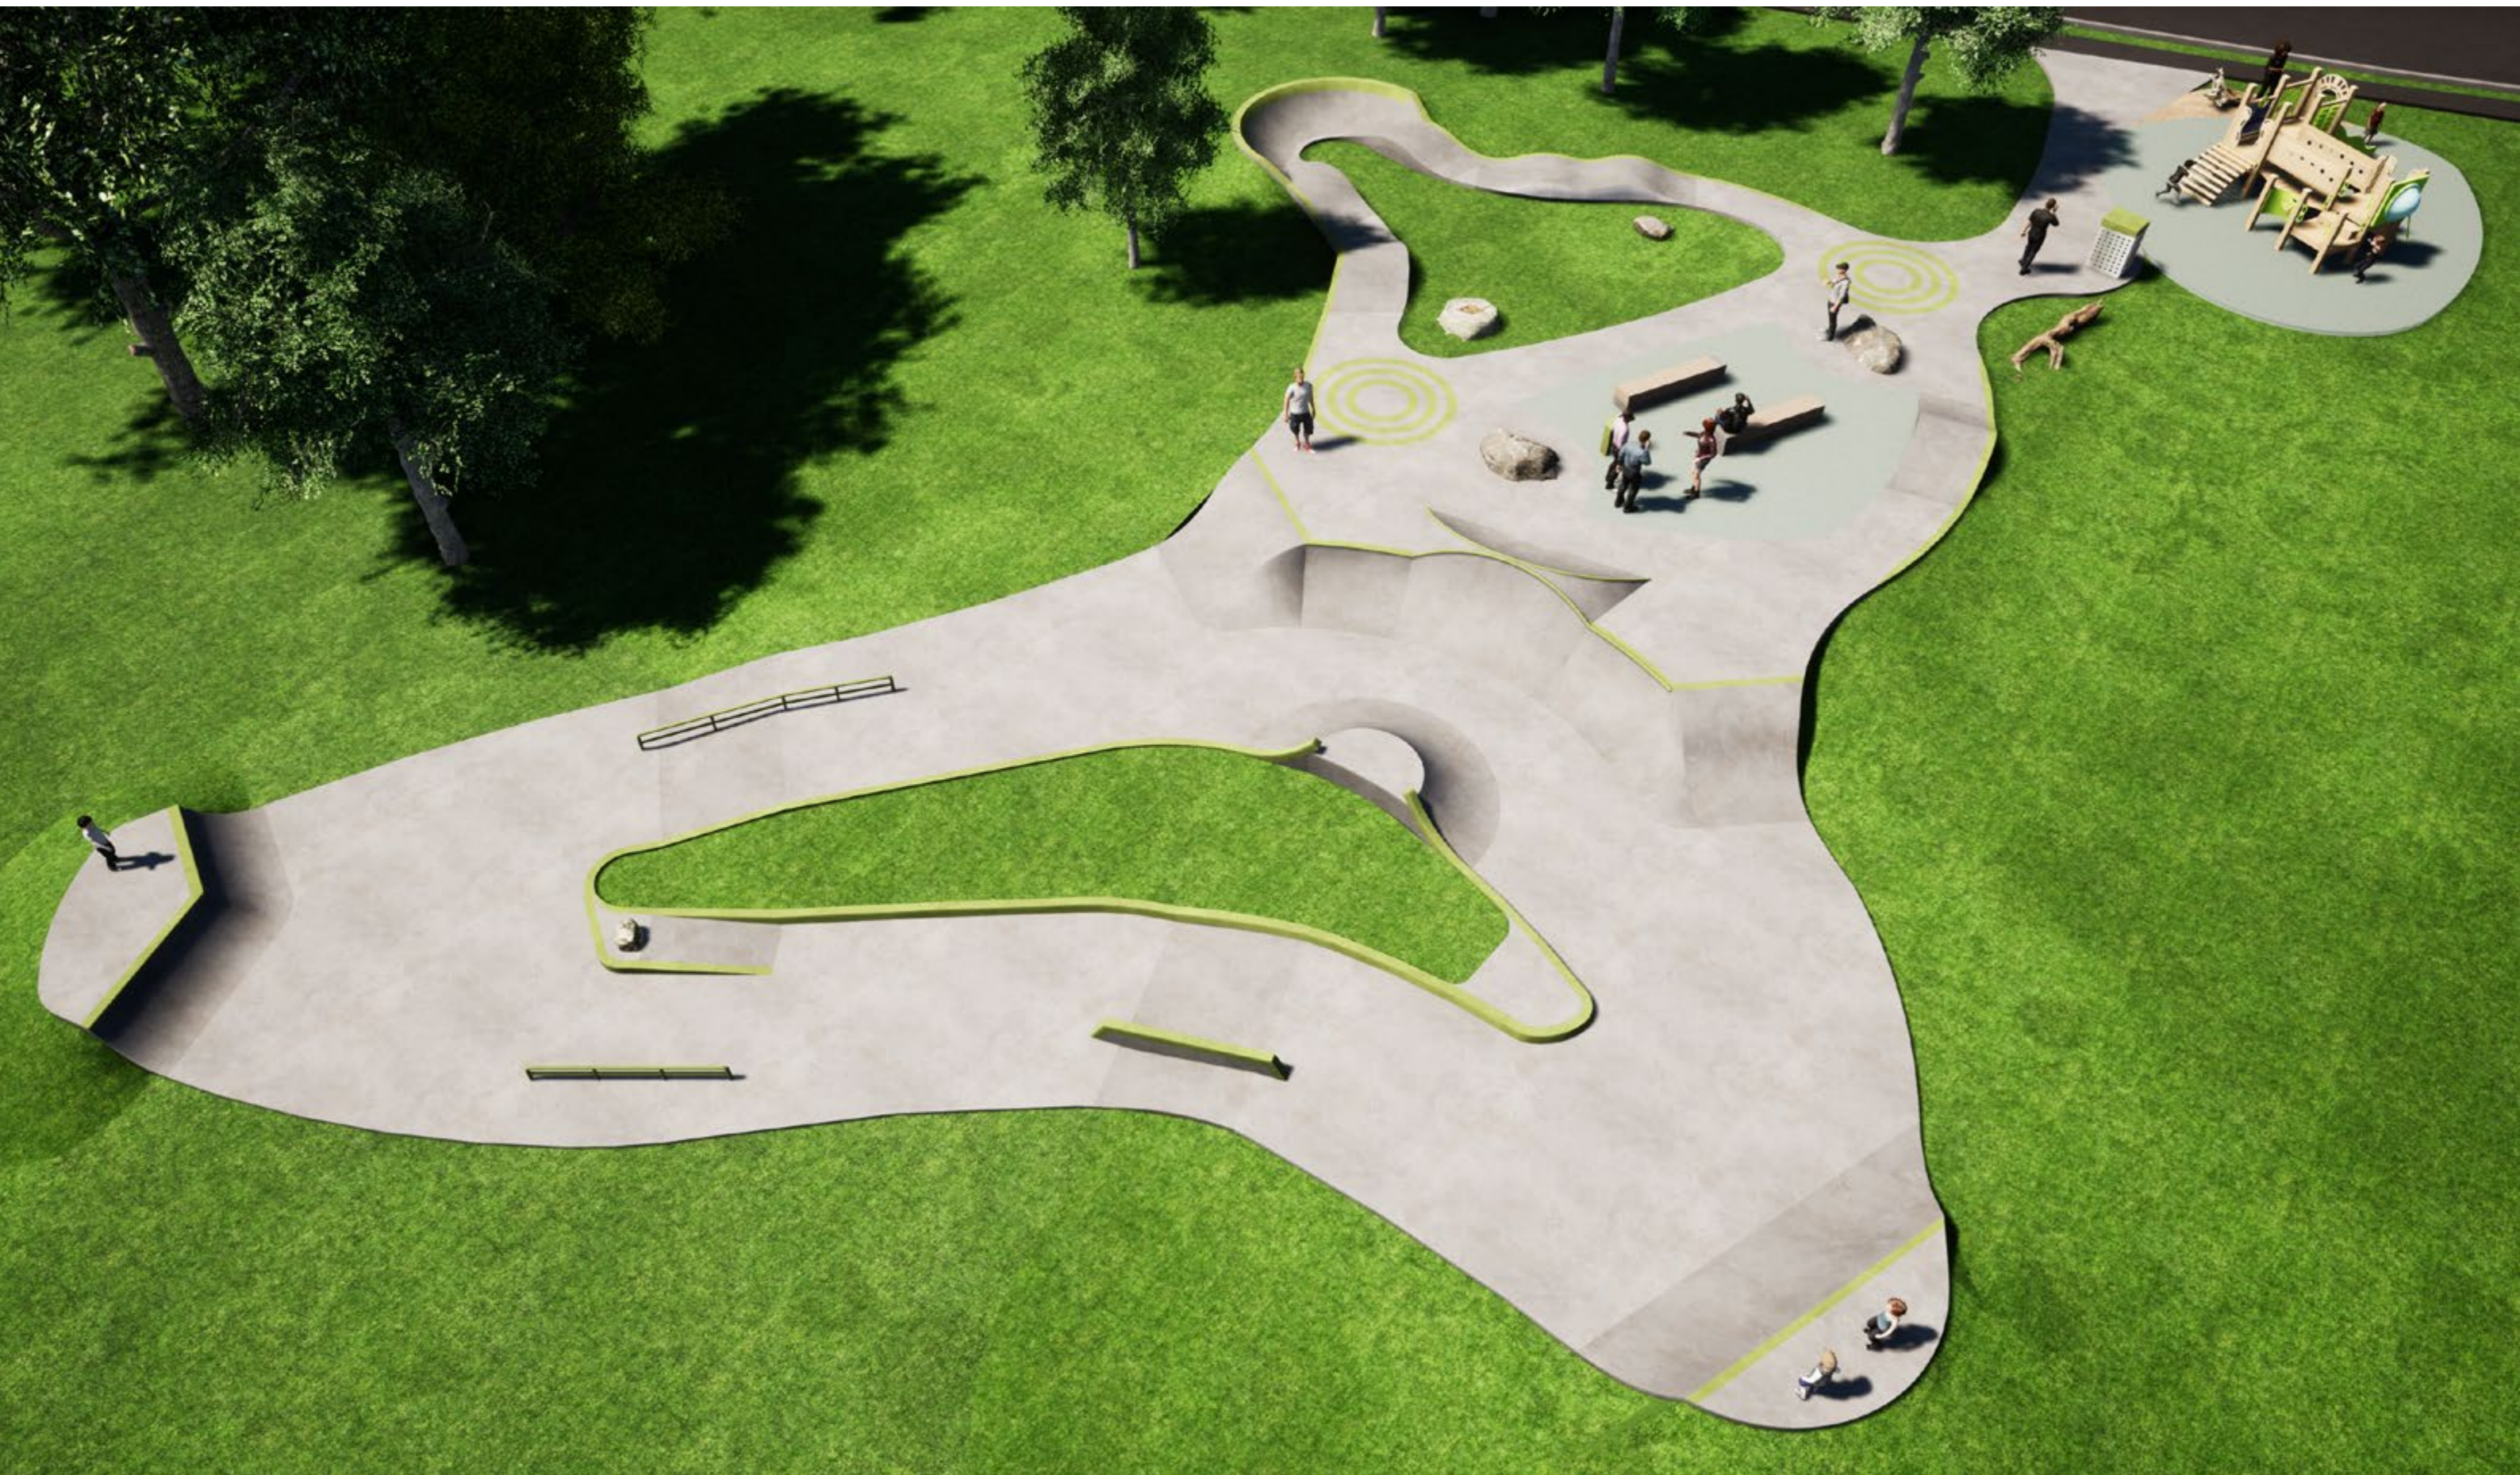
3D OVERVIEW | SKATE + PUMP + PATH + PLAY

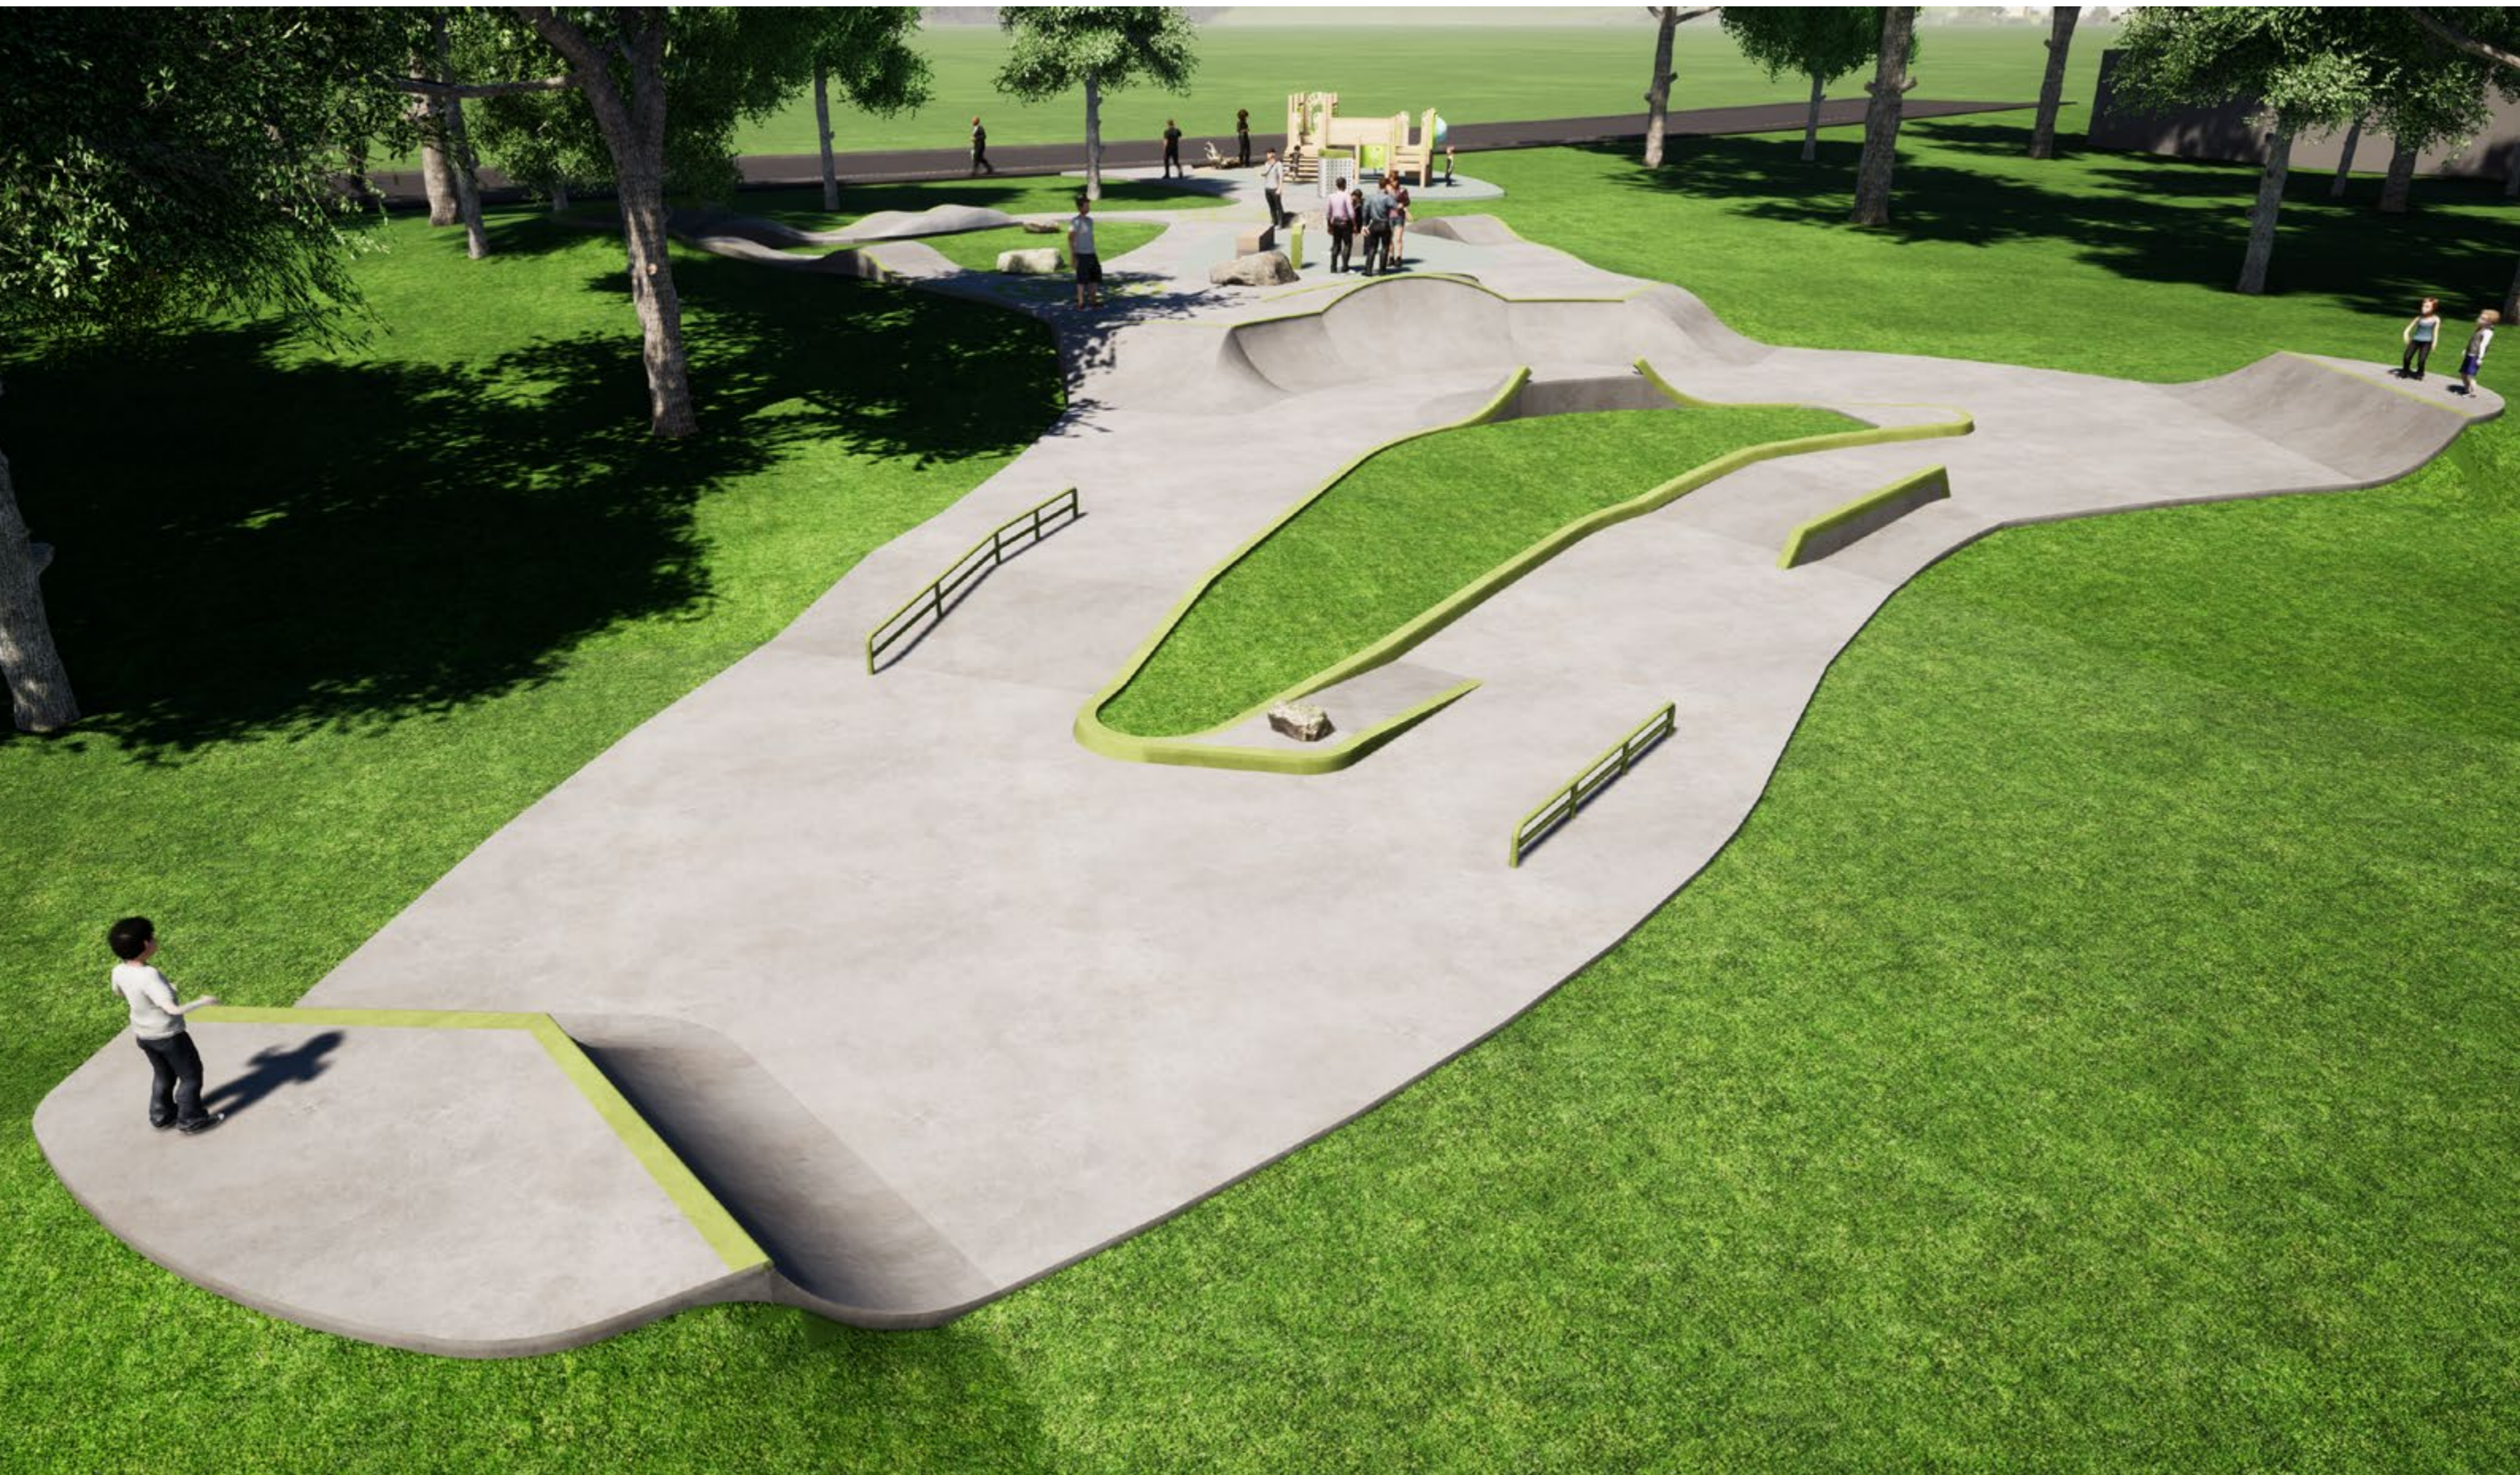
3D OVERVIEW | SKATE

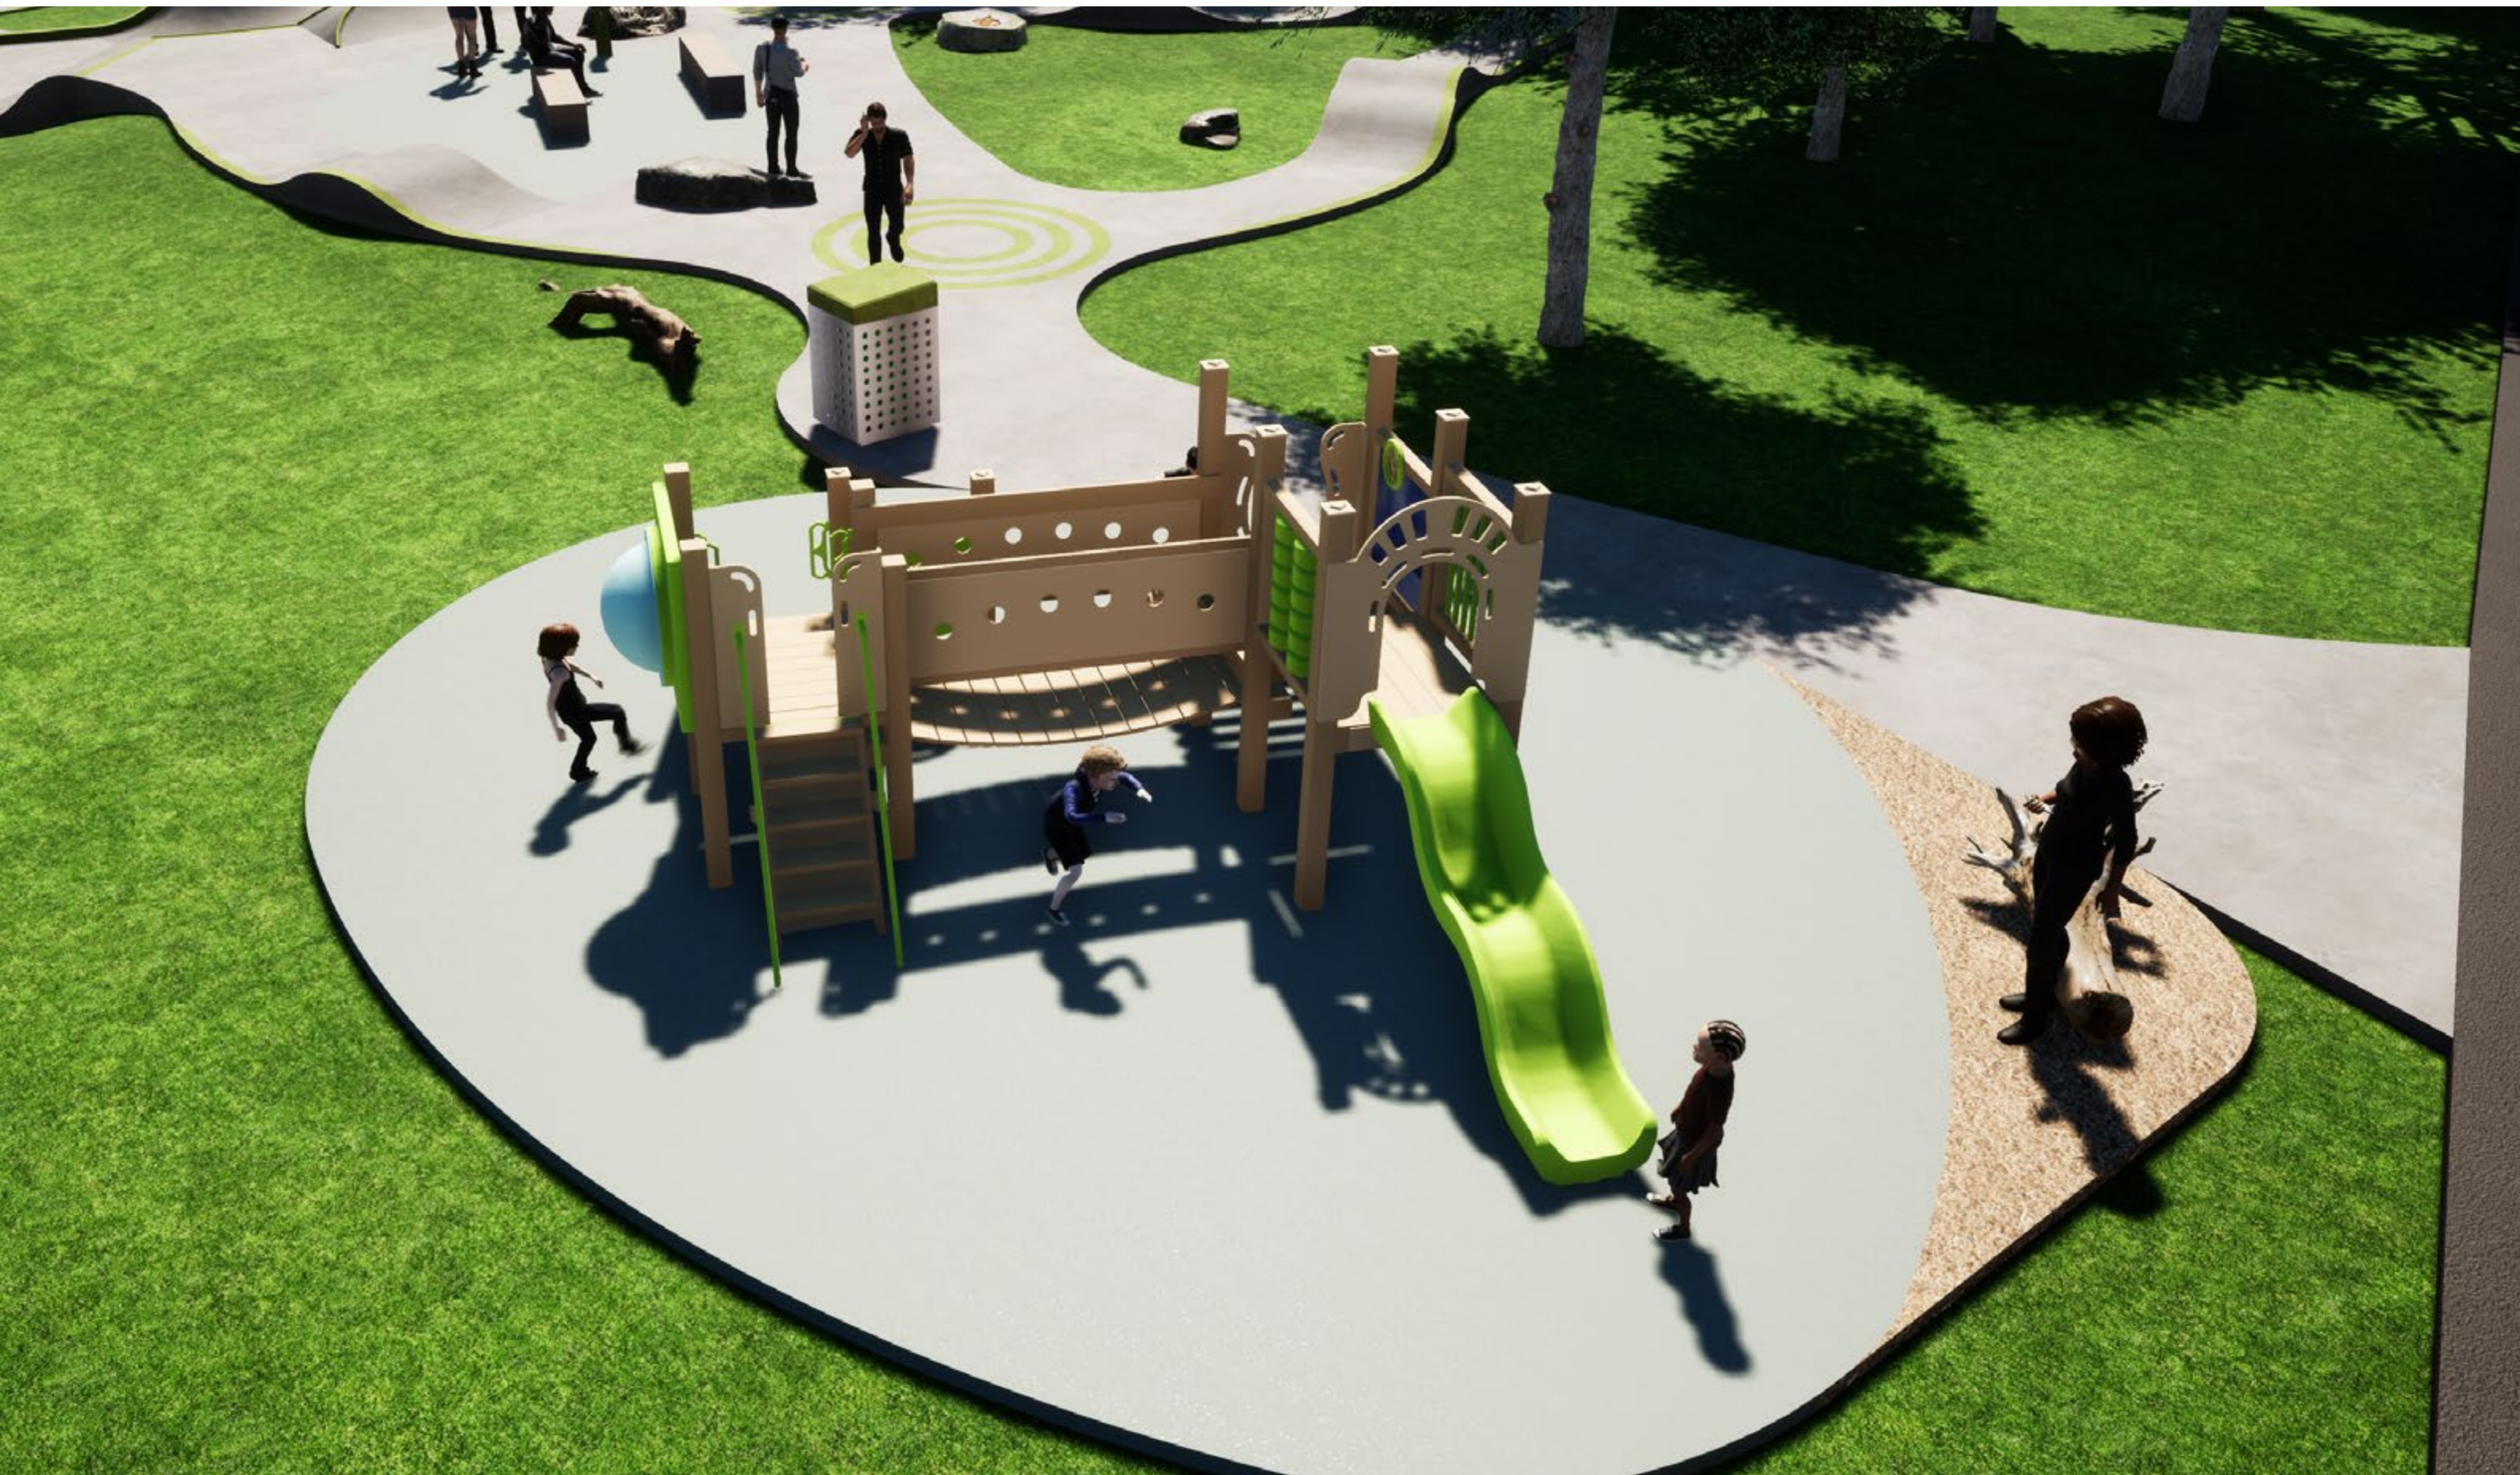
3D OVERVIEW | SKATE + PUMP + PATH + PLAY

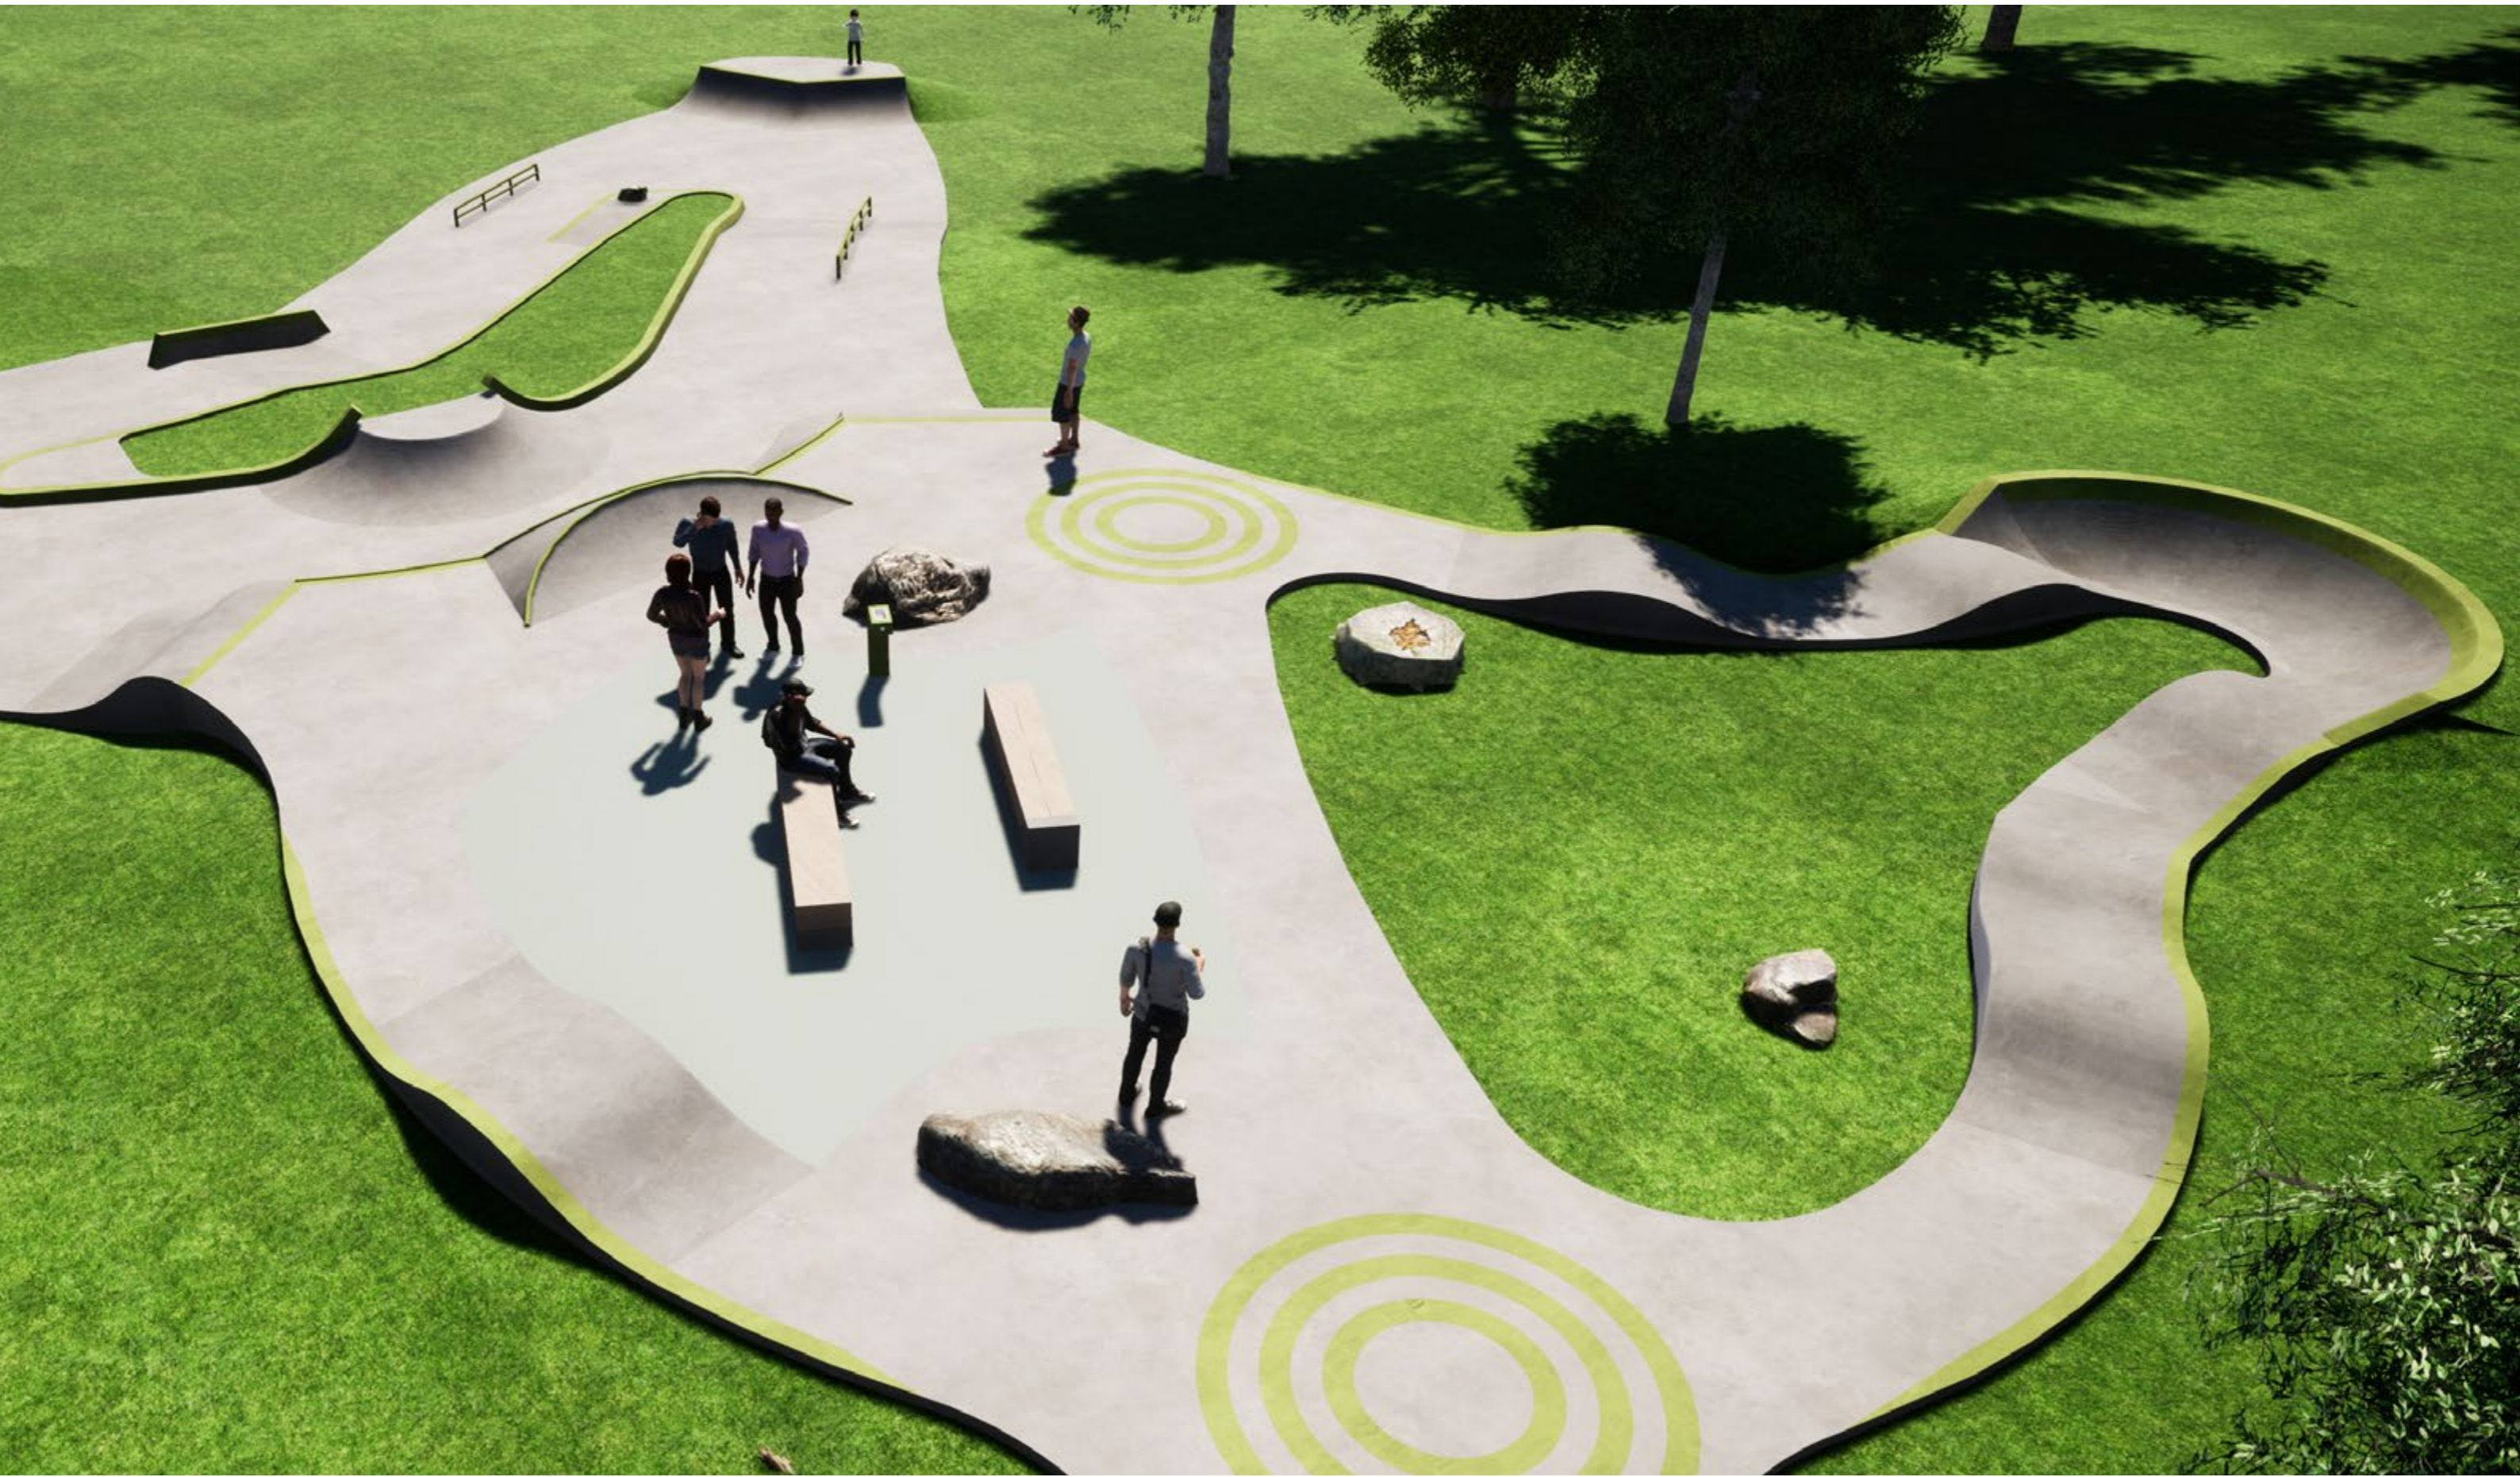
3D OVERVIEW | PUMP
