KARIONG OVAL RECREATION AREA

DRAFT CONCEPT | DESIGN WORKSHOP
MAY 2021

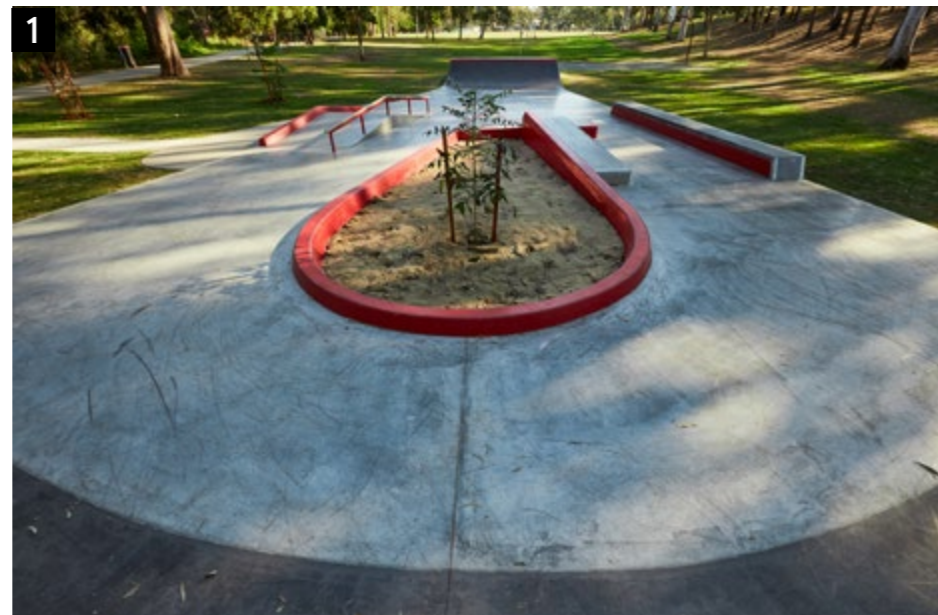
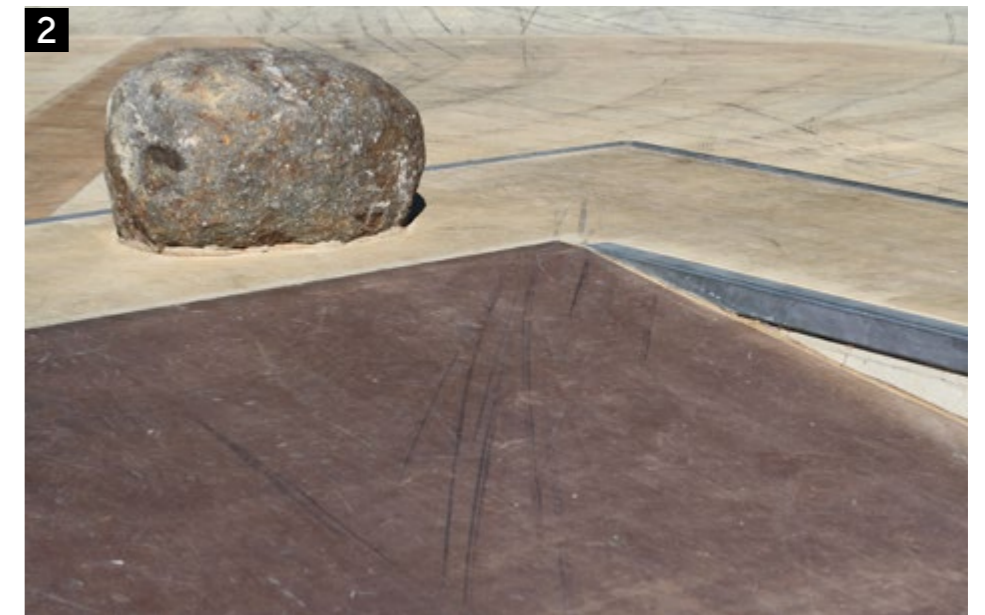
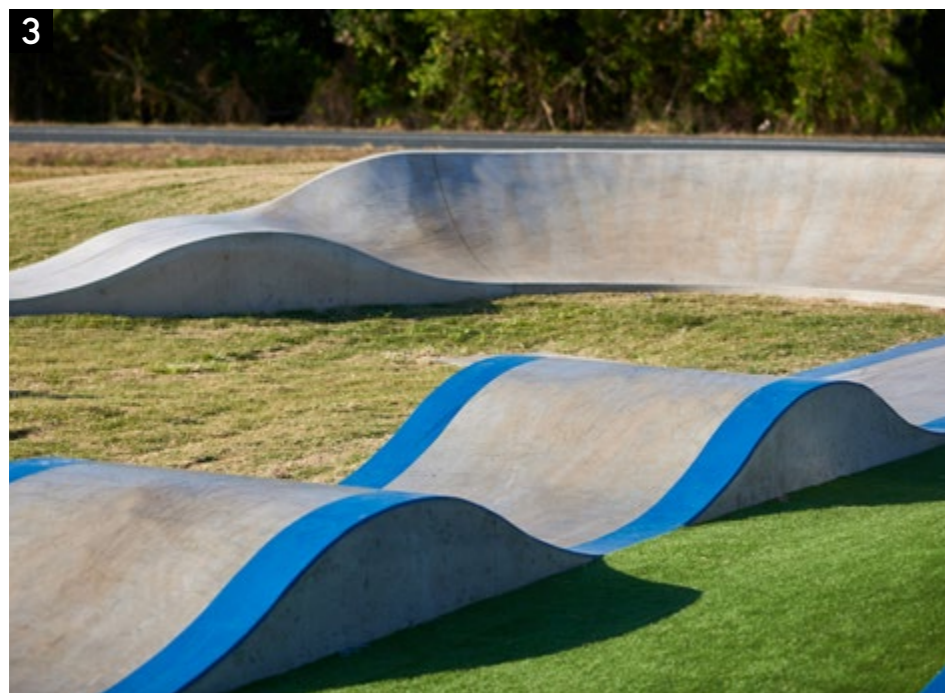
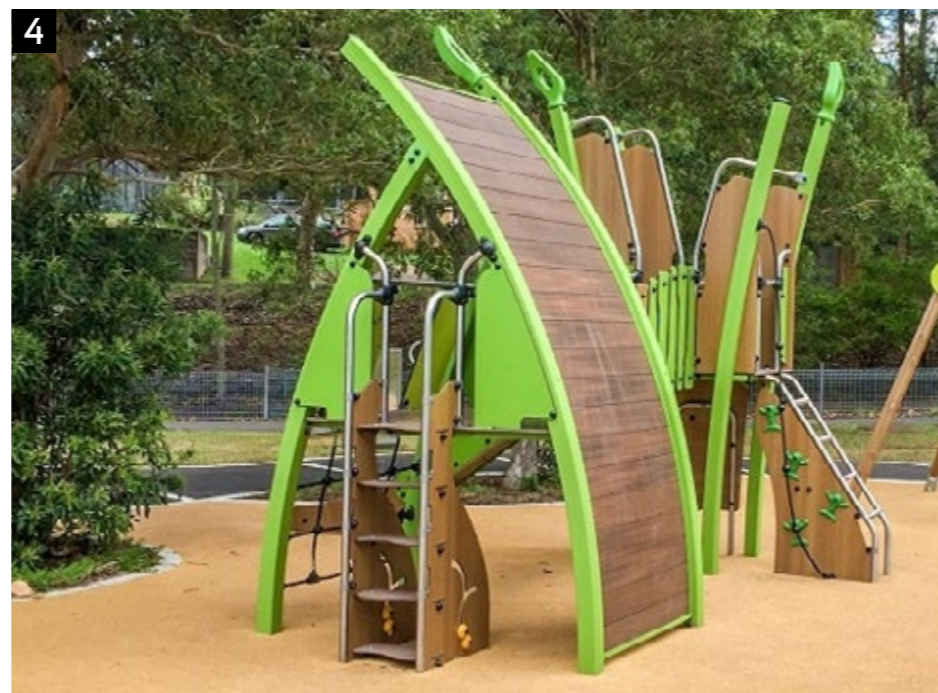
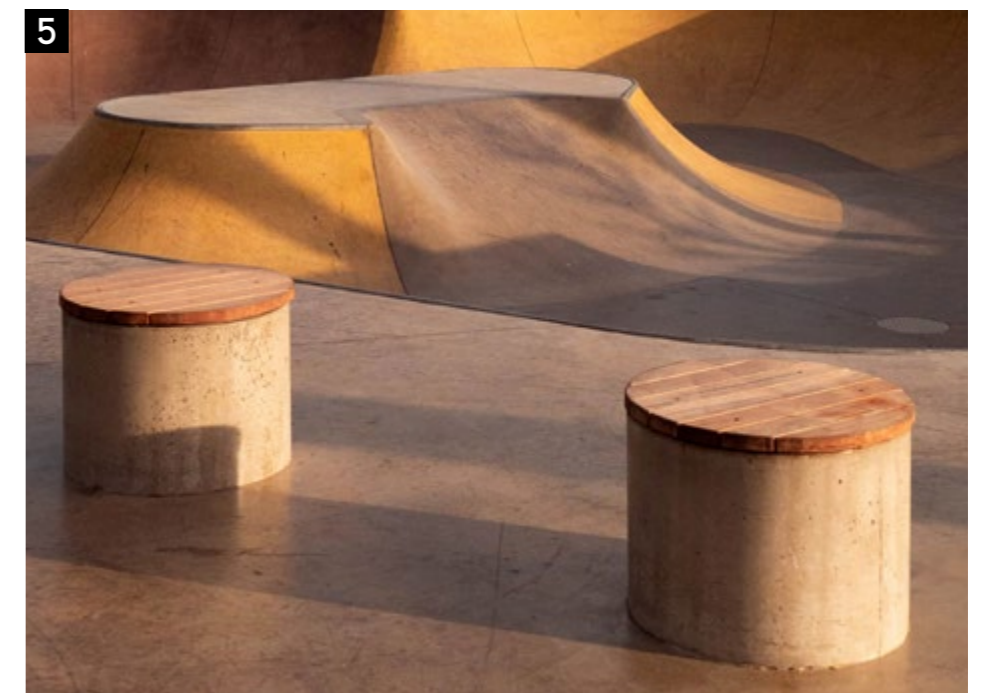
SKATE FEATURE PRECEDENTS

1. Centralised Curbed Garden Bed
2. Kicker to Rock Gap
3. Painted Pump Rollers
4. Play Equipment
5. Timber Topped Seats
