1.1 Overall Landscape Concept Plan

1.3 Lookout 01 Concept Plan (Eastern)

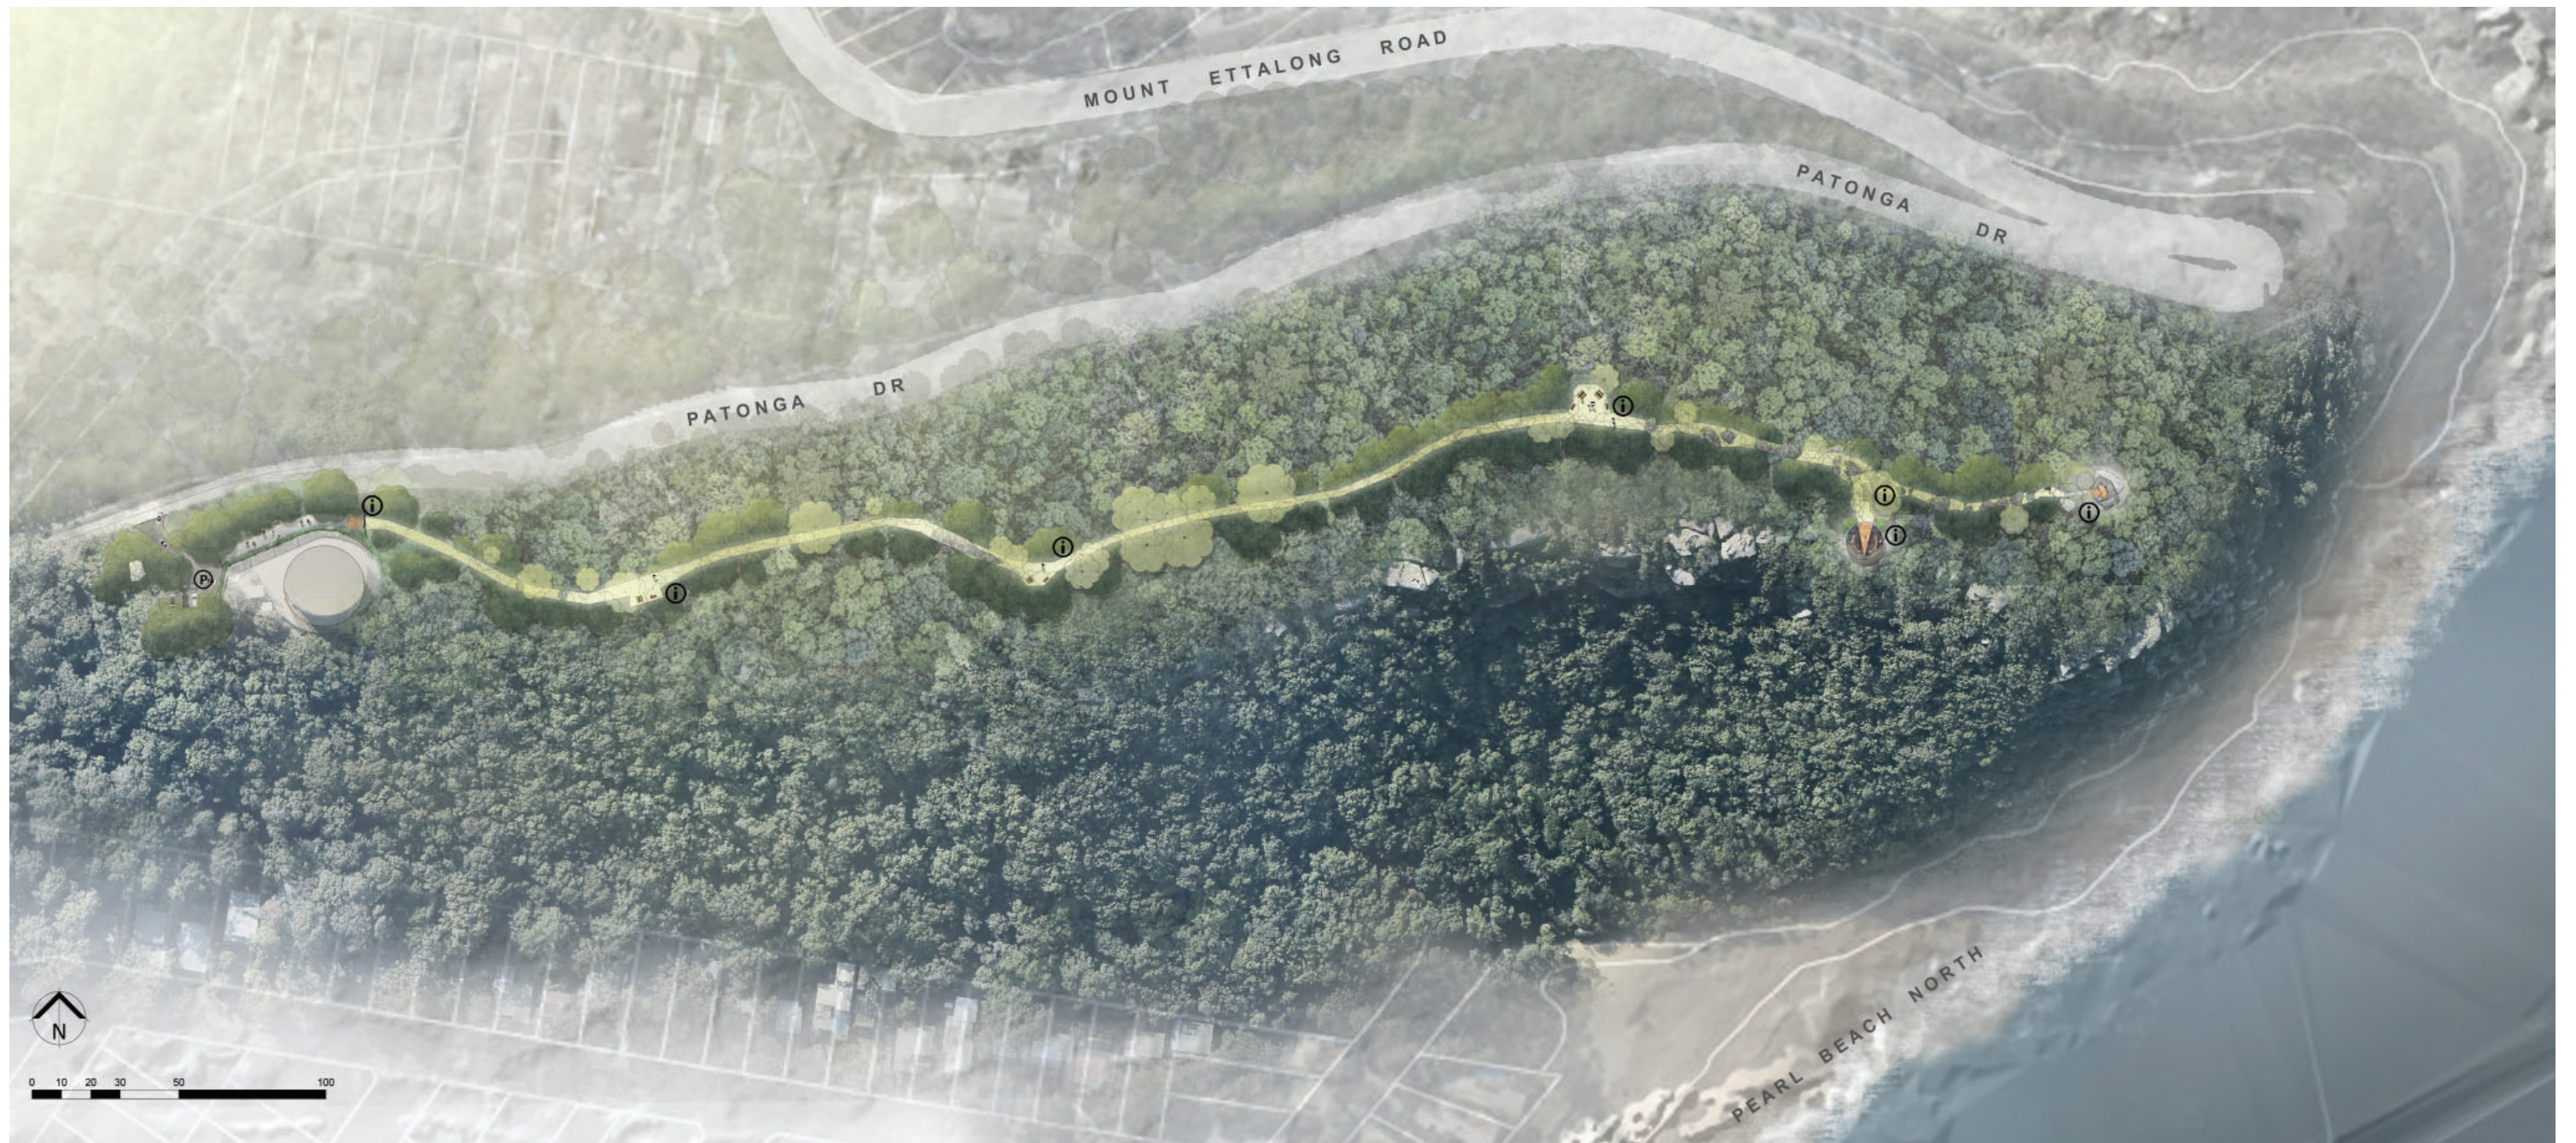
Surrounding Spotted Gum forest to north of the site
-

Surrounding Smooth Barked Apple/Heathy woodland on sandstone to south of the site
-

Imminent existing trees along trail track

Imminent existing hollow bearing trees along trail track
-

Trail track to be re-surfaced with granitic sand
-

Existing embeded rockes on trail track to be retained where possible

Proposed resting points along track with seating bench / picnic setting
-

Car park to be formalised and re-surfaced
-

Indicative signage locations along trail track and at lookouts

Fence around water reservoir to be re-designed with vertical climbing plants
-

Entry path to be formalised with resurfacing and planting and seating benches along the path leading up to the gate. Area of timber paving to the front of gate to signify start of trail track

Proposed southern lookout refer to detail plan
-

Proposed eastern lookout refer to detail plan

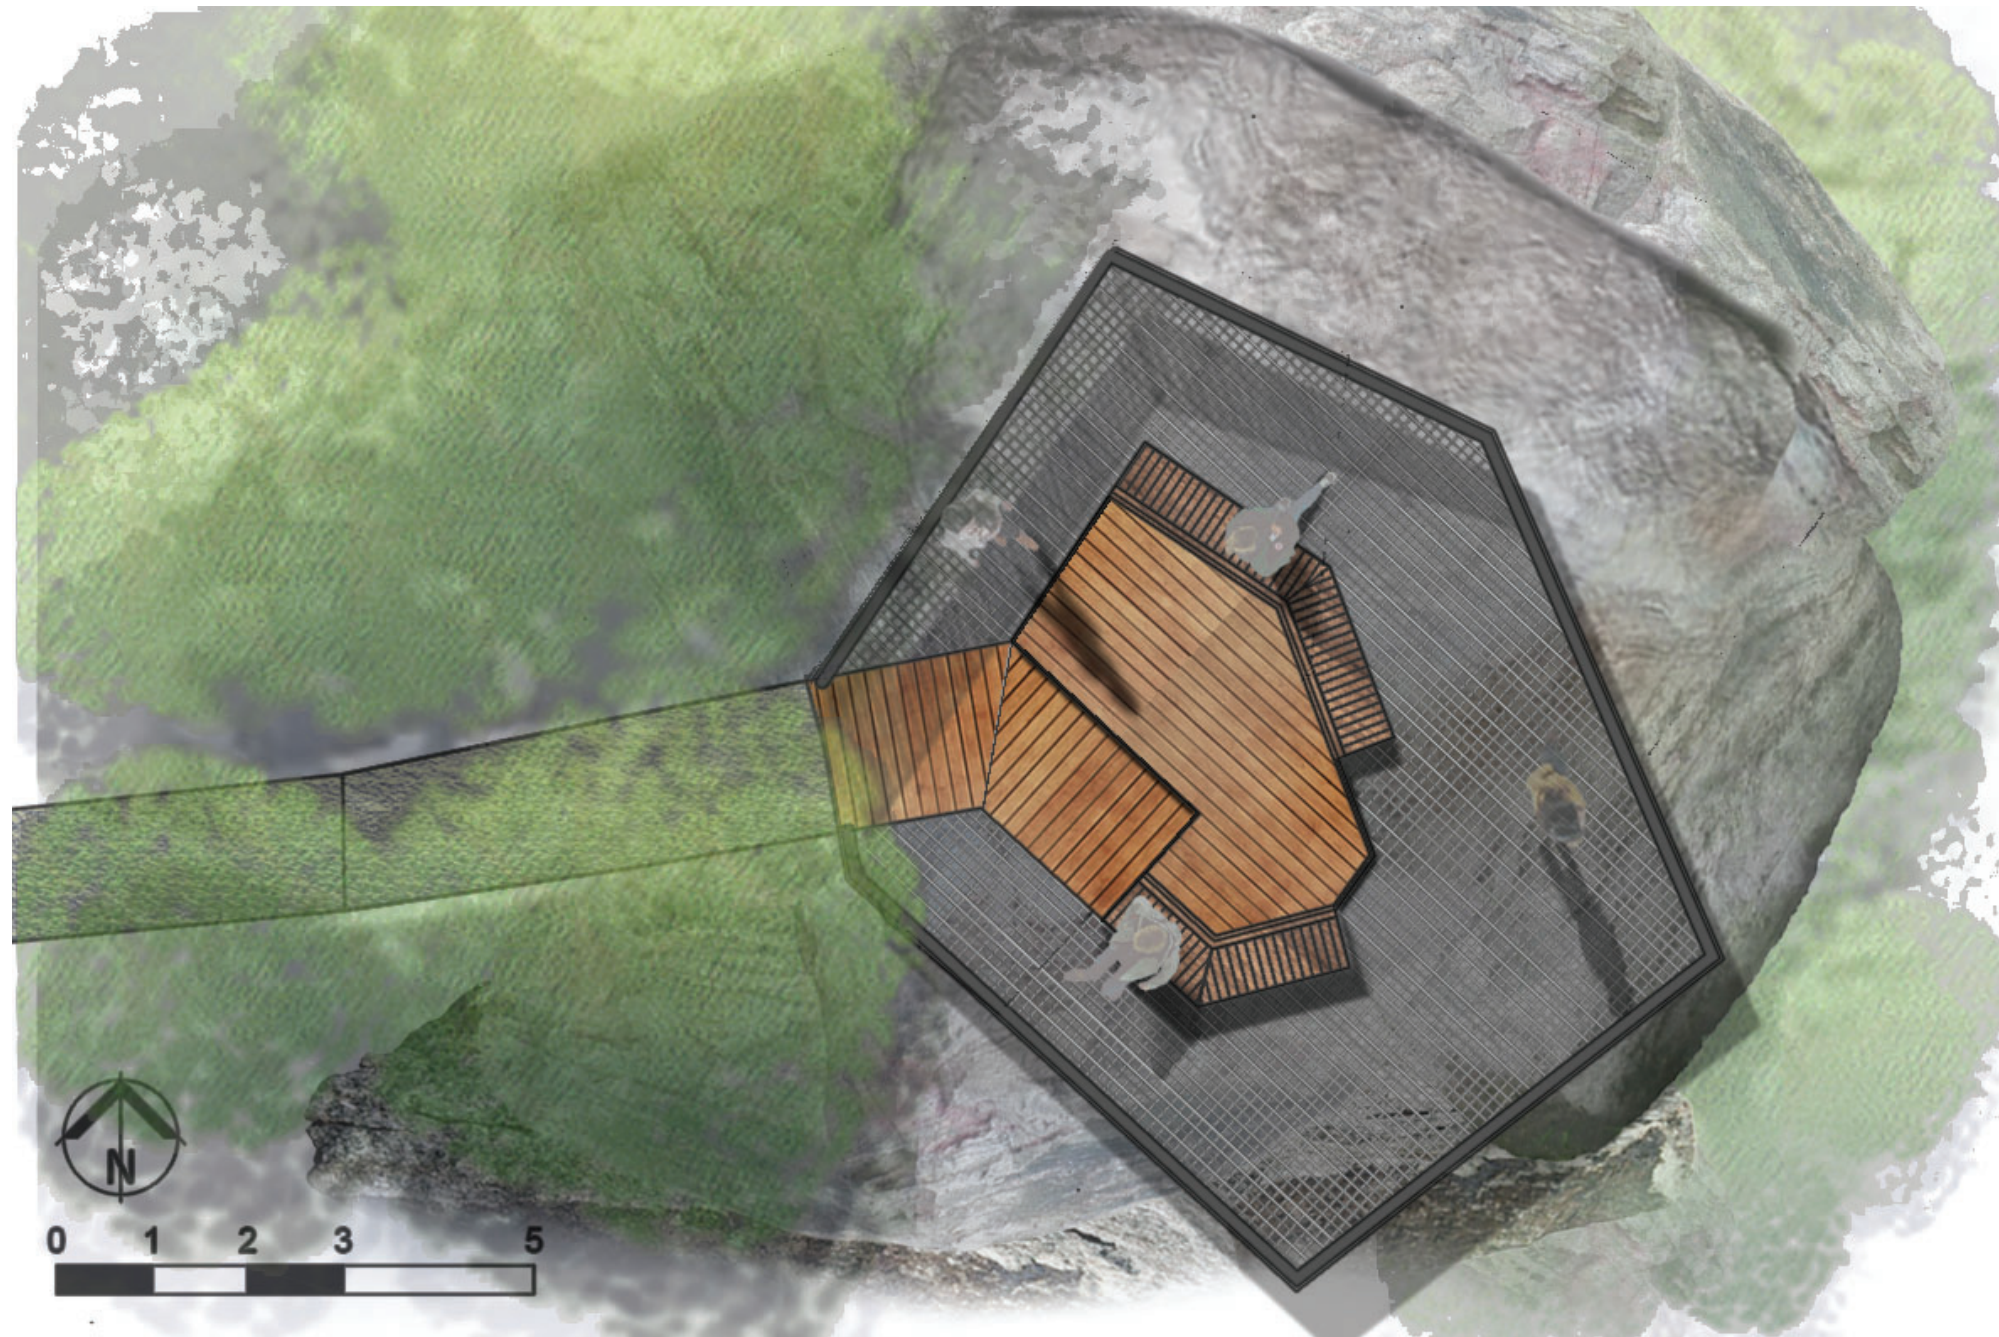
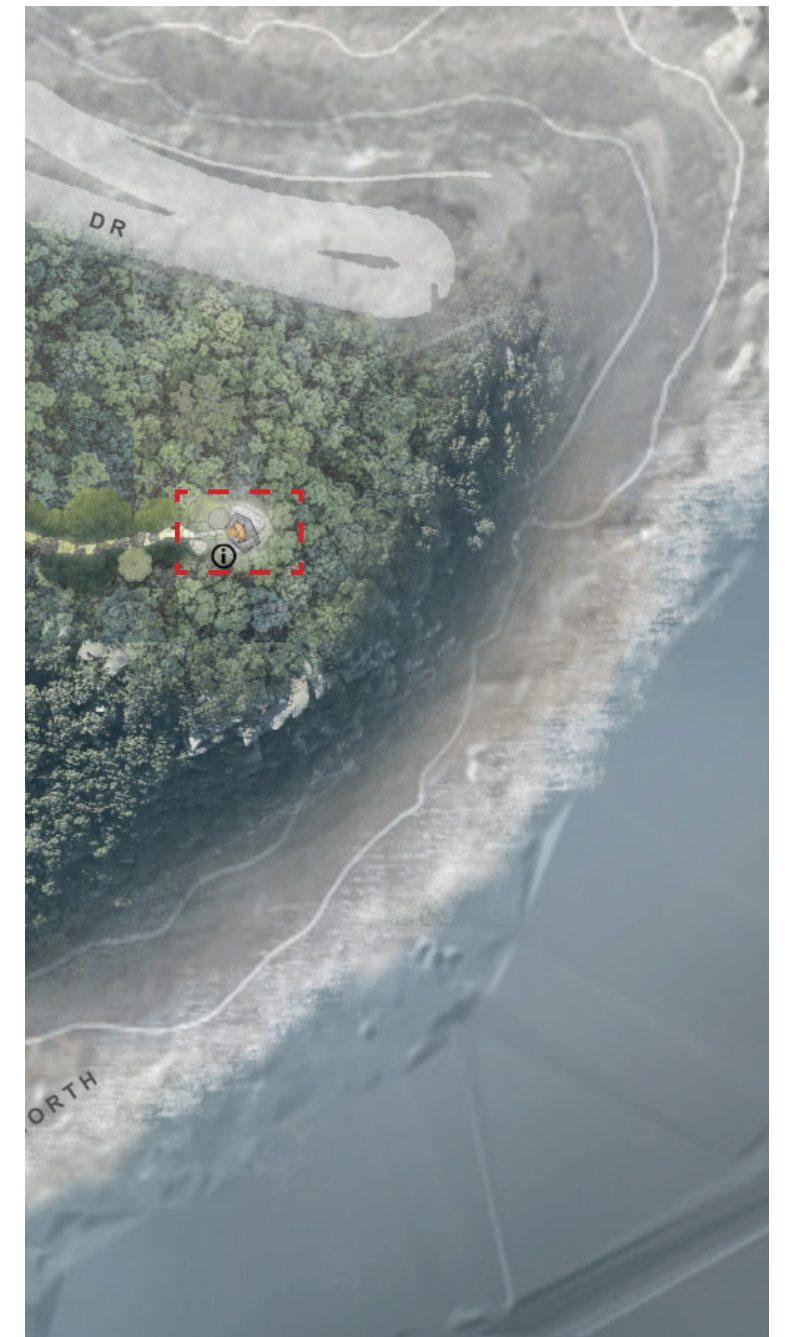
- Hexagon in form provides Wayfinding distinction between Lookout 01 (southern);
- Timber decking (flush with gravel) leads out to the lookout – and steps up as a smaller viewing platform. Integrated seats are then built into the edges of this decking, with arm rests and backings;
- Two separate angled seat plinths with backings and armrest provide wide views out to the south east / east & north east;
- Steel mesh surface finishes flush with the timber decking, and provide a light touch surface, that floats on-top of the rock platform;
- Steel rod balustrades provide a contemporary, low maintenance material that safely allow people to hold and enjoy views;
- Opportunity to include Indigenous and Flora / Fauna representation in surface finishes and furniture items. Eg. Stingray referenced in Balustrade handrail or a phrase written in dialect and etched in timber etc.

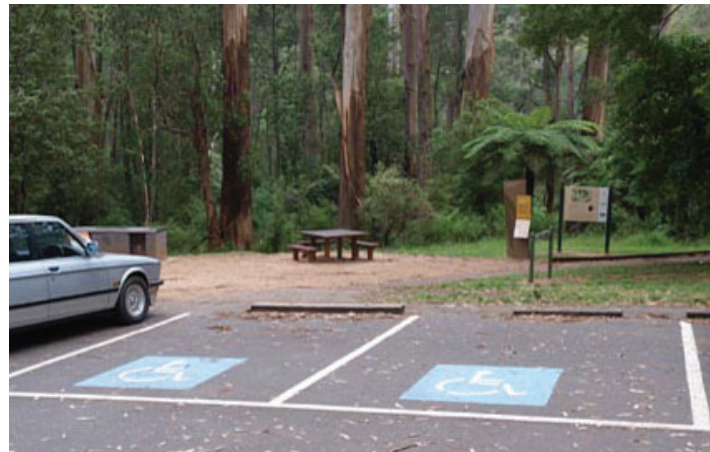
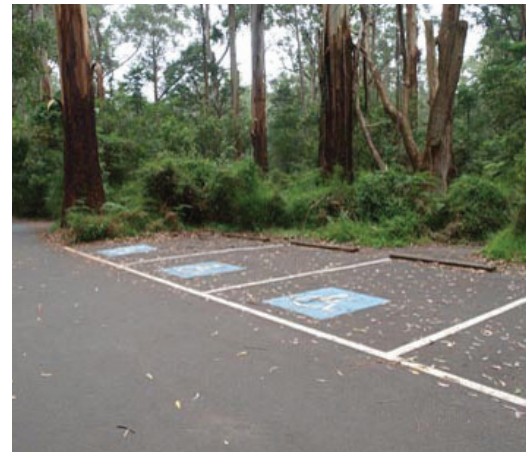
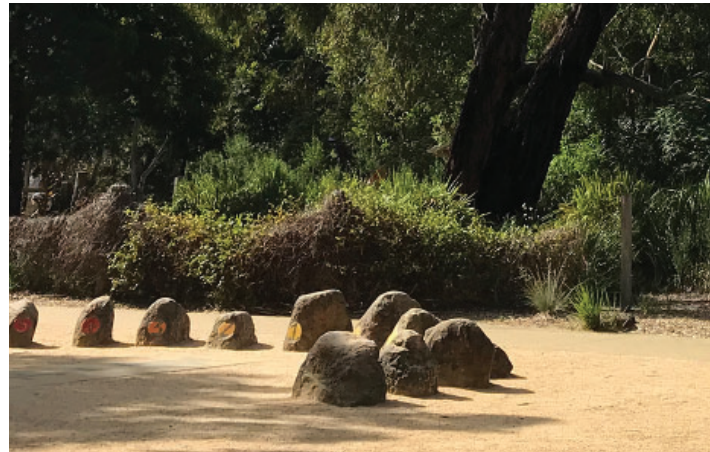
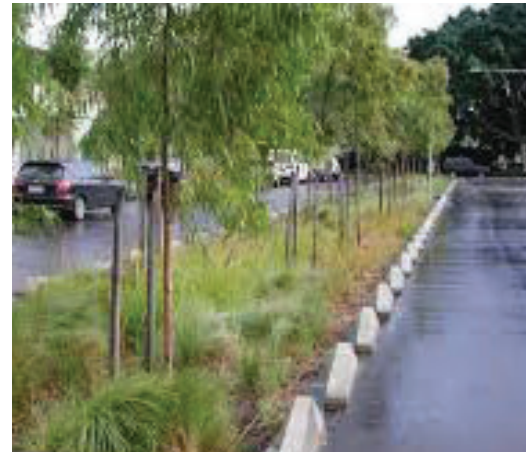
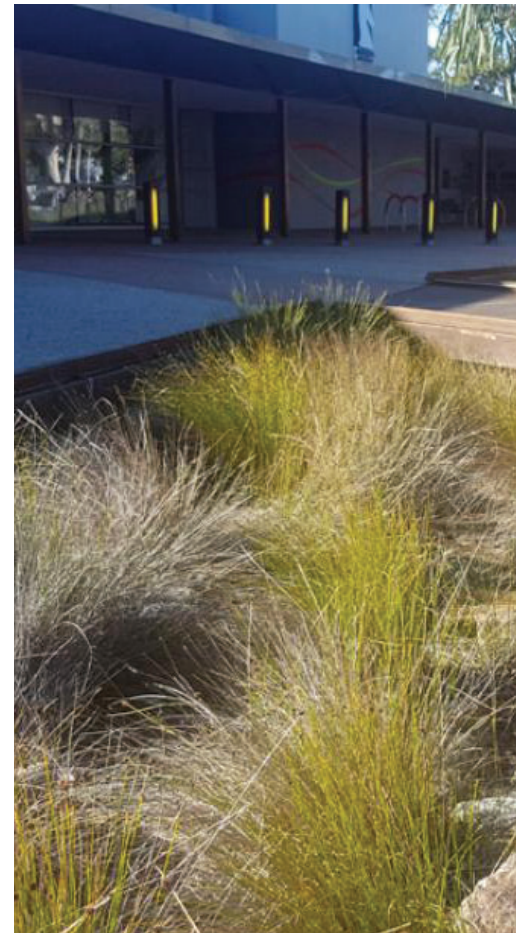
1.1 Car Park and Entry

- Resurface car park, provide line-marking and clearly display DDA car parking places;
- Incorporate WSUD treatments for runoff through integrated use of native rain-gardens;
- Provide timber bollard fencing and placement of rocks to contain car park space;
- Provide clear and safe pedestrian access through car park to start of Mt Ettalong lookout nature trail;
- Minimise removal of tree and vegetation within area;

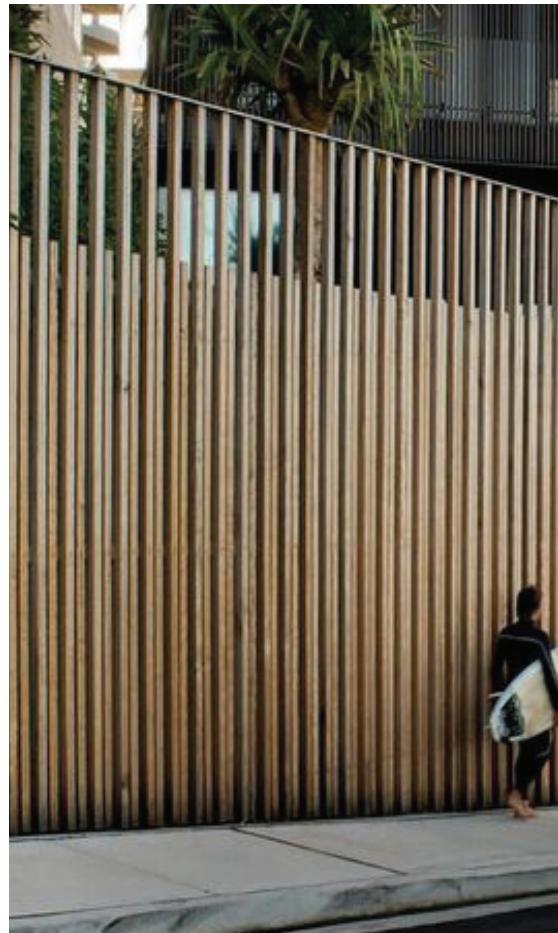
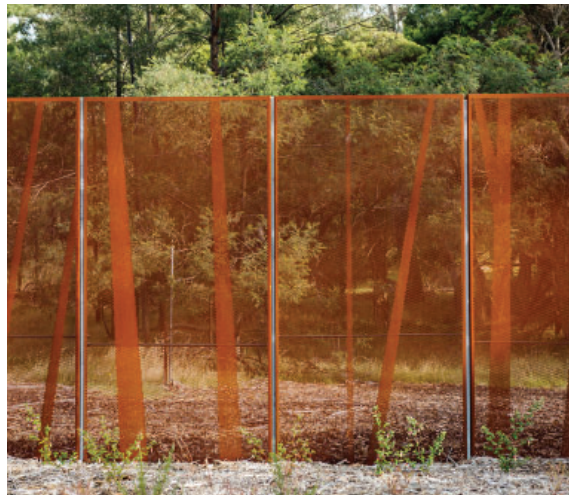
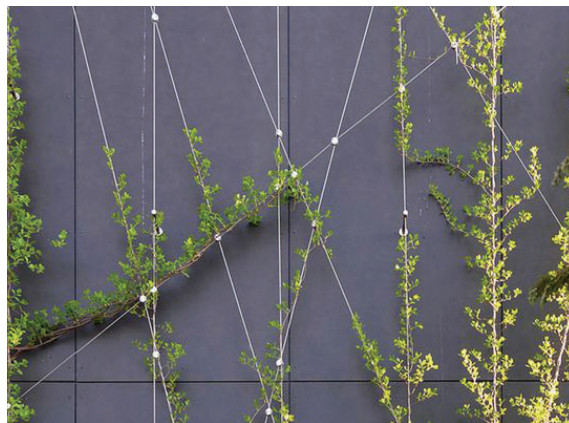
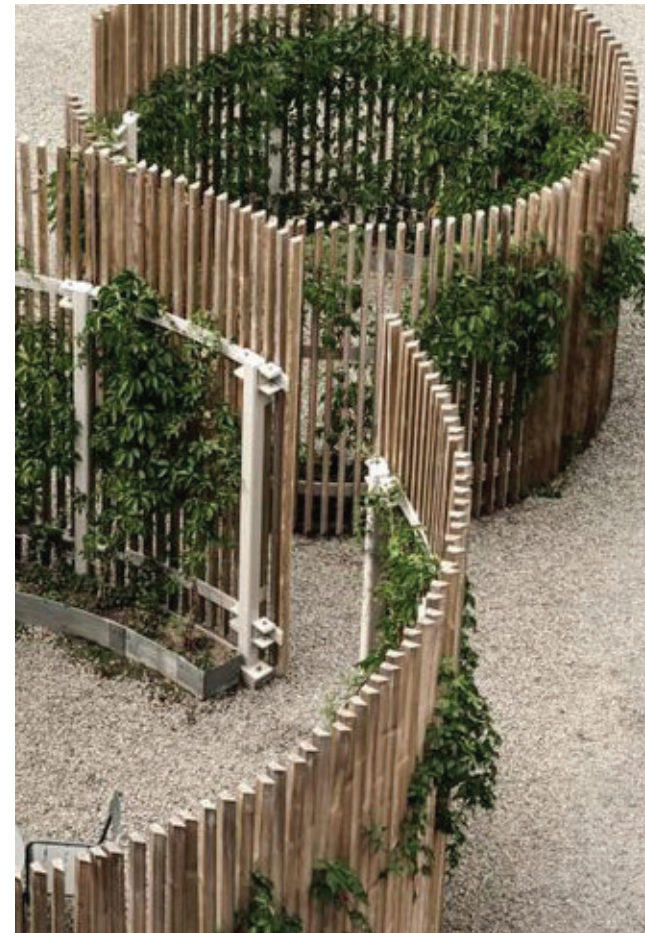
1.2 Water Reservoir

- Remove existing fence and replace with Timber Batten or Perforated Corten Steel Screening fence. Ensure adequate vertical spacing / perforations so visual surveillance through fence is maintained;
- Opportunity to incorporate endemic vertical climbing plants to blend fence better with natural surrounds.

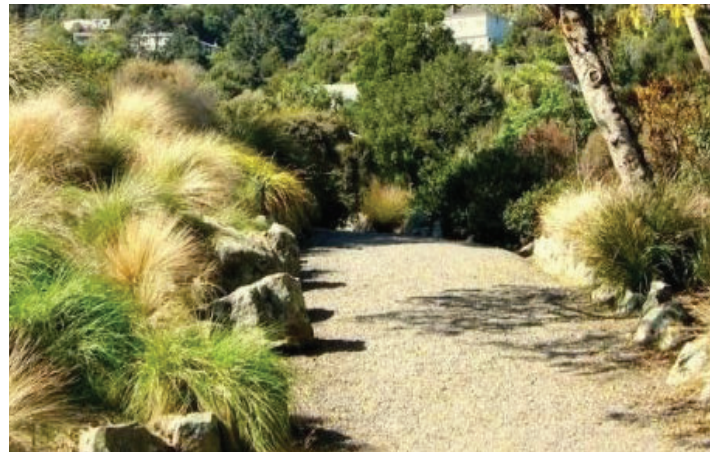
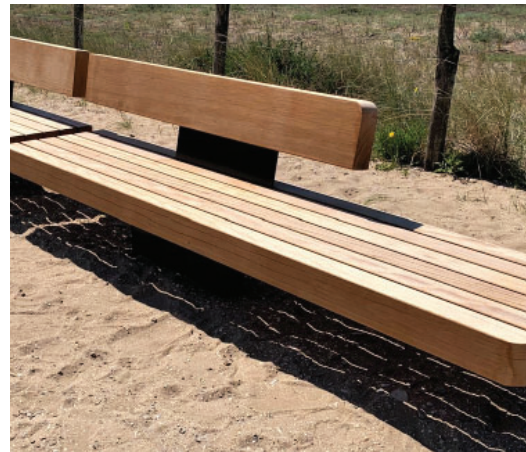
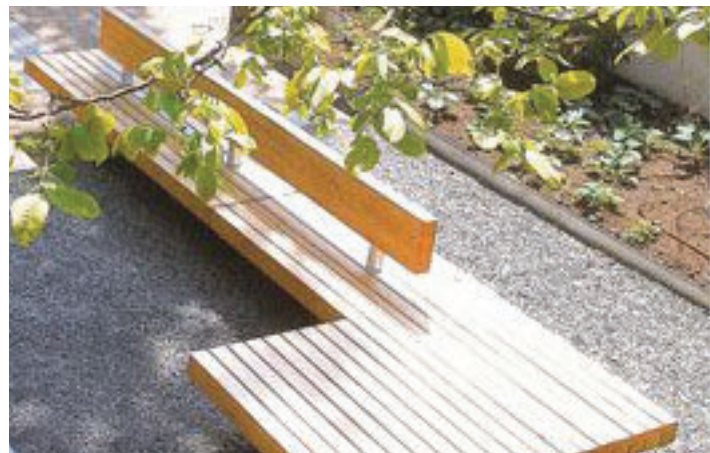
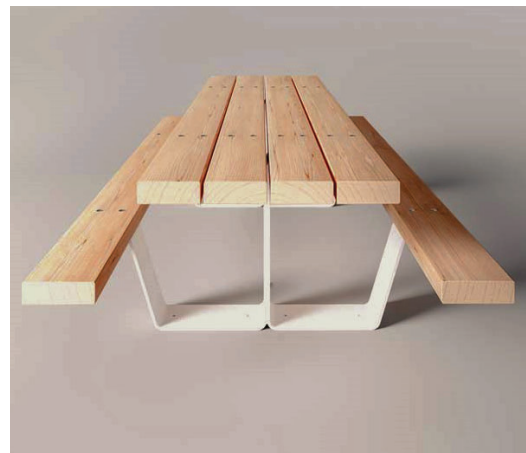
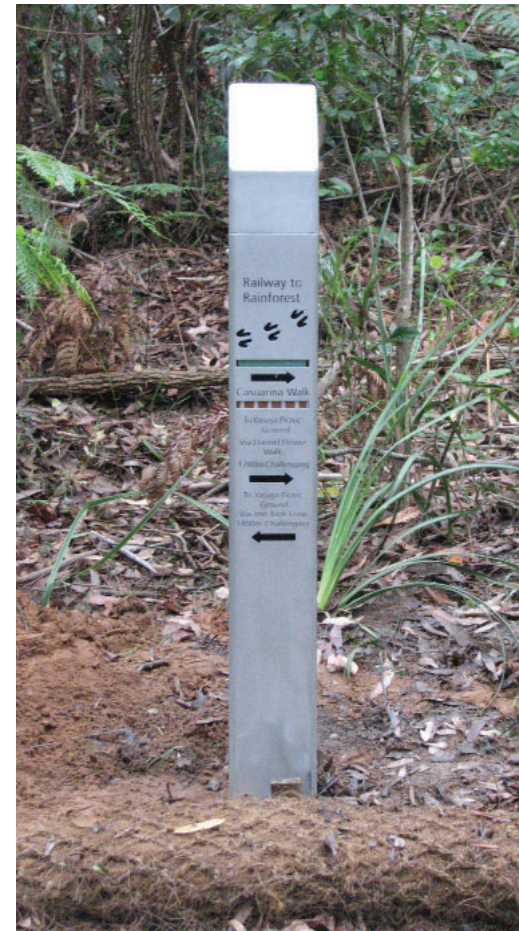
1.3 Trail and Furniture

- Retain alignment and layout of existing granitic sand path;
- Re-level, resurface and grade path to ensure safer access throughout trail;
- Provide robust Way-finding & Information Signage at key locations shown as: ⓘ
- Seated rest stops are provided at various locations along the trail;
- Ensure a variety of seating to allow for all ability access, backrests, arm rests, picnic and flexible bench seating.

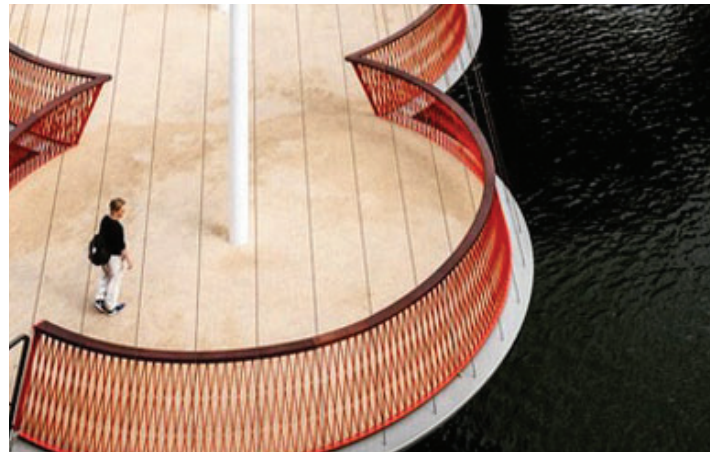
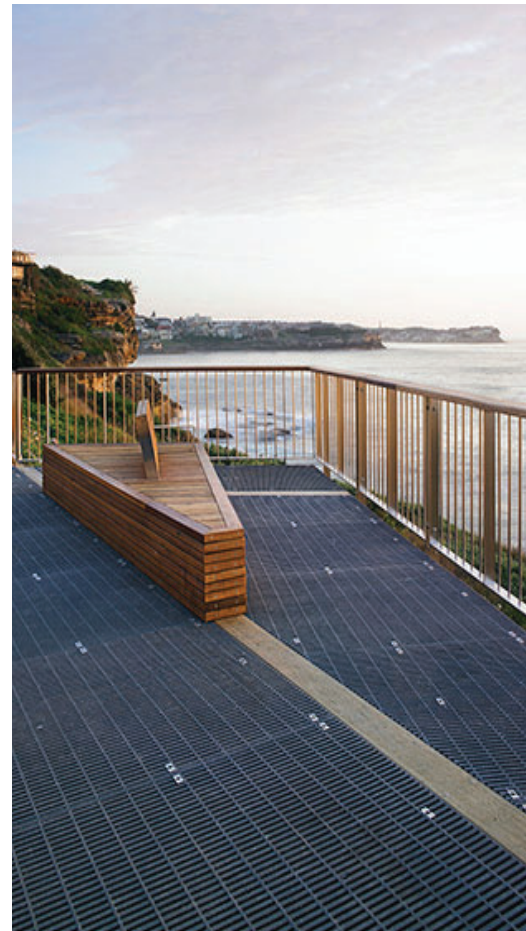
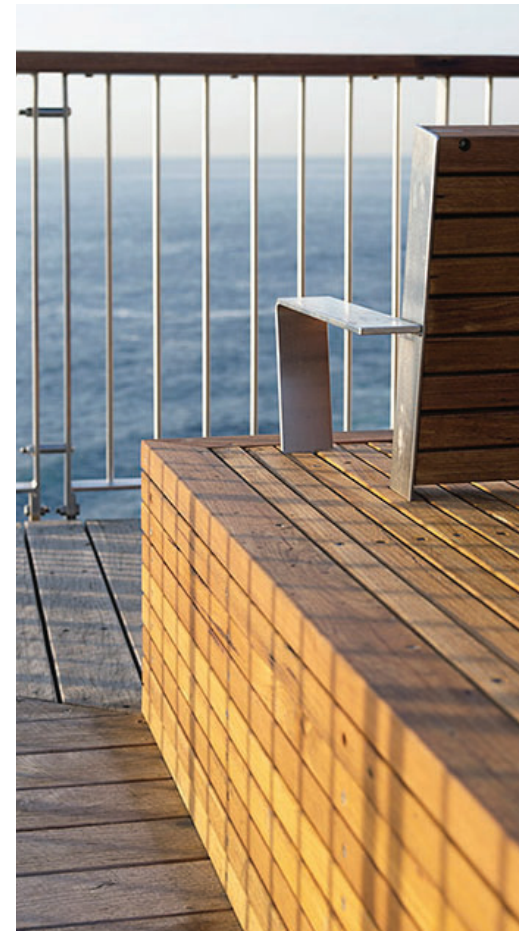
1.3 Lookout 01 (Southern)

- A new fencing arrangement that meets Australian Standards, the safety issues of the site and the aesthetics (i.e. railing configuration) of the site will be installed at this location.
- Images displayed are to provide examples of fencing options only, a phrase written in dialect and etched in timber etc.
